### Granite Downtakings – King Edward Steps

### Granite Downtakings – Wall Part 2

### Granite Downtakings – Wall

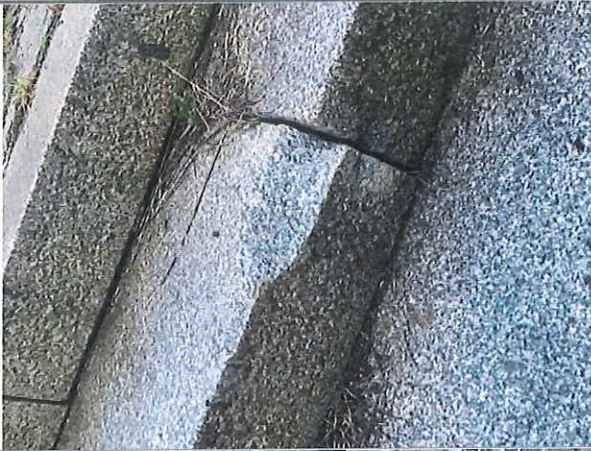
Step	Description	Image
2.7	Corner cracked

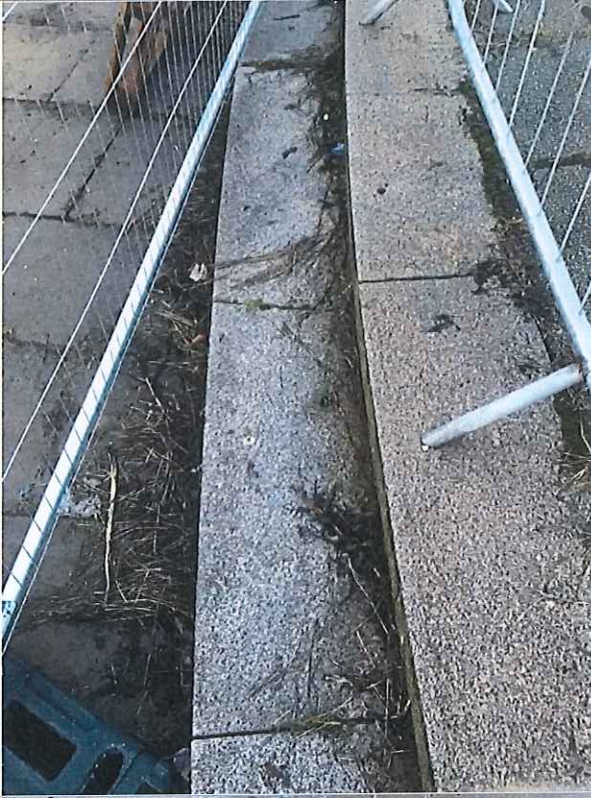
A close-up photograph of a concrete corner where a diagonal crack has formed. The crack runs from the top-left towards the bottom-right, splitting the concrete into two pieces. The surface is rough and appears to be part of a larger structure.
2.9	Split in two

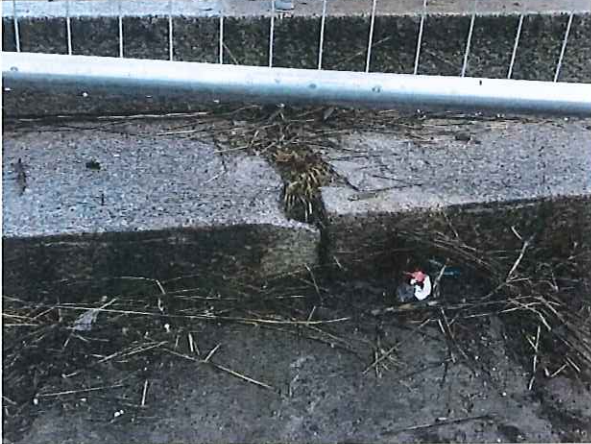
A photograph showing a concrete slab that has been split in two by a metal railing. The railing is positioned vertically, and the concrete has broken apart, with one piece shifted away from the other. The ground is covered with dry grass and debris.
2.10	Corner cracked
