# Appendix 1

Title UNION TERRACE GARDENS Balustrade Report As-Built			
Original Scale As Shown	Designed/Drawn Fraser Conway	Checked Fraser Conway	Authorised
Date 10/10/19	Date 10/10/19	Date 00/00/00	
Status W	Drawing Number UTG/FC002	Rev A

Project Title  
**Union Terrace Gardens**

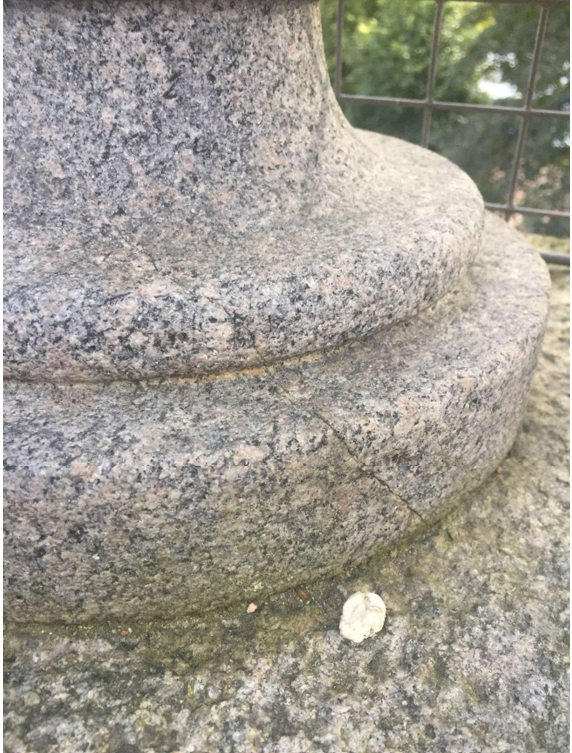
Item	Location	Description	Image
1	Section 1 Balustrade 9	Crack in base

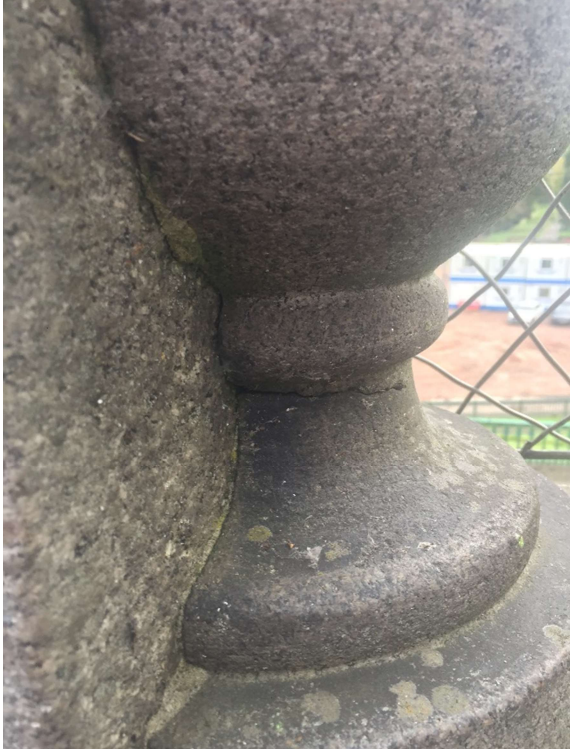
A close-up photograph of a stone balustrade base. The stone is dark grey with some lighter spots. A thin crack is visible in the lower part of the balustrade. A small, light-colored object, possibly a piece of debris or a small hole, is visible on the surface of the stone.
2	Section 3 Balustrade 1	Crack in base

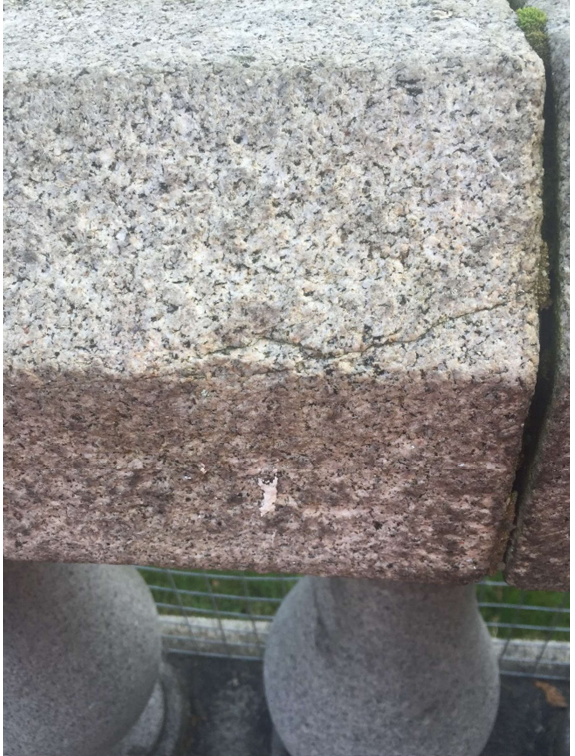
<p><b>3</b></p>	<p>Section 4 Slab 7</p>	<p>Crack in outer side</p>

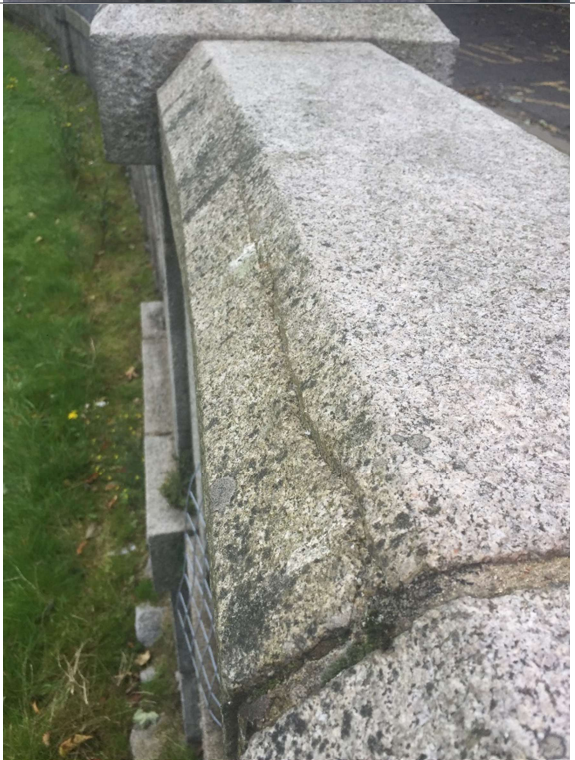
A close-up photograph of a concrete slab. The slab is light-colored with a dark, reddish-brown horizontal band near the bottom. A vertical crack is visible on the right side of the slab. Below the slab, two large, rounded concrete supports are visible.
<p><b>4</b></p>	<p>Section 4 Slab 13</p>	<p>Crack in inner side</p>

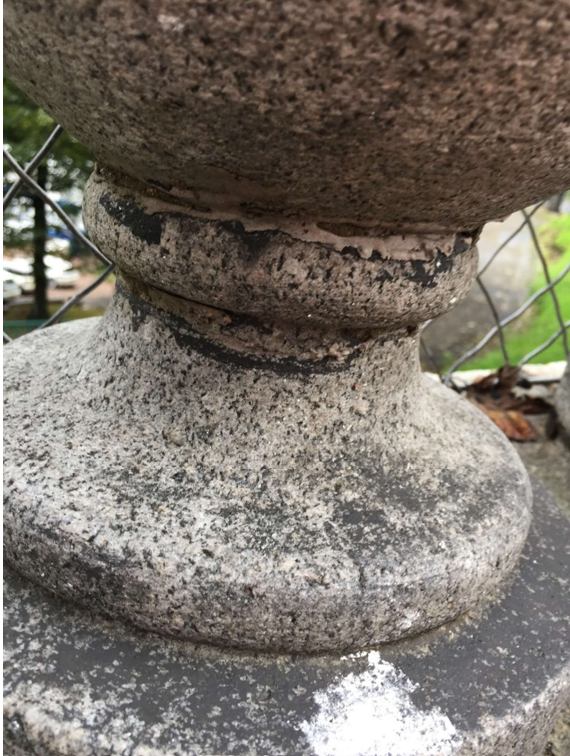
<p>9</p>	<p>Section 6 Balustrade 6</p>	<p>Patch up job over crack through bottom neck</p>

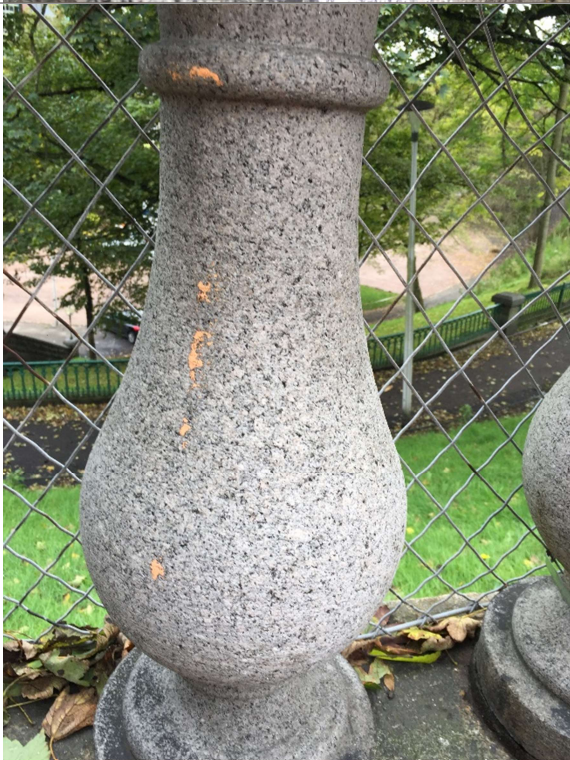
<p>10</p>	<p>Section 6 Balustrade 20</p>	<p>Paint over balustrade</p>

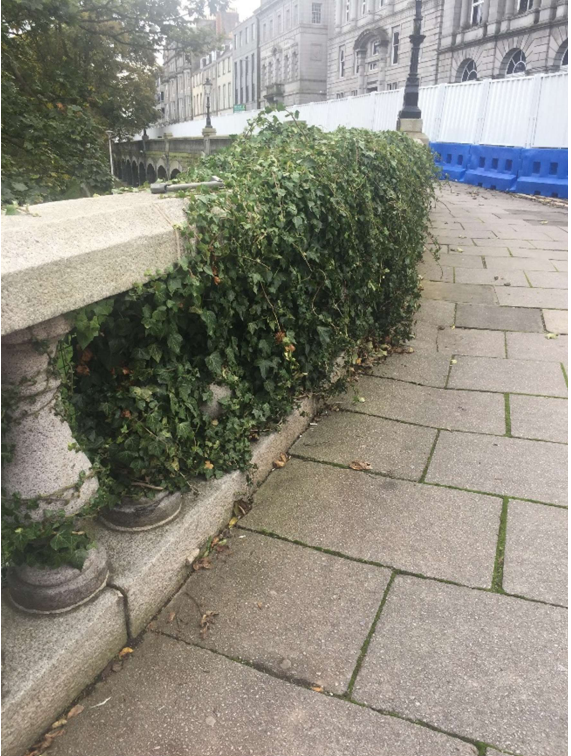
<p><b>11</b></p>	<p>Section 7</p>	<p>Ivy covering balustrade, potential damage caused</p>

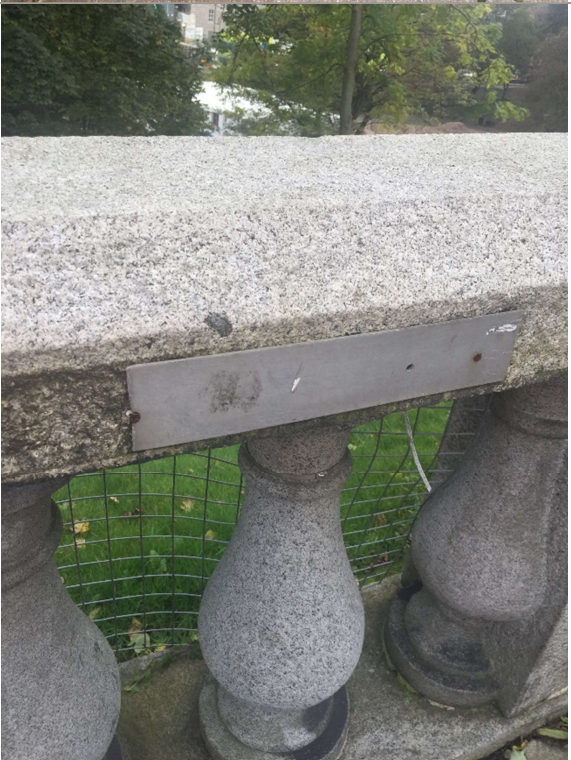
<p><b>12</b></p>	<p>Section 7</p>	<p>Metal plate, potentially covering crack or adding support</p>

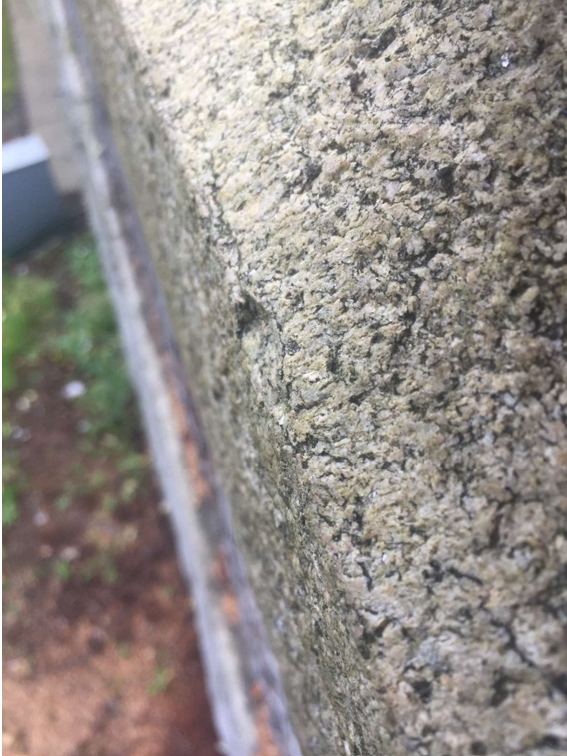
<p><b>15</b></p>	<p>Section 9 Slab 9</p>	<p>Chip along inner edge</p>

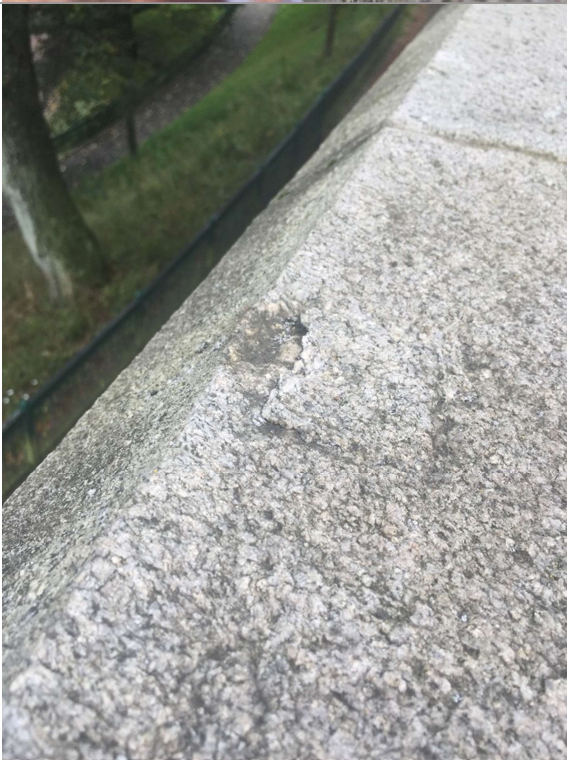
<p><b>16</b></p>	<p>Section 11 Slab 5</p>	<p>Chipped along inner edge</p>

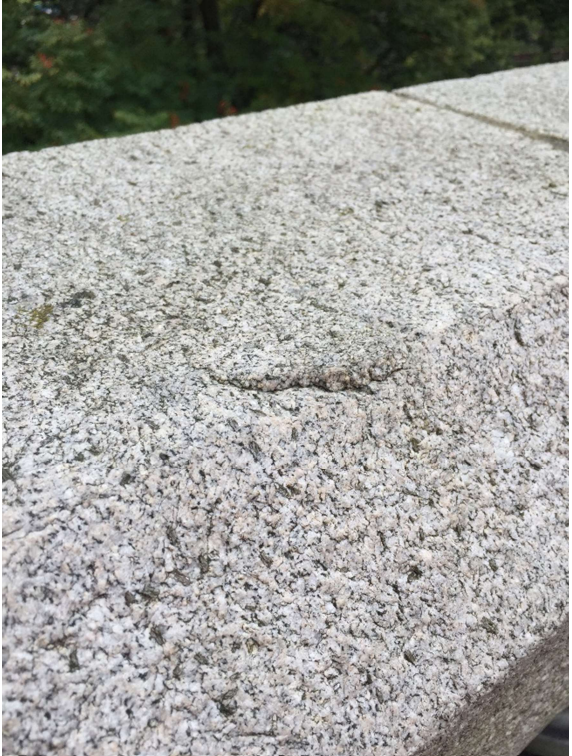
<p><b>17</b></p>	<p>Section 12 Slab 12</p>	<p>Chipped along outer edge</p>

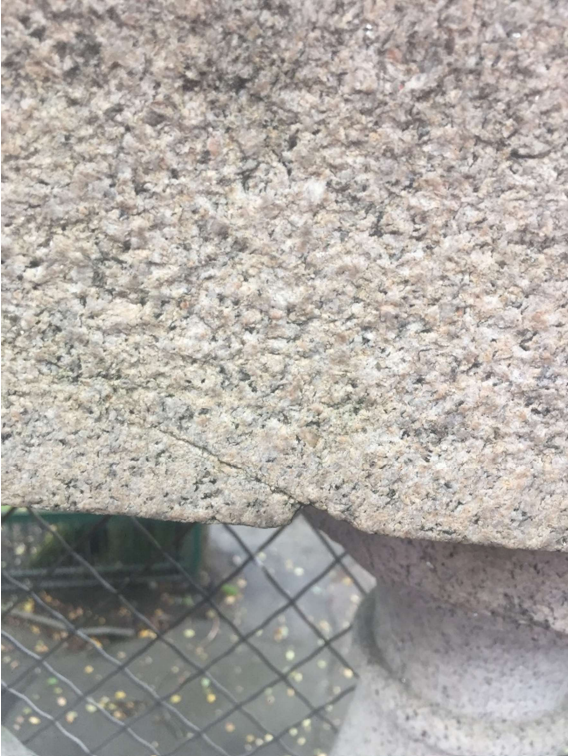
<p><b>25</b></p>	<p>Section 18 Slab 6</p>	<p>Crack in outer side</p>

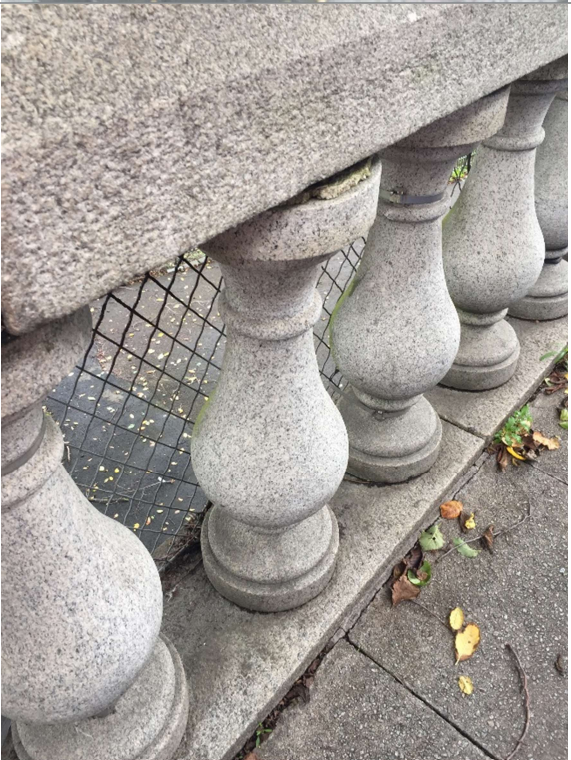
A close-up photograph of a concrete slab. A distinct crack runs horizontally across the top surface of the slab. Below the slab, a metal mesh fence is visible, and some greenery is seen in the background.
<p><b>26</b></p>	<p>Section 18 Balustrade 9</p>	<p>Out of place at top of balustrade (crooked)</p>

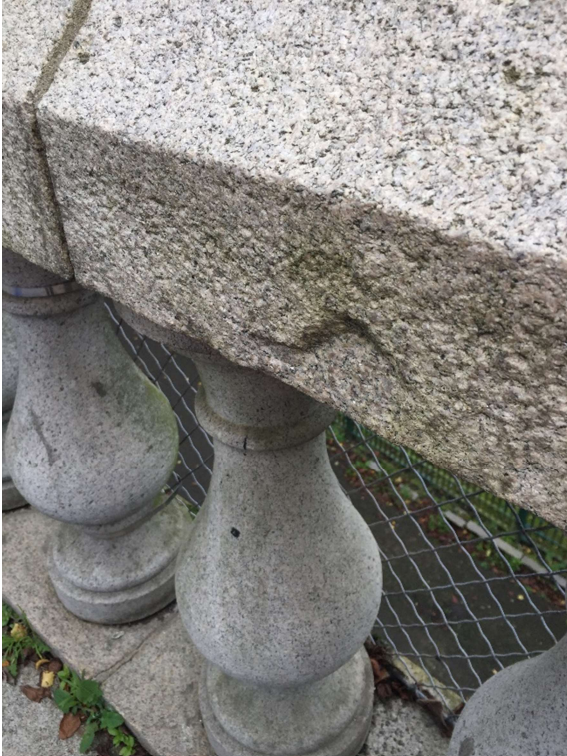
<p><b>27</b></p>	<p>Section 19 Slab 9</p>	<p>Chip in outer side</p>

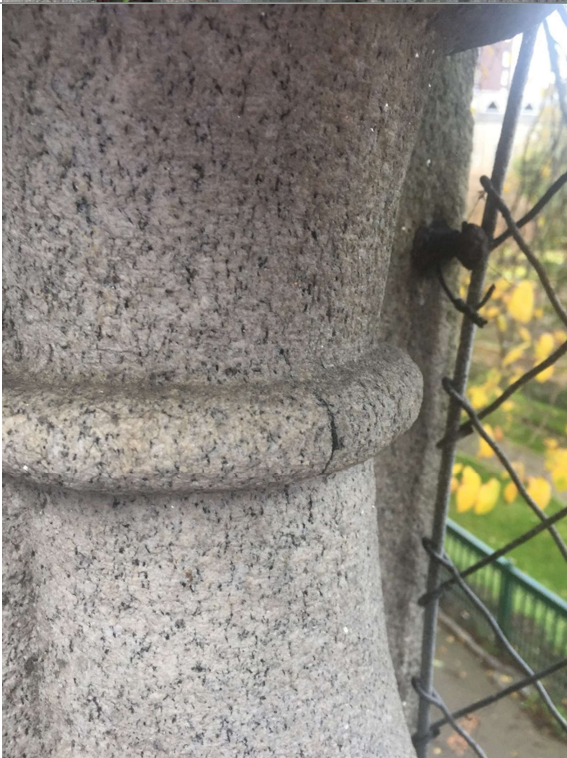
A close-up photograph of a stone balustrade slab. The slab is made of light-colored, textured stone. On the right side of the slab, there is a distinct chip or missing piece of stone. Below the slab, a metal mesh fence is visible, and the ground appears to be paved with some small plants growing between the stones.
<p><b>28</b></p>	<p>Section 19 Balustrade 1</p>	<p>Crack in south of upper neck</p>

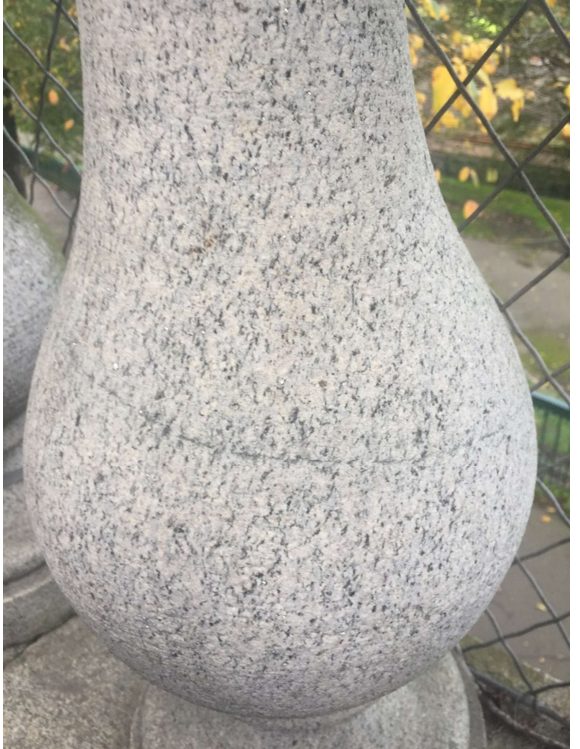
<p><b>29</b></p>	<p>Section 19 Balustrade 3</p>	<p>Crack around the middle</p>

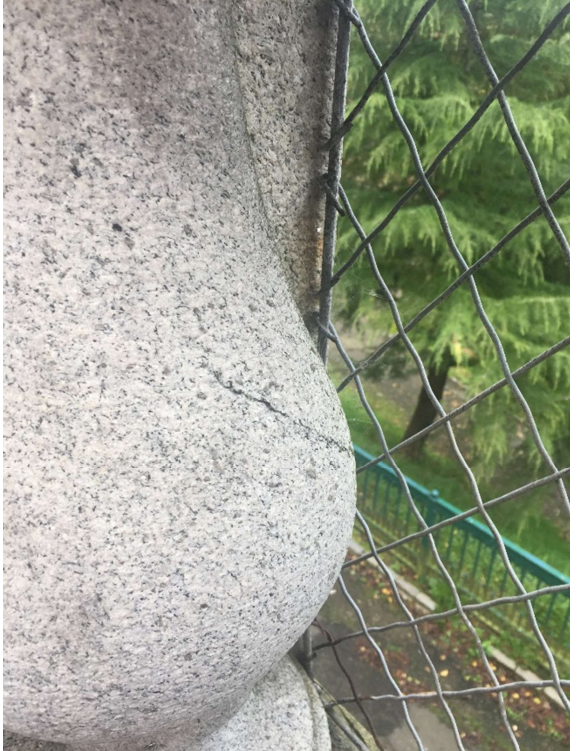
<p><b>30</b></p>	<p>Section 20 Balustrade 1</p>	<p>Crack in south of middle section</p>

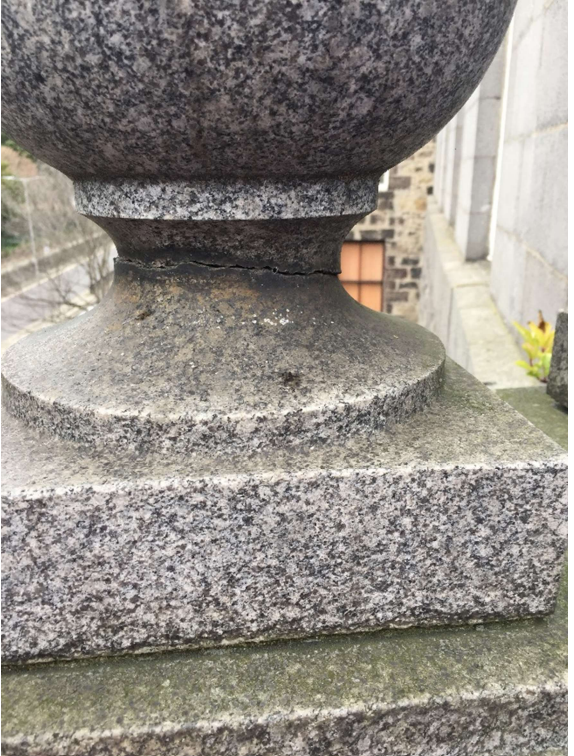
<p><b>41</b></p>	<p>East Union Street Section Balustrade 5</p>	<p>Crack through bottom neck</p>

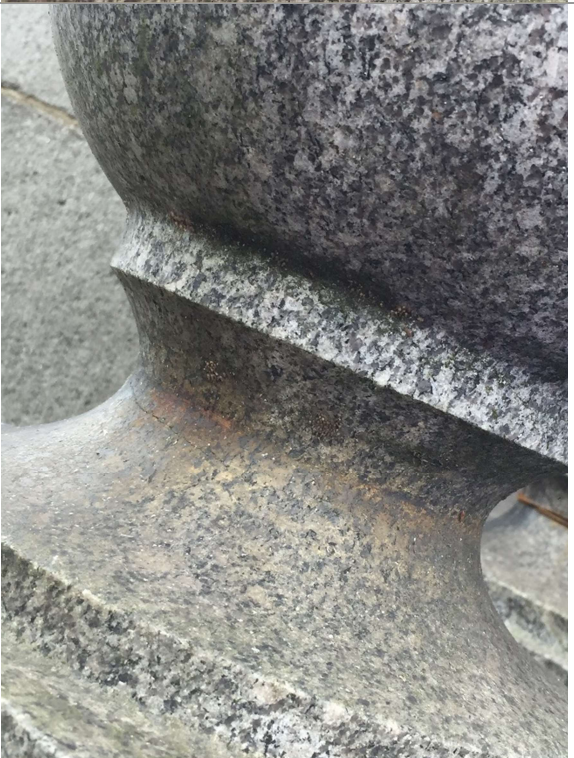
<p><b>42</b></p>	<p>East Union Street Section Balustrade 7</p>	<p>Crack in bottom neck</p>
