**Aberdeen City Council**

**RAAC Inspections  
Balnagask Mono-Pitches**

**November 2023**

**CLIENT:** Aberdeen City Council  
**PROJECT TITLE:** RAAC Inspections - Balnagask Mono-Pitched Properties  
**REPORT TITLE:** Intrusive Inspection Report  
**PROJECT REFERENCE:** 157606  
**DOCUMENT NUMBER:** 157606/Report

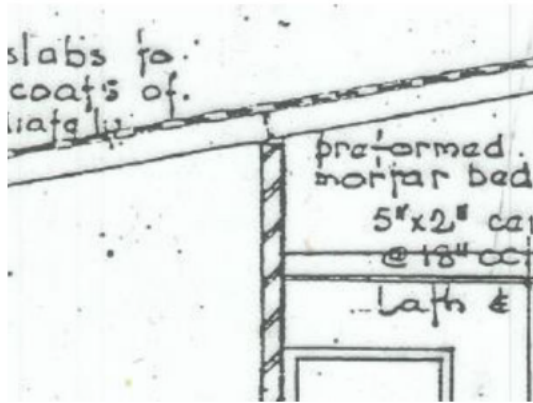
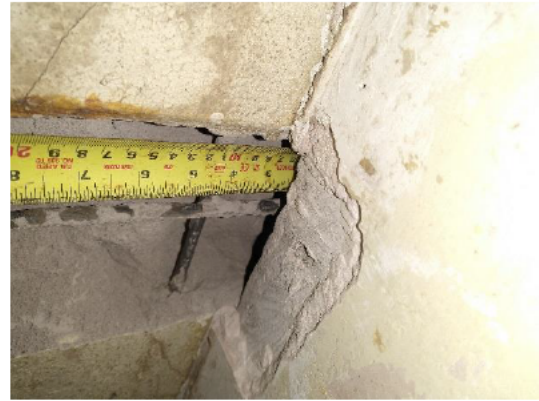
10.2. Panel bearings at central load bearing internal brickwork partition are typically 40-60mm i.e. 2no. panels bearing onto 114mm thk brickwork wall (<75mm requirement);

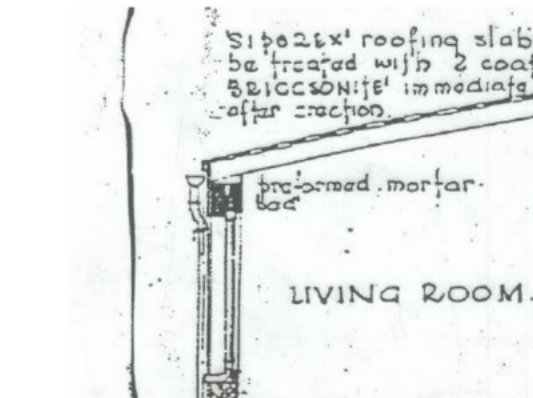
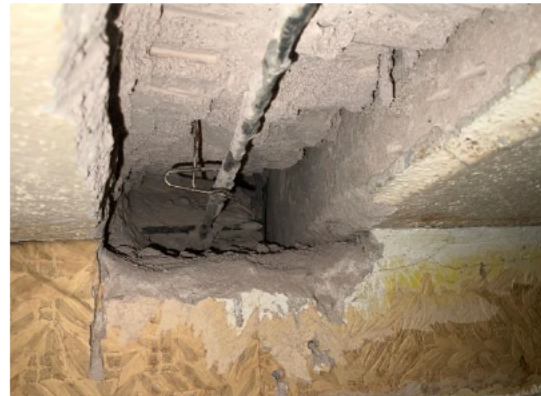
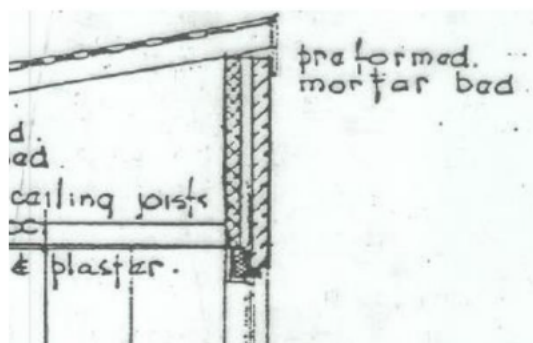
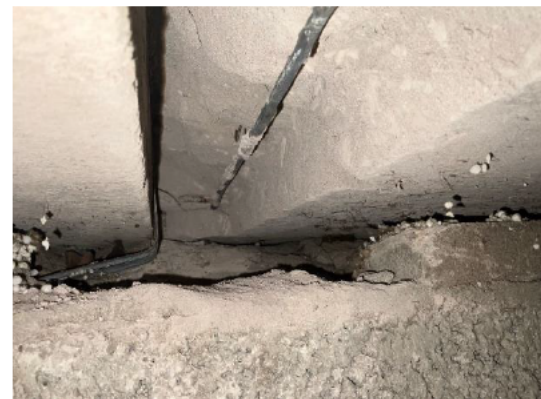
10.3. Panel bearings at front and rear external walls are typically 150mm+ (>75mm requirement);

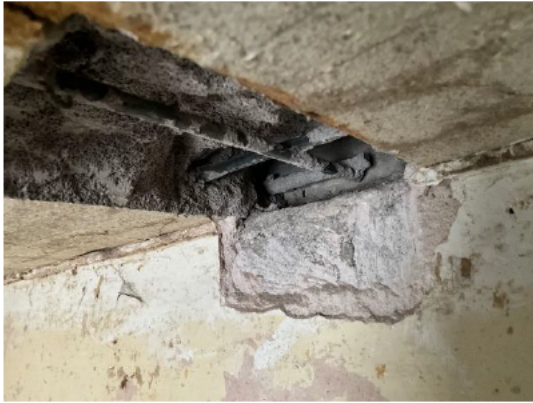
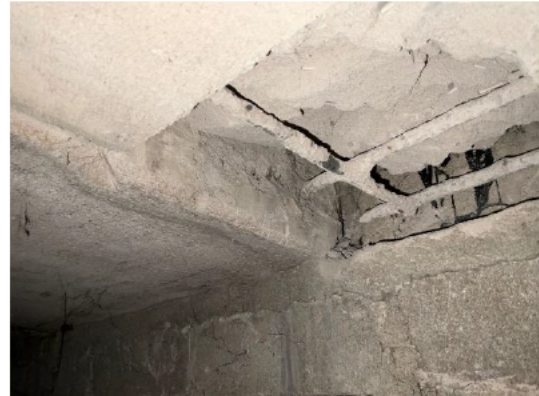
10.4. The transverse anchorage reinforcement was present over the bearing at all panels inspected;

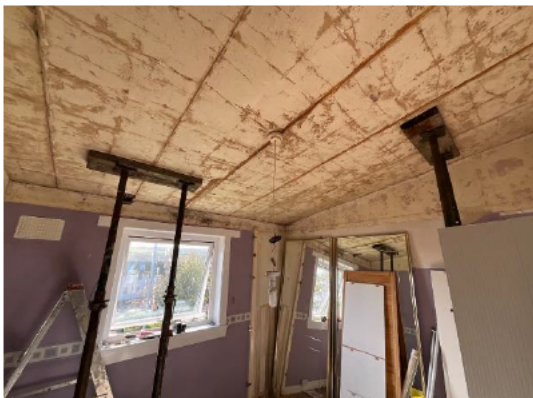
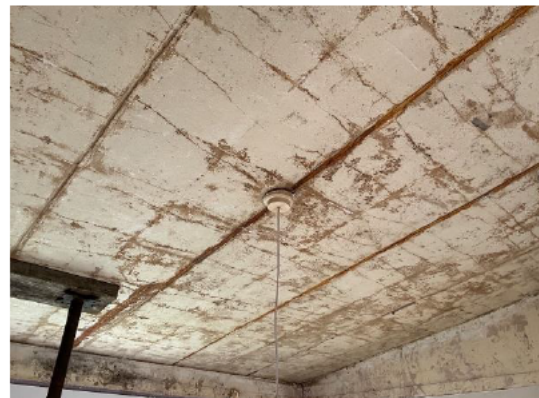
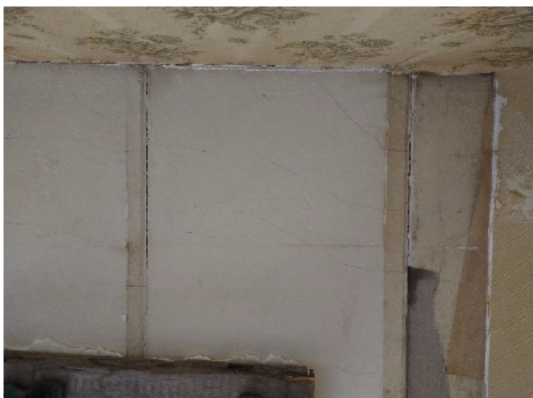
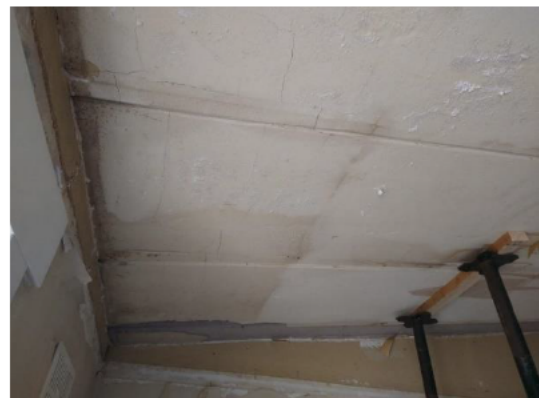
10.6. Consistent transverse cracks along the full length of the panels and close to the bearings were noted throughout [REDACTED] Balnagask Road;

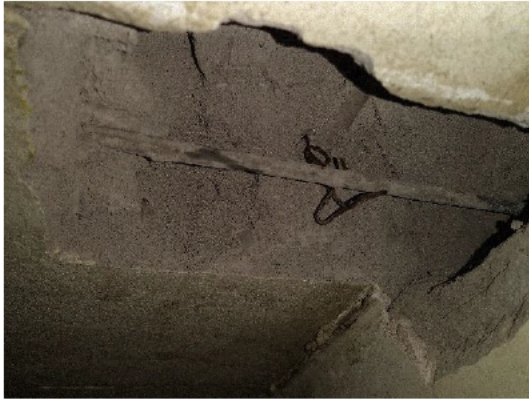
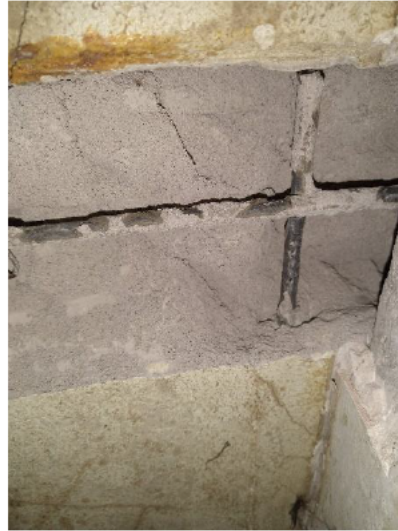
10.7. These transverse cracks typically travel through the full depth of the panels, and therefore should be classed as 'major';

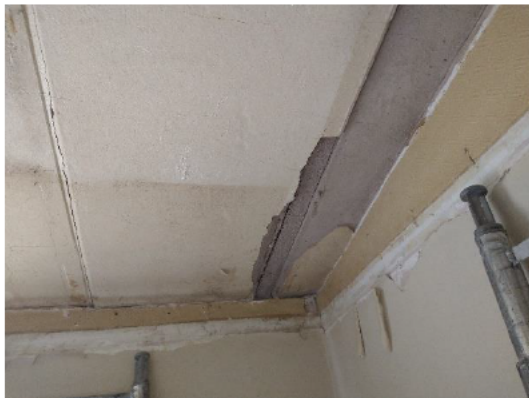
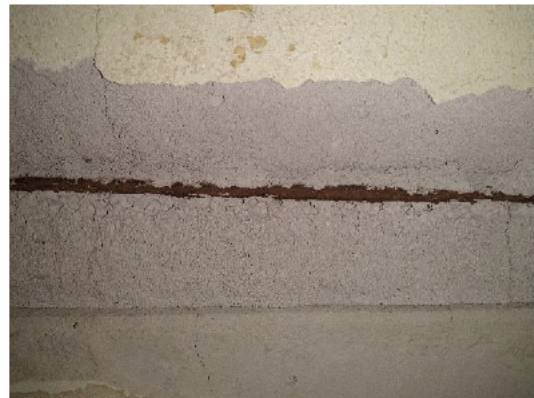
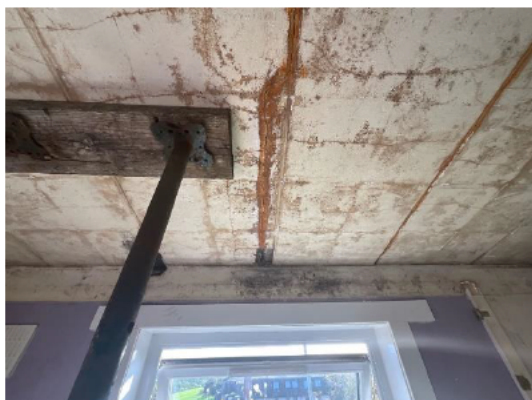
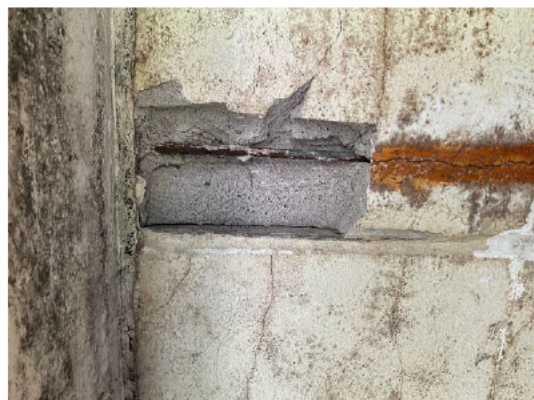
10.8. We also noted several longitudinal cracks to the panels. These are typically combined with spalling of the concrete and corrosion of the longitudinal reinforcement bar;

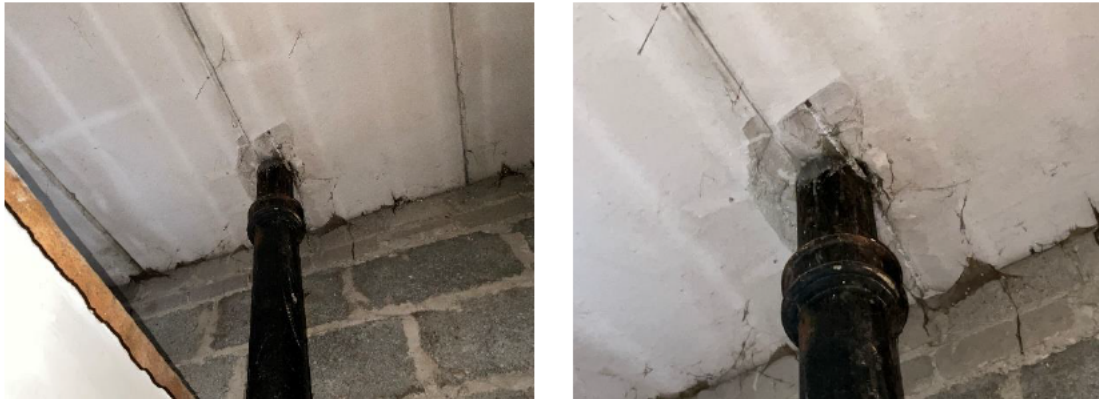
10.9. SVPs were noted at the property. These are located within a cupboard, penetrate two of the RAAC panels and project from the roof. These are shown on the original drawings, however, the penetrations appear to have been carried out on site, with damage to the panel and reinforcement visible;

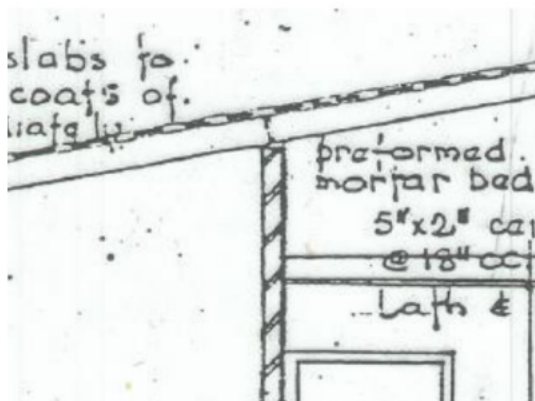
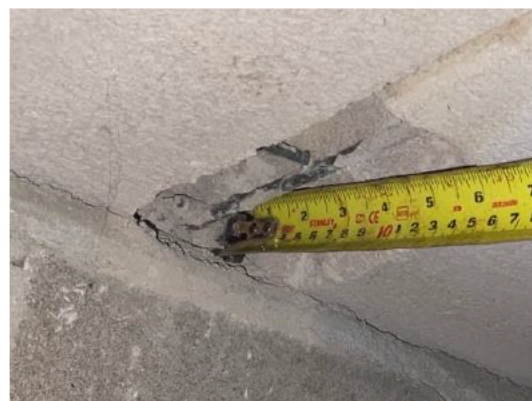
11.2. Panel bearings at central load bearing internal brickwork partition are typically 40-60mm i.e. 2no. panels bearing onto 114mm thick brickwork wall (<75mm requirement);

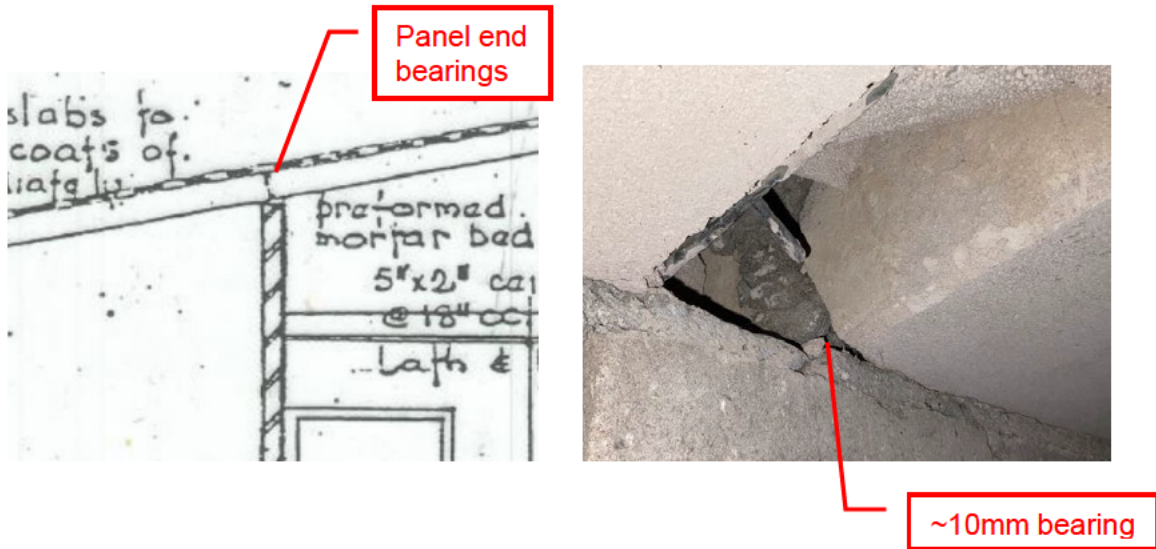
11.3. 1No. panel was seen to have a bearing at the central load bearing internal brickwork partition of approx. 10mm (<75mm requirement), with the gap between the end-to-end panels filled with poor quality infill mortar and general builder's debris.

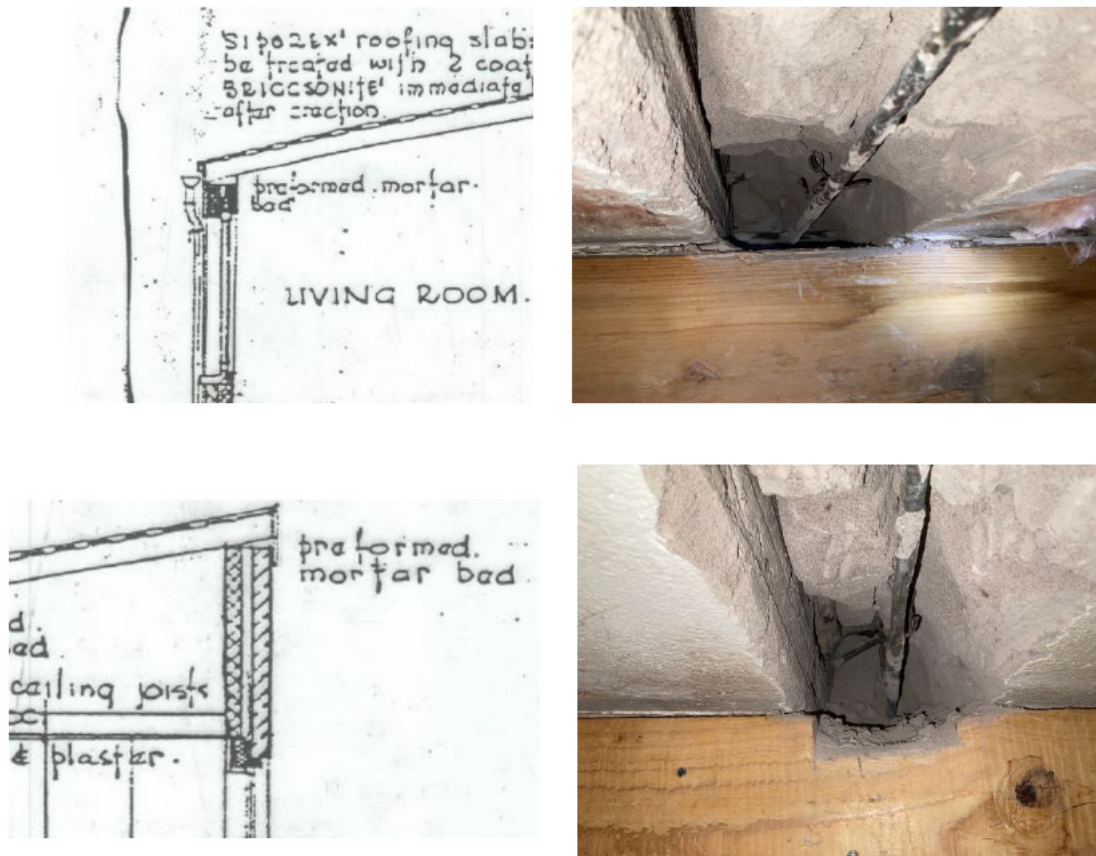
11.4. Panel bearings at front and rear external walls are typically 150mm+ (>75mm requirement);

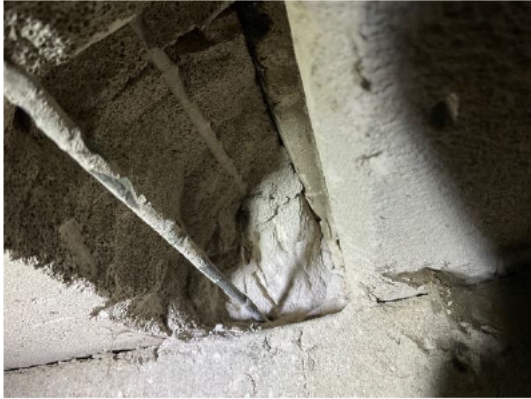
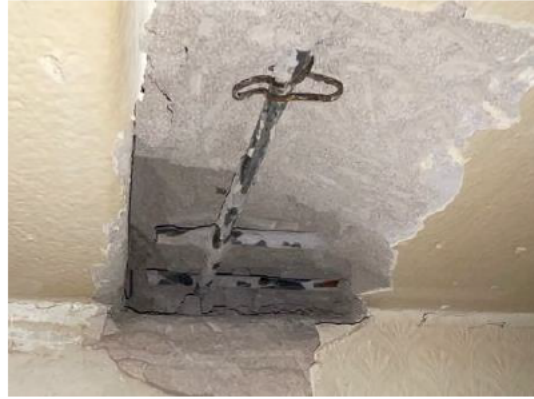
11.5. The transverse anchorage reinforcement was present over the bearing at all other panels inspected;

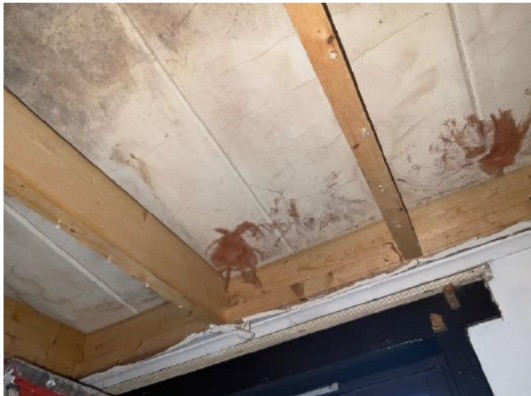
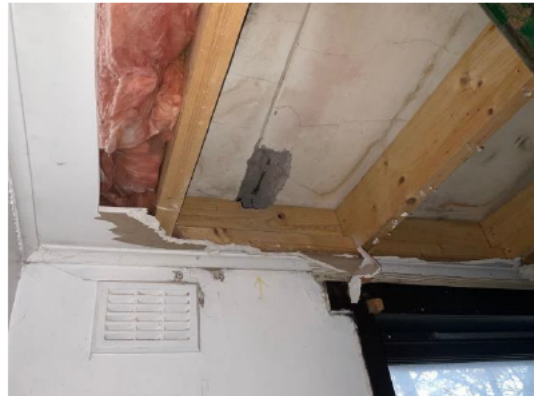
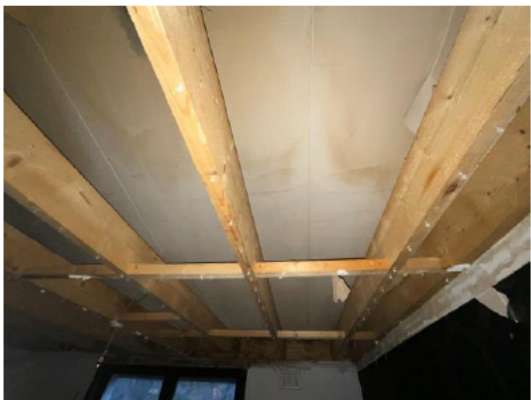
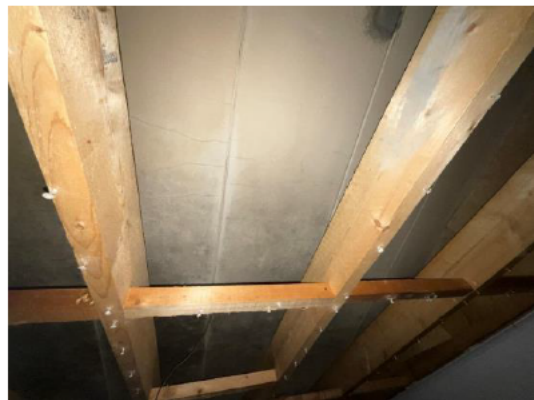
11.7. Consistent transverse cracks along the full length of the panels and close to the bearings were noted throughout █ Pentland Crescent;

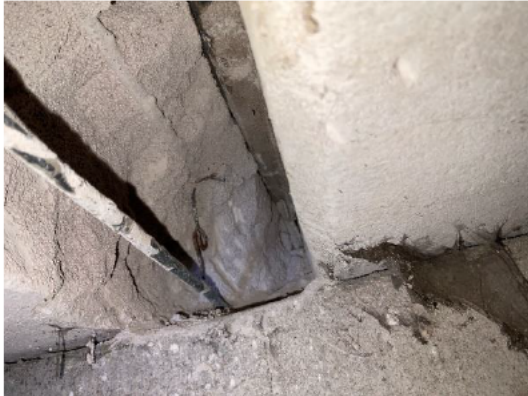
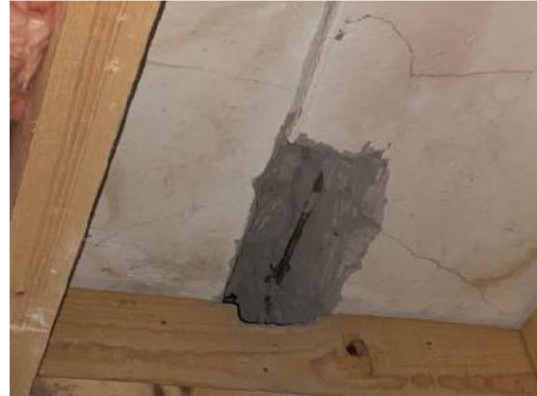
- 11.8. These transverse cracks typically travel through the full depth of the panels, and therefore should be classed as 'major';

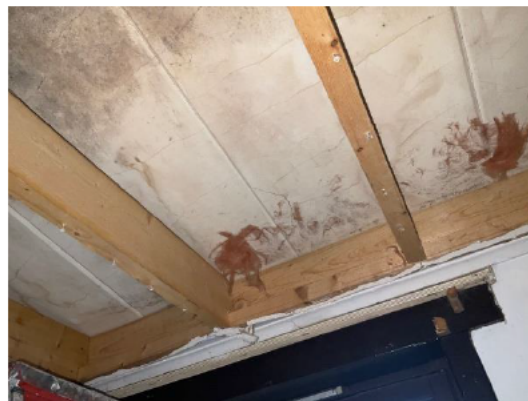
- 11.9. We also noted several longitudinal cracks to the panels. These are typically combined with spalling of the concrete and corrosion of the longitudinal reinforcement bar;
