Balnagask
Outline RAAC Business
Case Review
July 2024
Issue 1

PROJECT TITLE:Balnagask RAAC Review

REPORT TITLE: Balnagask Outline RAAC Business Case Review

PROJECT REFERENCE: 160260

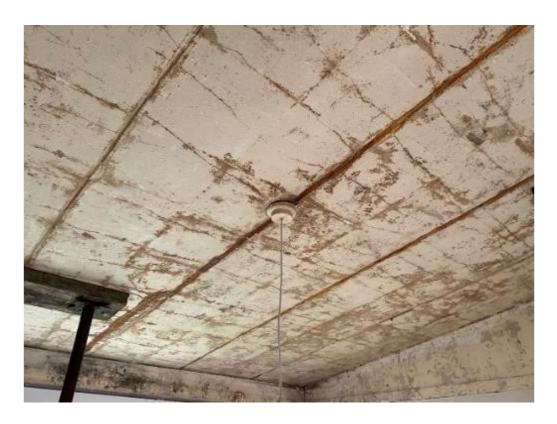
Figure 6: Typical RAAC panels condition observed during surveys

The properties at Balnagask are two-storey buildings with traditional cavity blockwork wall construction and mono-pitched 125mm (5") thick RAAC roof panels spanning front to back, bearing onto external walls and a 100mm thick central concrete brickwork partition. See Figures 2 - 5 showing typical existing building construction. Figure 6 shows the typical RAAC panels condition observed during structural surveys.

All of the slabs in the occupied and void properties inspected have transverse cracking, along the full length of the panel, including potential shear cracks within 500mm of the bearings. These cracks also typically travel through the full depth of the panels.

All of the slabs in the properties inspected have deflections generally similar.

All of the slabs in properties inspected found service penetrations/builder modifications.

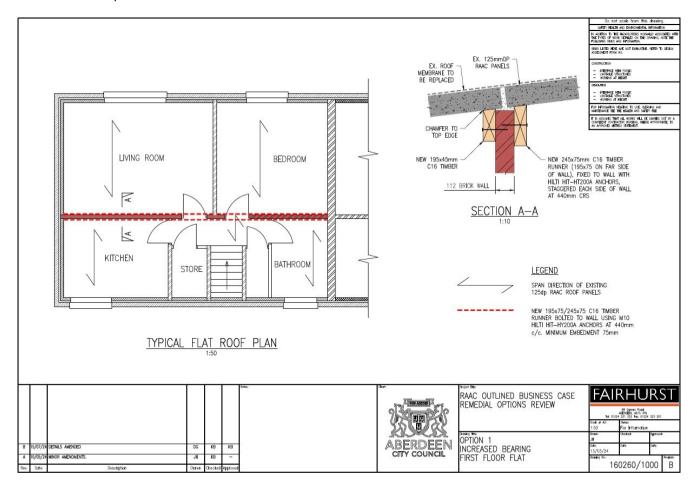
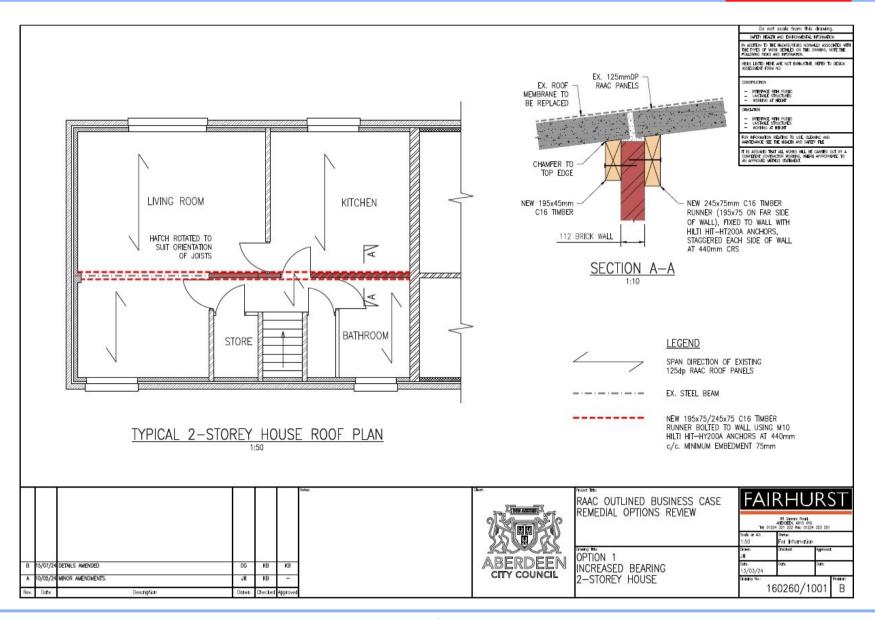
By virtue of the fact that the central support wall is only 100mm wide, none of the slabs supported on the central wall achieve the required 75mm minimum bearing, required by the IStructE guidance. Notwithstanding the fact that as part of the overall Risk Assessment we have undertaken and proven in all but one of our inspections that both longitudinal and transverse bars exist at the slab bearings along the central 100mm wide wall. Of all the slabs inspected to date, one slab within an unoccupied property was found to have a bearing of 10mm. This slab was considered **RED Critical**. Propping was put in place to temporarily address this defect.

This option would involve fixing timber runners to the face of internal 100mm brick walls thus increasing bearing to satisfy the minimum bearing requirement of 75mm. See drawings 160260/1000/1001 for proposed remedial details for both the 2 storey house and flatted property. Refer to **Table 2** for a risk category assessment for each of the remedial option.

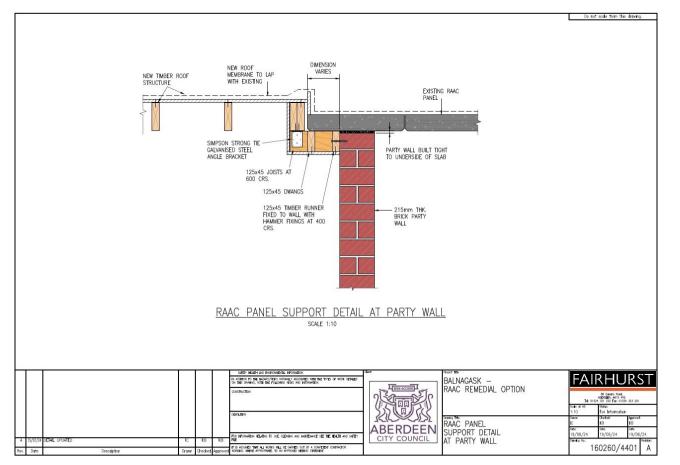
RAAC Panels Party Wall Support Remedial Detail

During our surveys existing RAAC panels were found to be bridging over party walls between properties. The 215mm party wall was also found to be built tight to underside of panels. Please see adjacent drawing showing the typical as built panel arrangement. To minimise disruption to adjacent properties during the removal of RAAC panels the following has been proposed:

Panels Over Party Wall: Panels that are directly over the party wall will remain in place. This ensures stability and avoids unnecessary disturbance to adjacent properties.

Timber Support Frame: A timber support frame will be installed under the overhang of the RAAC panel. By doing so, a small section of the RAAC panel becomes structurally redundant. This approach allows for safer removal without compromising the adjacent property.

Sequencing of Works: The removal process will be carefully sequenced to minimise both disruption and vibration to neighbouring properties during the construction.

New Roof Membrane Flashing: As part of the process, new roof membrane flashing will be installed up to the external face of the party wall. This ensures proper waterproofing and protects against any potential leaks.
