FAIRHURST

Aberdeen City Council

Balnagask

Re-inspection Reports

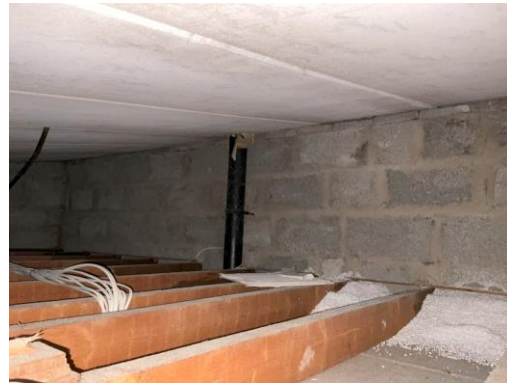
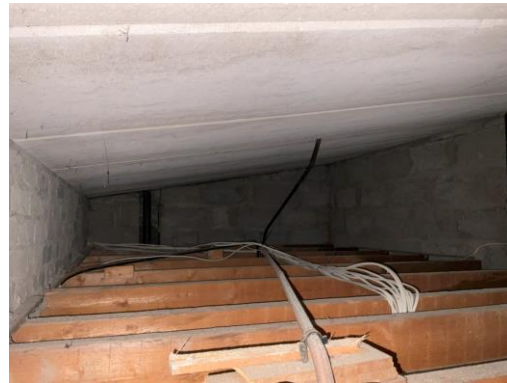
**Builder's works / building modifications
(High Risk)**

- Typically cored on site during construction for penetration of conduits and SVP with damage to units.
- No changes noted during inspection dated 27/01/2025.

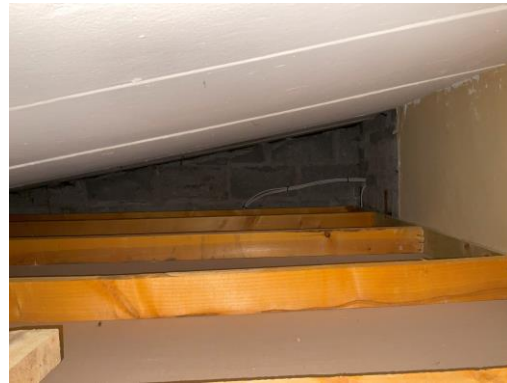
Deflection measurements (Medium Risk)

- No deflection measurements taken through the hatches, however, no excessive deflections noted from visual inspection.
- No changes noted during inspection dated 27/01/2025.

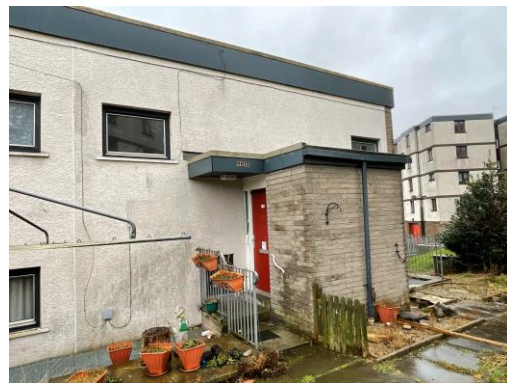
Adverse or changes in loading (Medium Risk)

- Replacement roofing system with additional insulation noted.
- No changes noted during inspection dated 27/01/2025.

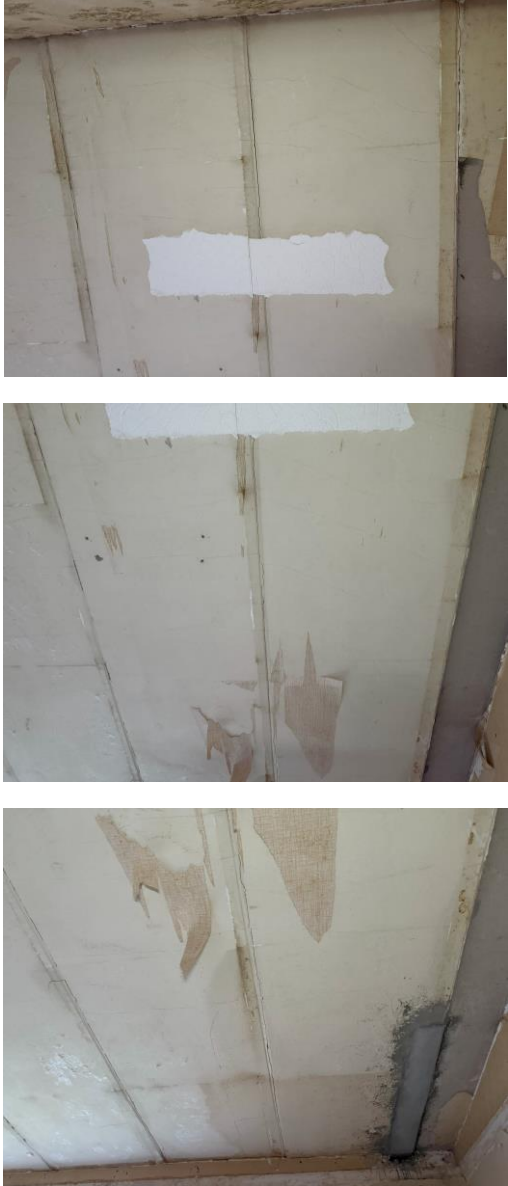
Three photographs stacked vertically, showing different areas of transverse cracking in panels. The top photo shows a horizontal crack across a panel. The middle photo shows a vertical crack and some peeling material. The bottom photo shows a vertical crack and some peeling material, similar to the middle photo. The panels are light-colored and appear to be part of a wall or ceiling structure.

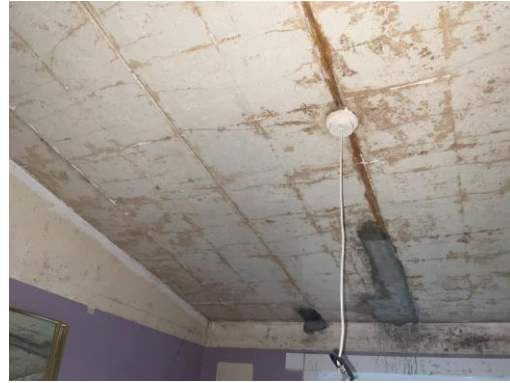
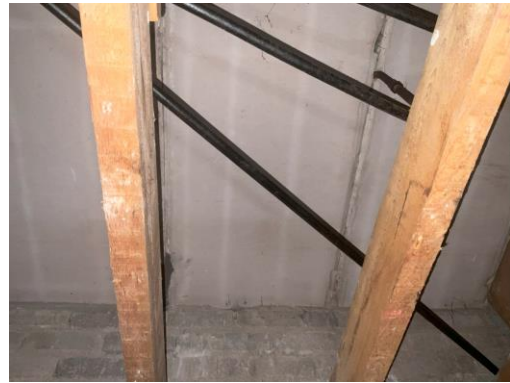
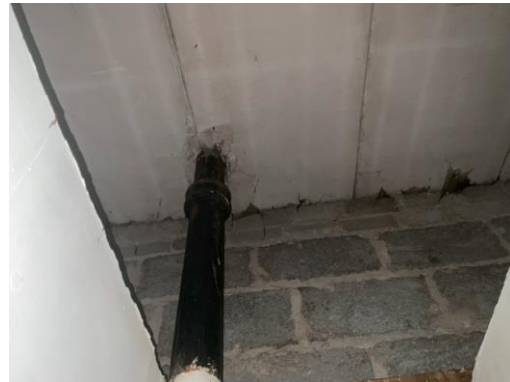
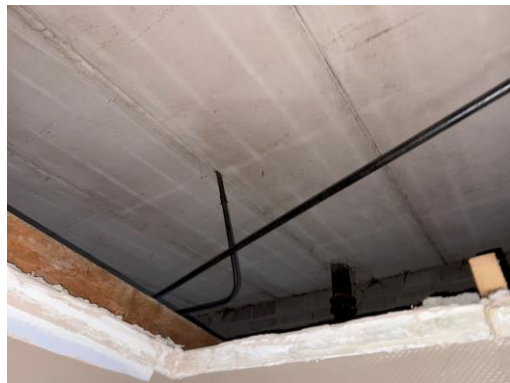
- Typically cored on site during construction for penetration of conduits and SVP with damage to units.

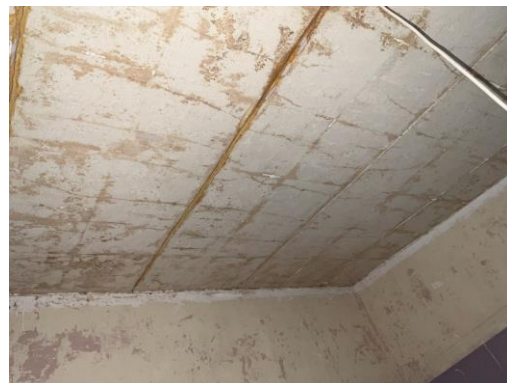
- Deflection measurements were taken during the initial inspections, with no issues present.
- Areas were visually inspected during this follow up inspections, with no issues noted.

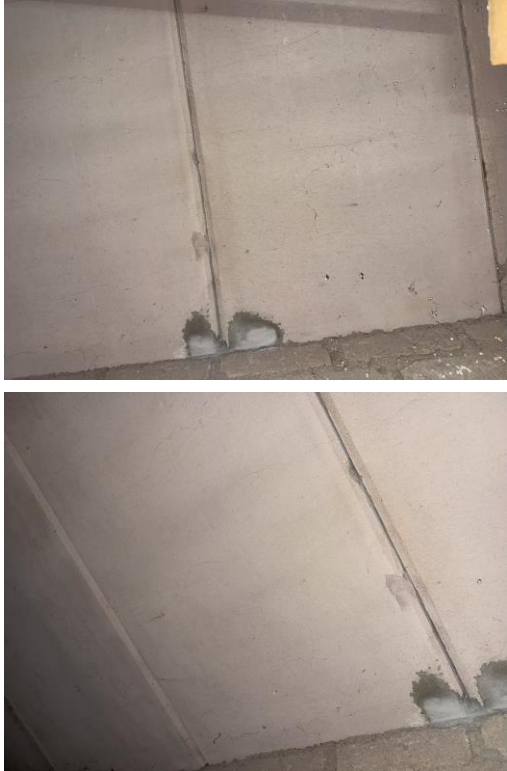
Risk Factors	Typical Survey Photographs
Cut panels (Low Risk) <ul style="list-style-type: none">– We did not identify any cut panels within the property via our hatch inspections.– No changes noted during inspection dated 23/01/2025.	
Cracking (High Risk) <ul style="list-style-type: none">– Transverse cracking found along full length of panels and within 500mm of the support.– No changes noted during inspection dated 23/01/2025.

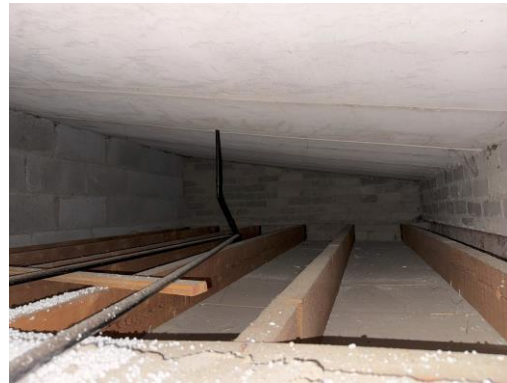
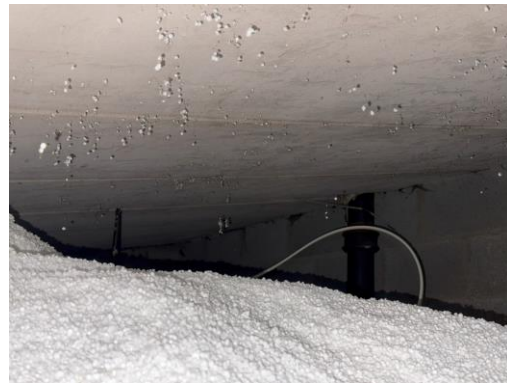
**Builder's works / building modifications
(High Risk)**

- Typically cored on site during construction for penetration of conduits and SVP with damage to units
- No changes noted during inspection dated 23/01/2025.

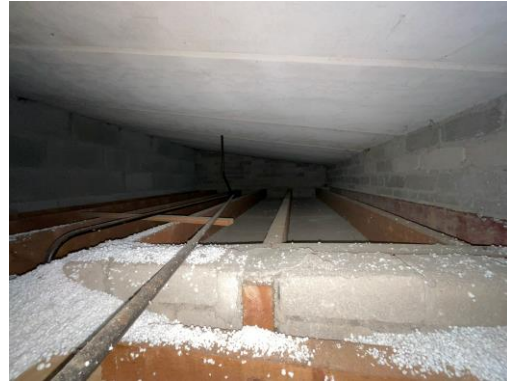
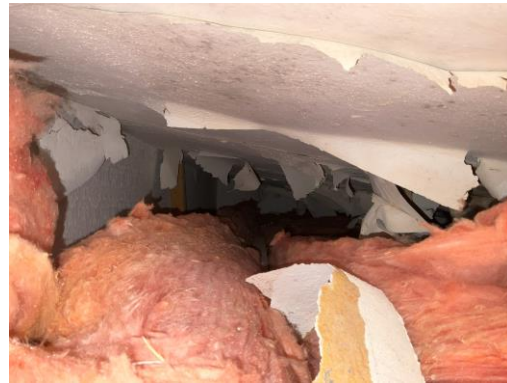
- No deflection measurements taken through the hatches, however, no excessive deflections noted from visual inspection.
- No changes noted during inspection dated 23/01/2025.

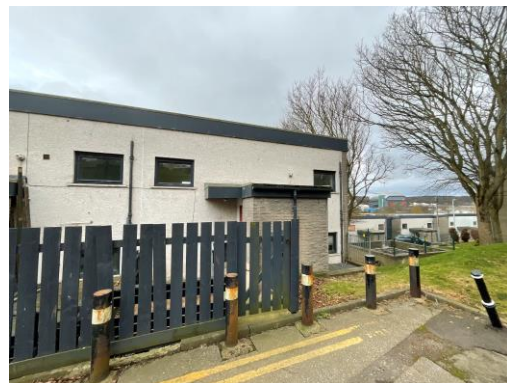
Adverse or changes in loading (Medium Risk)

- Replacement roofing system with additional insulation noted.
- No changes noted during inspection dated 23/01/2025.

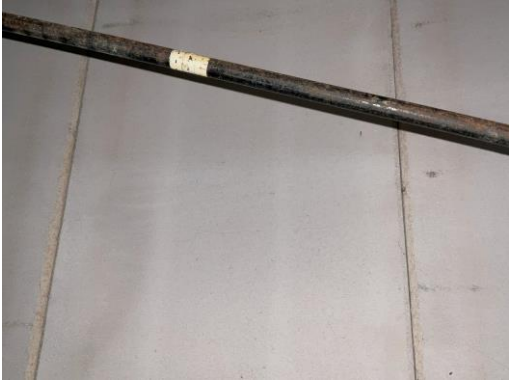
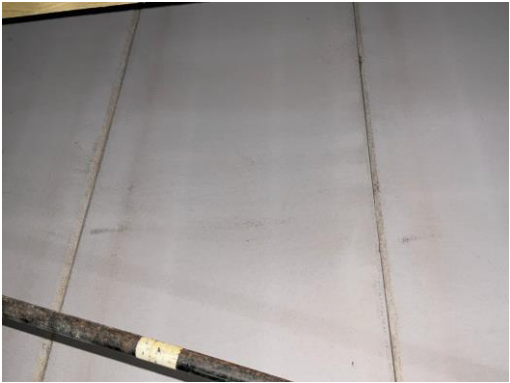
Risk Factors	Typical Survey Photographs
Cut panels (Low Risk) <ul style="list-style-type: none">– We did not identify any cut panels within the property via our hatch inspections.– No changes noted during inspection dated 23/01/2025.	
Cracking (High Risk) <ul style="list-style-type: none">– Transverse cracking found along full length of panels and within 500mm of the support.– No changes noted during inspection dated 23/01/2025.

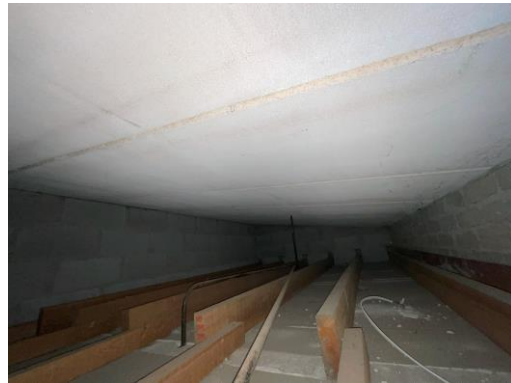
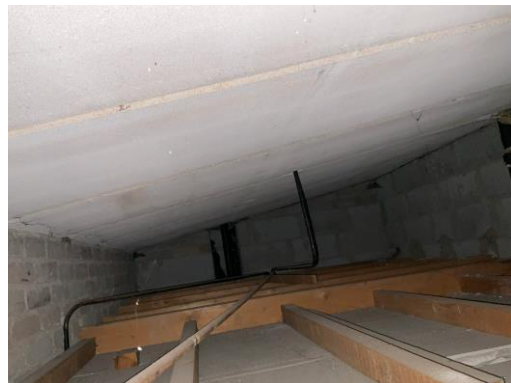
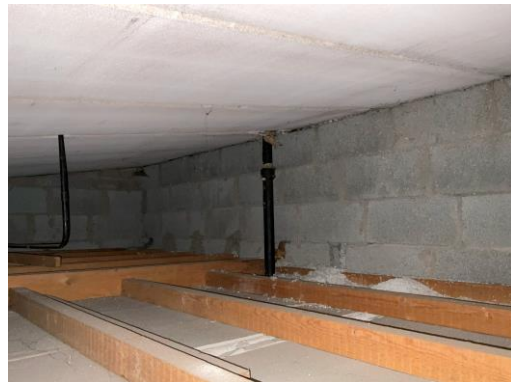
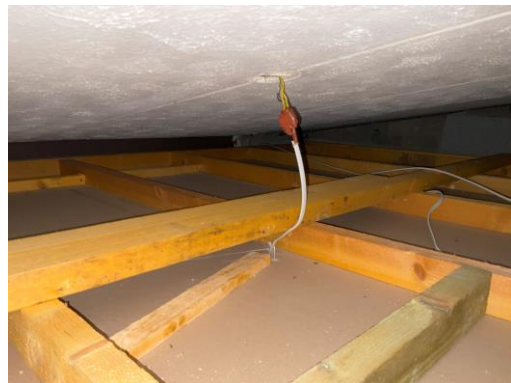
**Builder's works / building modifications
(High Risk)**

- Typically cored on site during construction for penetration of conduits and SVP with damage to units
- No changes noted during inspection dated 23/01/2025.

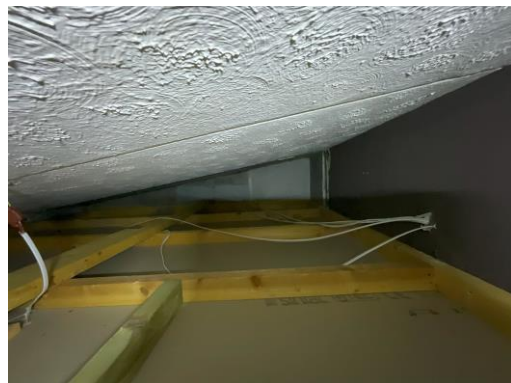
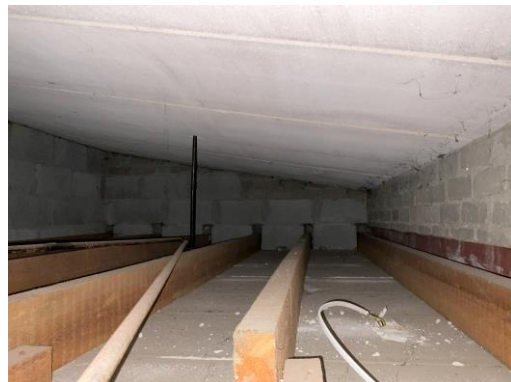
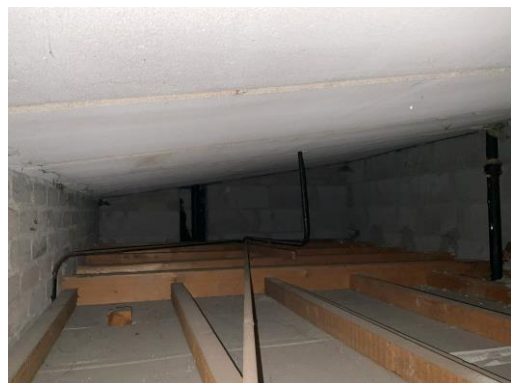
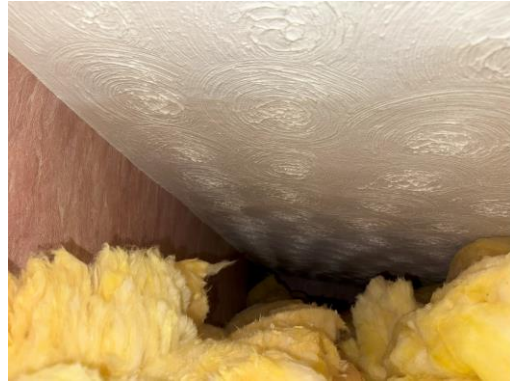
- No deflection measurements taken through the hatches, however, no excessive deflections noted from visual inspection.
- No changes noted during inspection dated 23/01/2025.

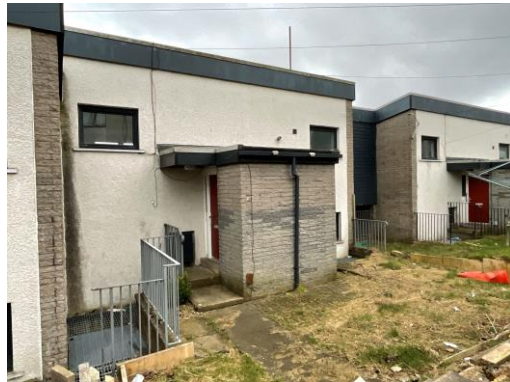
**Adverse or changes in loading
(Medium Risk)**

- Replacement roofing system with additional insulation noted.
- No changes noted during inspection dated 23/01/2025.

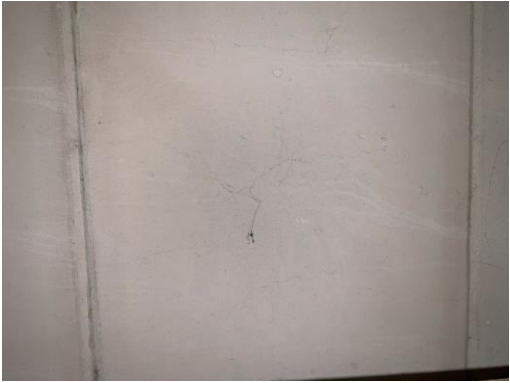
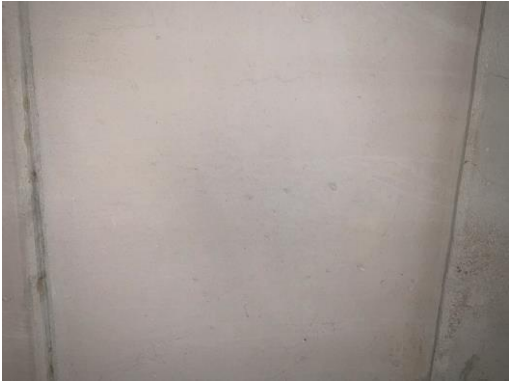
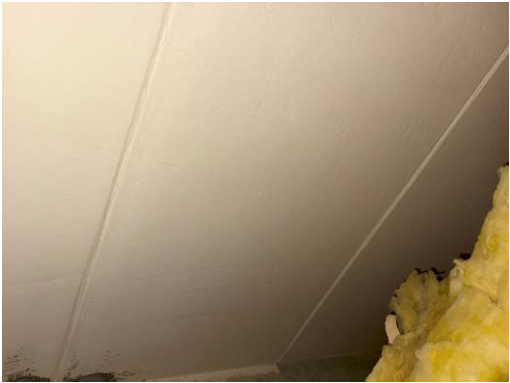
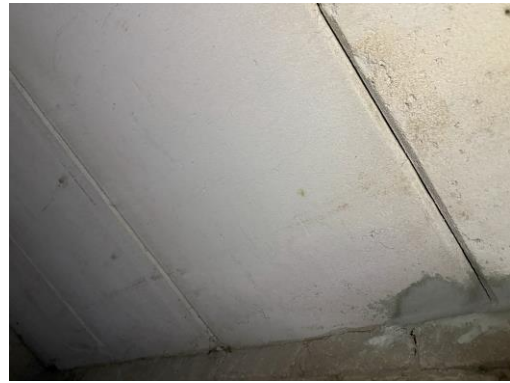
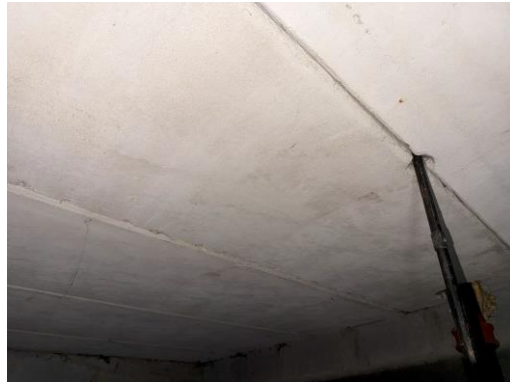
Risk Factors	Typical Survey Photographs
Cut panels (Low Risk) <ul style="list-style-type: none">– We did not identify any cut panels within the property via our hatch inspections.	
Cracking (High Risk) <ul style="list-style-type: none">– Transverse cracking found along full length of panels and within 500mm of the support.– Spalling to edge of 1no. panel.

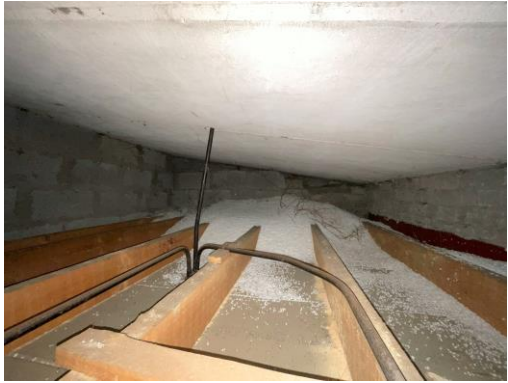
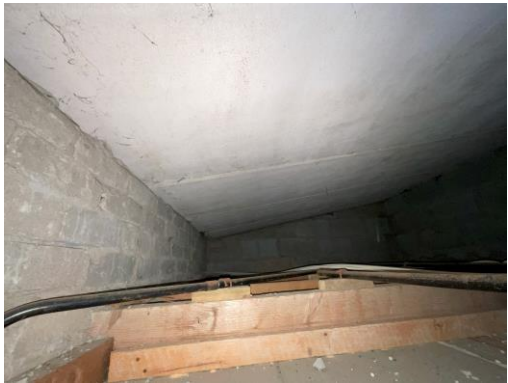
- No deflection measurements taken through the hatches, however, no excessive deflections noted from visual inspection.

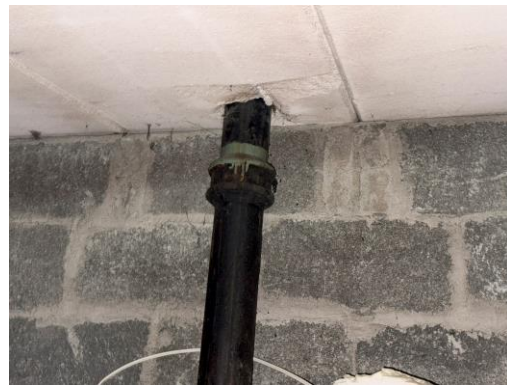
- Typically cored on site during construction for penetration of conduits and SVP with damage to units
- No changes noted during inspection dated 27/01/2025.

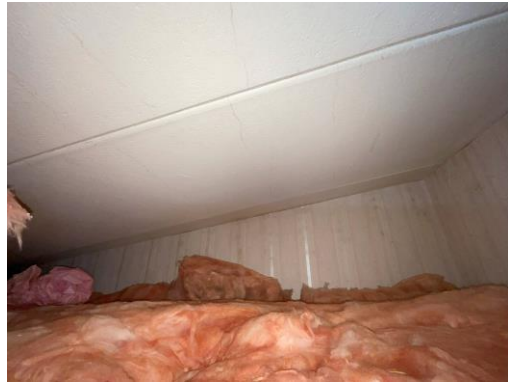
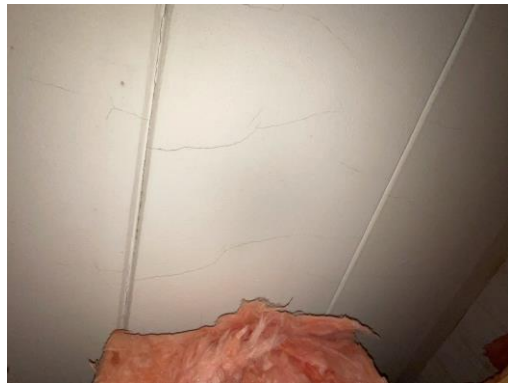
Risk Factors	Typical Survey Photographs
Cut panels (Low Risk) <ul style="list-style-type: none">– We did not identify any cut panels within the property via our hatch inspections.– No changes noted during inspection dated 23/01/2025.	
Cracking (High Risk) <ul style="list-style-type: none">– Transverse cracking found along full length of panels and within 500mm of the support.– No changes noted during inspection dated 23/01/2025.

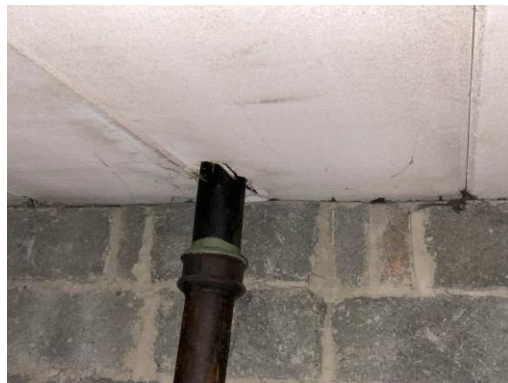
**Builder's works / building modifications
(High Risk)**

- Typically cored on site during construction for penetration of conduits and SVP with damage to units
- No changes noted during inspection dated 23/01/2025.

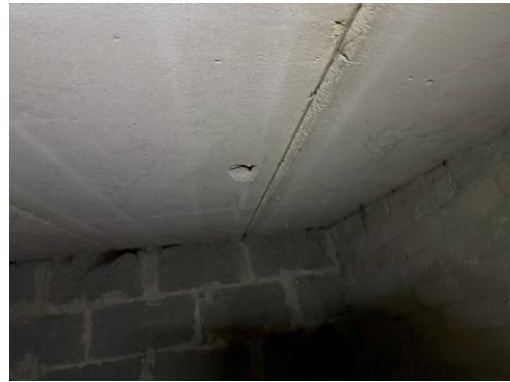
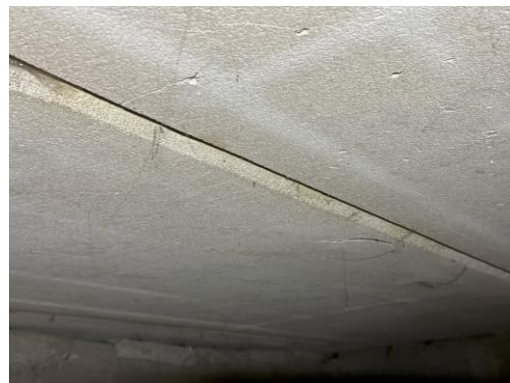
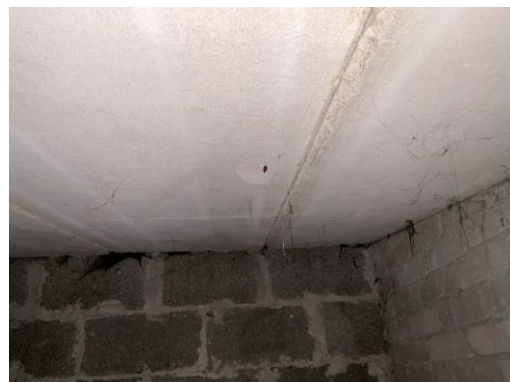
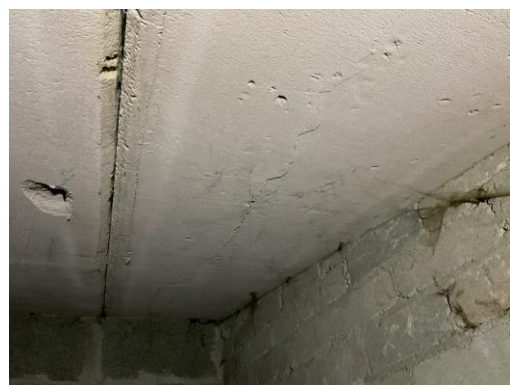
Risk Factors	Typical Survey Photographs
Cut panels (Low Risk) <ul style="list-style-type: none">– We did not identify any cut panels within the property via our hatch inspections.– No changes noted during inspection dated 27/01/2025.	
Cracking (High Risk) <ul style="list-style-type: none">– Transverse cracking found along full length of panels and within 500mm of the support.– Longitudinal cracking noted along 1no. panel.– Minor spalling noted with reinforcement noted in 1no. location.– No changes noted during inspection dated 27/01/2025.

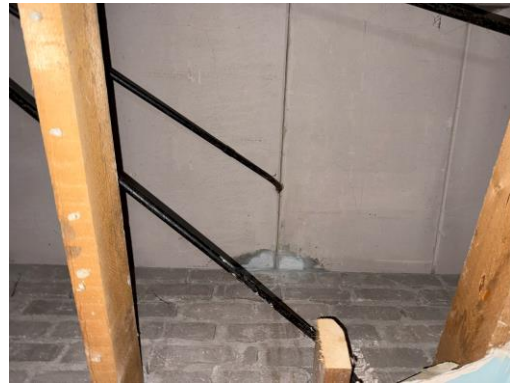
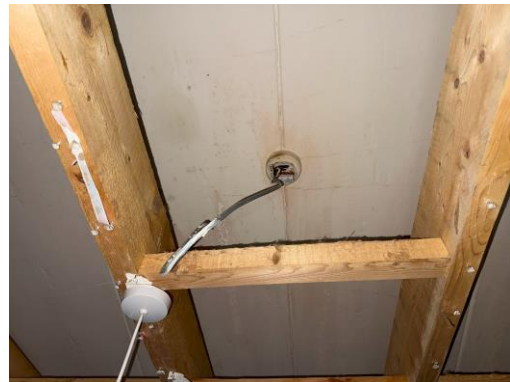
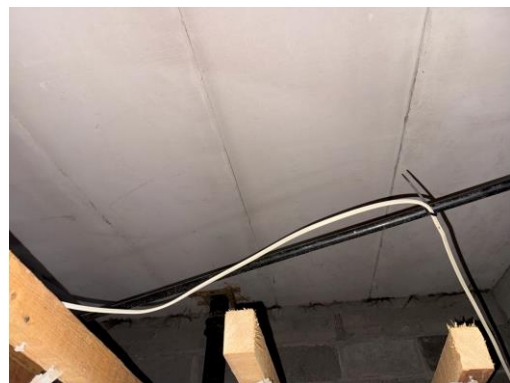
Builder's works / building modifications
(High Risk)

- Typically cored on site during construction for penetration of conduits and SVP with damage to units.

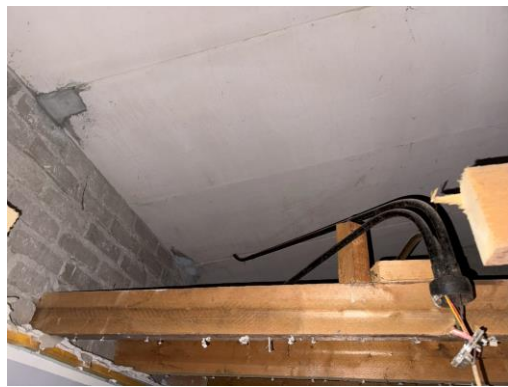
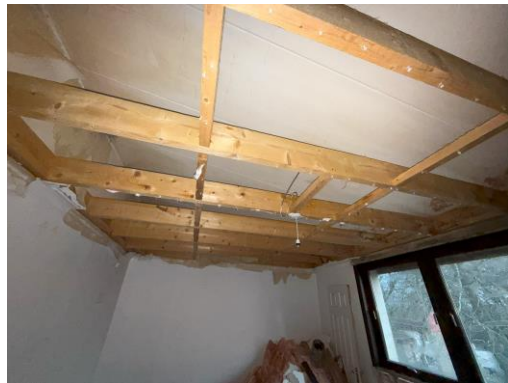
- Deflection measurements were taken during the initial inspections, with no issues present.
- Areas were visual inspected during this follow up inspections, with no issues noted.

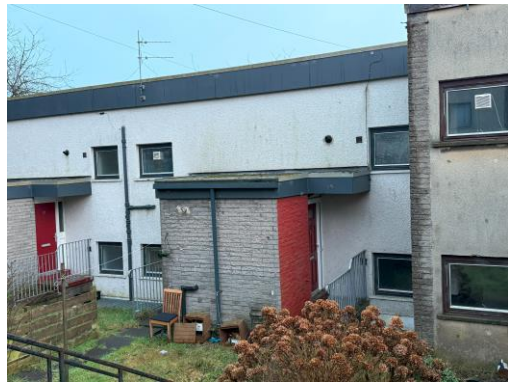
**Adverse or changes in loading
(Medium Risk)**

- Replacement roofing system with additional insulation noted.
