Aberdeen Donmouth Coastal Embankment

Risk Assessment

26 April 2017

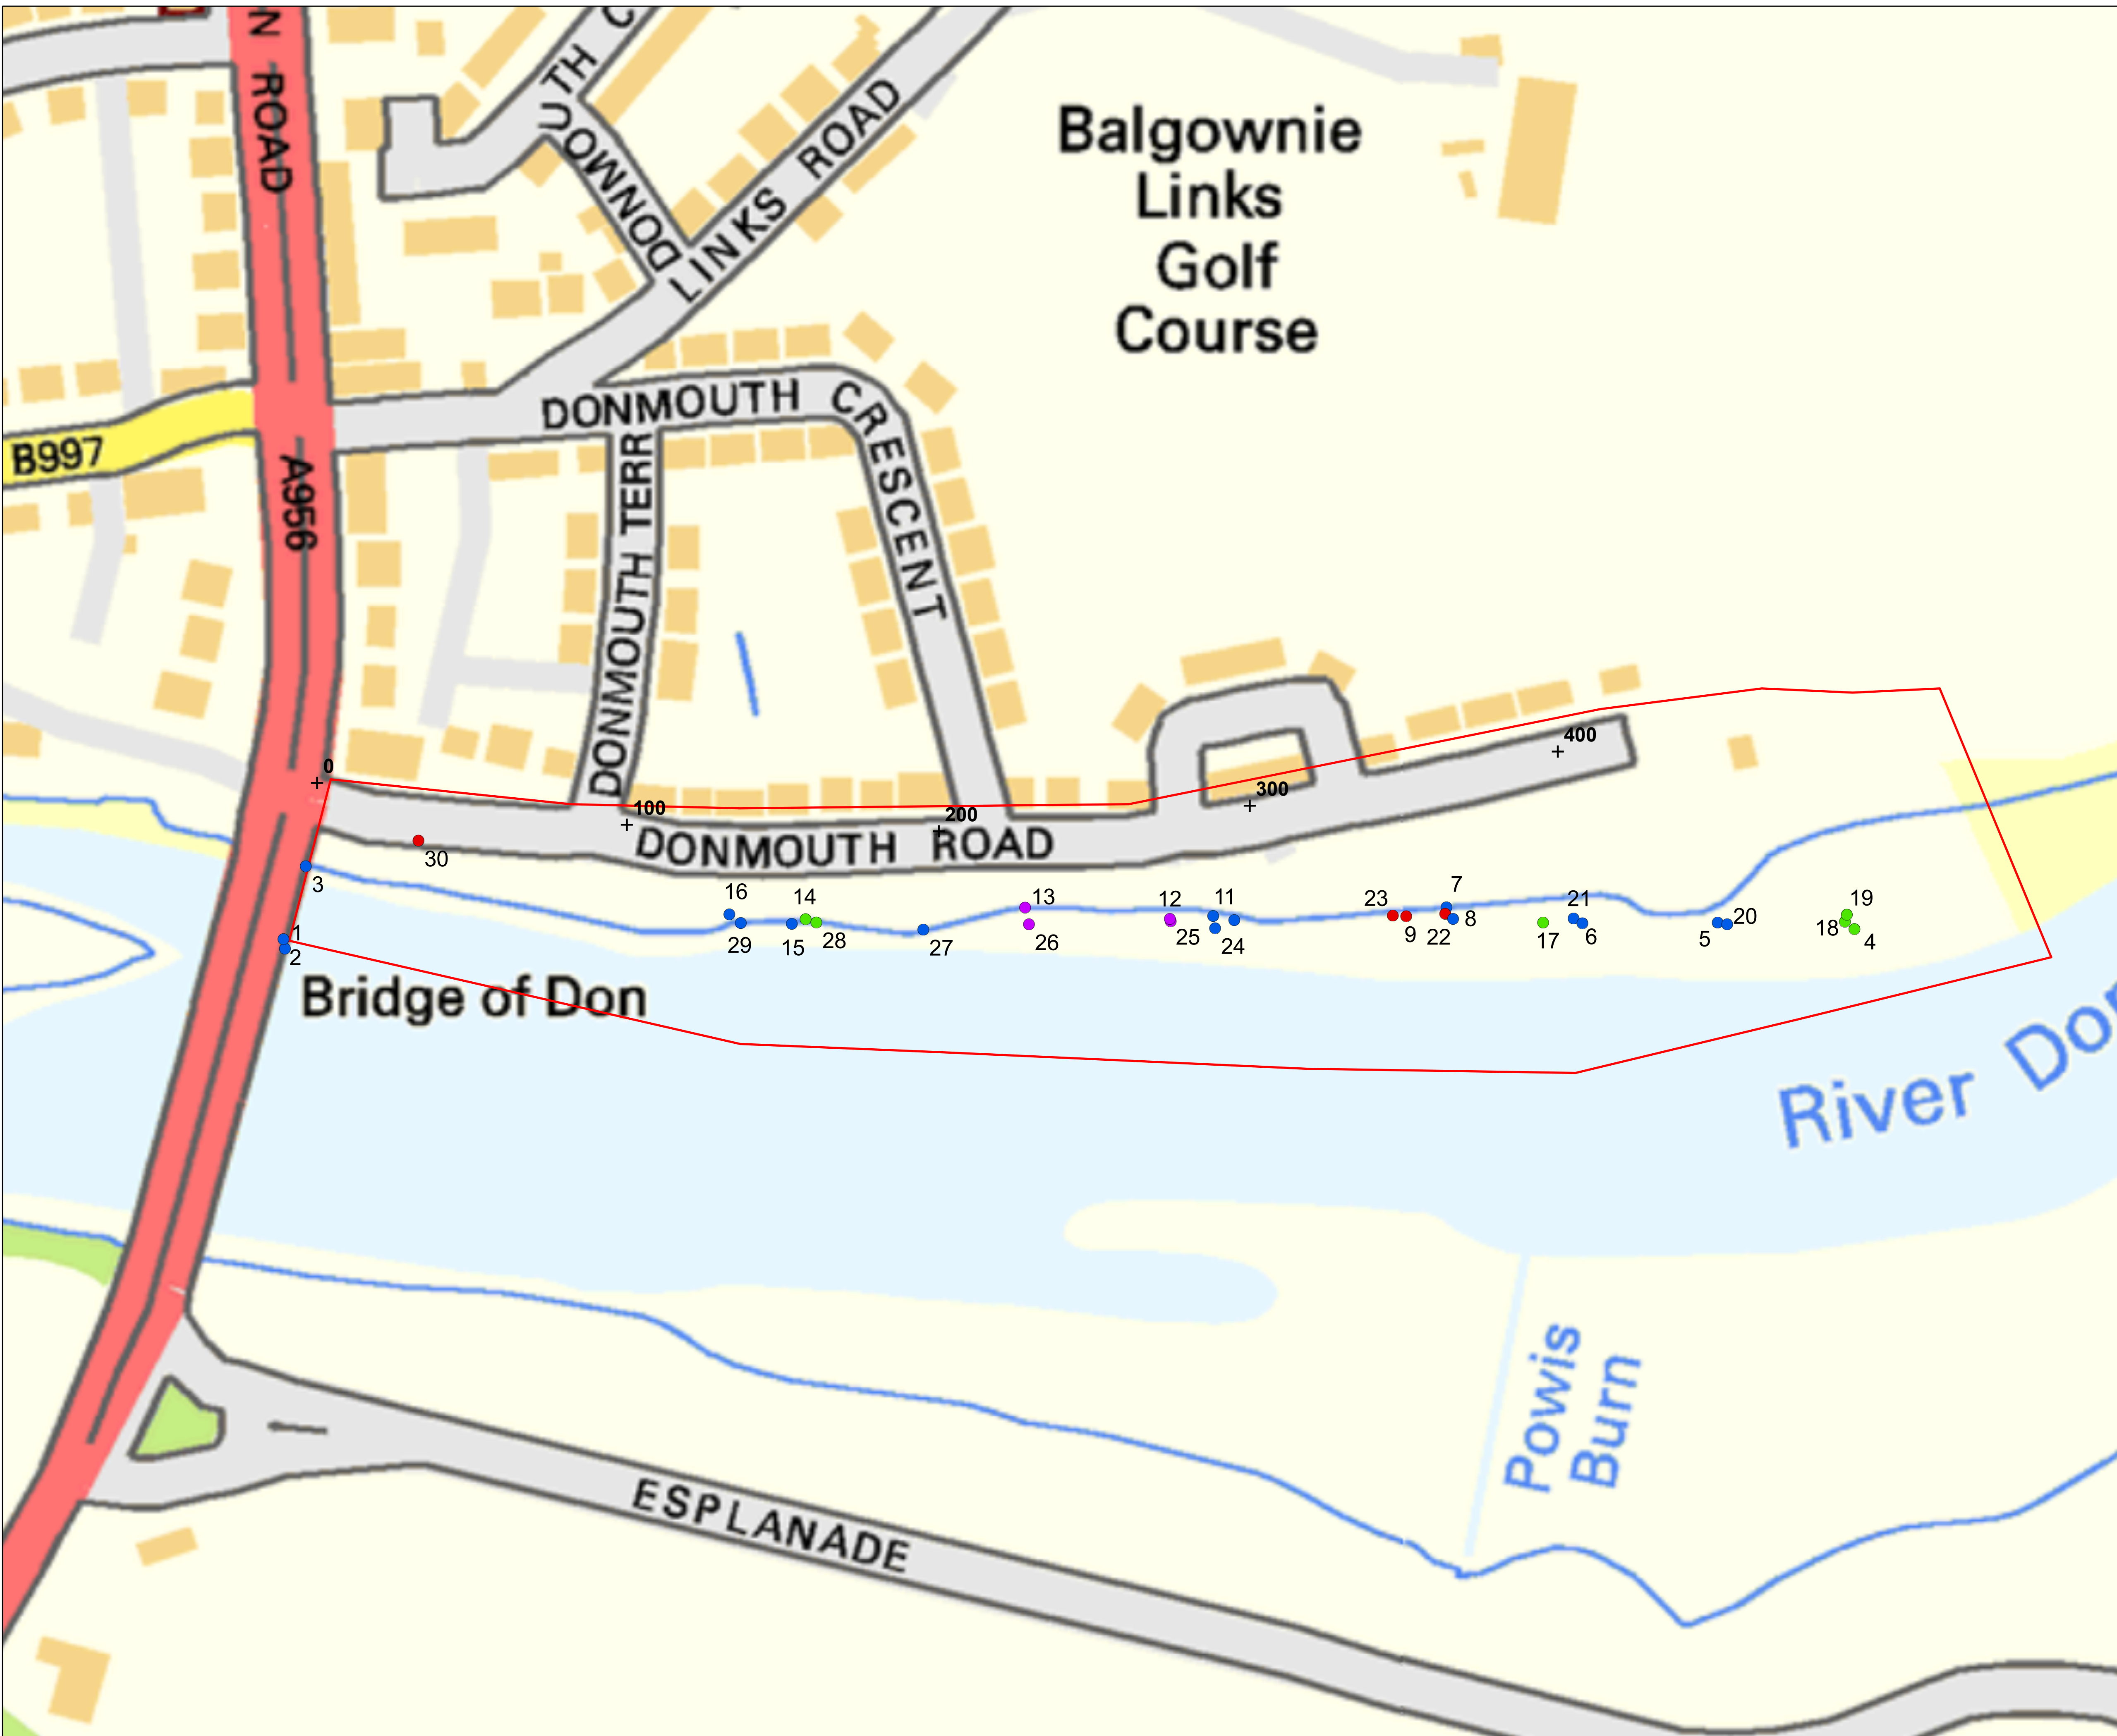
Figure A: Site Walkover Results

The slopes are generally steep below Donmouth Road, being between 45 and 55 degrees, becoming shallower at 15 degrees towards the eastern end of the site. The slopes range in height from approximately 10m in the west to 4m in the east and are vegetated with grasses and occasional trees and bushes to the end of the road, with sand dunes beyond. There is some debris at the base of the slope, either from material tipped or failed from the crest of the slope or deposited during flood events.

The site has previously been remediated at the western end, with coarse rock fill placed on the slope and new surfacing on the pavement at the crest of the slope. The new surfacing shows cracks parallel to the slope. Additionally, there have been two historical slips towards the centre of the site, between 4 and 6m in length, <10m³ material and with vegetated failed material on the slope and caught in trees at the base of the slope.

Evidence of flooding and deposition are present at the toe of the slope, with areas of erosion approximately 3m high into the toe of the slope visible towards the eastern end of Donmouth Road.

There are two culverts at the base of the slope, possibly associated with an historical burn. A large cracked concrete pipe is present at the eastern end of the site exposed within the river channel, possibly associated with the Sottish Water asset at the crest of the slope at the end of Donmouth Road.

Chainage (m)	Description	Grid Reference (centre)	Associated Features (Appendix A)	Consequence Rating	Likelihood Rating	Risk Rating	Risk Category	Prioritisation
0 to 30	This area comprises steep (40-60 degrees) vegetated slopes adjacent to the road bridge abutment and area that has previously failed. It is considered a similar slip could potentially happen in this area and should be monitored.	NJ 9468 0949	1, 2, 3	3	2	6	Moderate	2
30 to 40	This area has previously been remediated due to a slip by placement of rockfill material. Cracks were visible in the new footpath surface at the crest of the slope. It is not known if these are as a result of ongoing instability or settlement of the new surface. It is considered that while a further slip is unlikely, any potential movement should be monitored.	NJ 9469 0949	30	3	2	6	Moderate	2
40 to 200	Vegetated slope with concrete blocks at base of slope, possible failed edge protection. The slopes in this area appear to be generally stable; however, they are of a similar steepness to the adjacent area that failed. There is a culvert at the base of the slope, possibly from a burn. It is considered that the slopes may fail in the future, affecting the road at the crest, and it is recommended that remedial measures are considered.	NJ 9478 0948	14, 15, 16, 28, 29	3	3	9	High	1

200 to 300	This area has experienced historical slips, with	NJ 9491 0948	11, 12, 13, 24, 25, 26	3	3	9	High	1

deposition of material visible on slopes (vegetated) and against trees (<10m ³ volume). There is the potential for further failure in this area, potentially affecting Donmouth Road at the crest of the slope, and it is recommended that remedial measures are considered.							
300 to 400	This area has undergone erosion at the toe of the slope, potentially due to flooding scour. The height of the scour is 3m into a steep (50 degree) slope. It is considered that this area should be remediated to prevent deterioration of the slope, potentially affecting Donmouth Road above.	NJ 9500 0948	6, 7, 8, 9, 14, 21, 22, 23	3	3	9	High	1
400 to 496	The slopes in this area are relatively shallow (<15 degrees), grassy and sandy. There is no instability visible.	NJ 9511 0948	5, 20	1	2	2	Very Low	-
450	There is a cracked partially buried / submerged concrete pipe >1m diameter at this location. This is potentially a sewage pipe associated with the nearby Scottish Water asset.	NJ 9514 0946	4, 18, 19	N/A	N/A	N/A	N/A	-

It is recommended that potential mitigation and remedial measures are considered for those high risk areas to prevent damage to infrastructure. Management and monitoring measures are considered to mitigate potential risk for the identified moderate risk areas.

Immediate actions that may be undertaken at the site include setting up fixed monitoring points / tell tales on the pavement to allow measurement of the cracks that have formed.

It is recommended that the priority be to set up a monitoring routine / schedule to monitor those areas of slope that may fail and the toe of the slope that is showing current movement. This will allow an informed decision to be made as to the nature and extent of any remedial works.
