Aberdeen Greyhope Road Coastal Embankment

Risk Assessment

18 April 2017

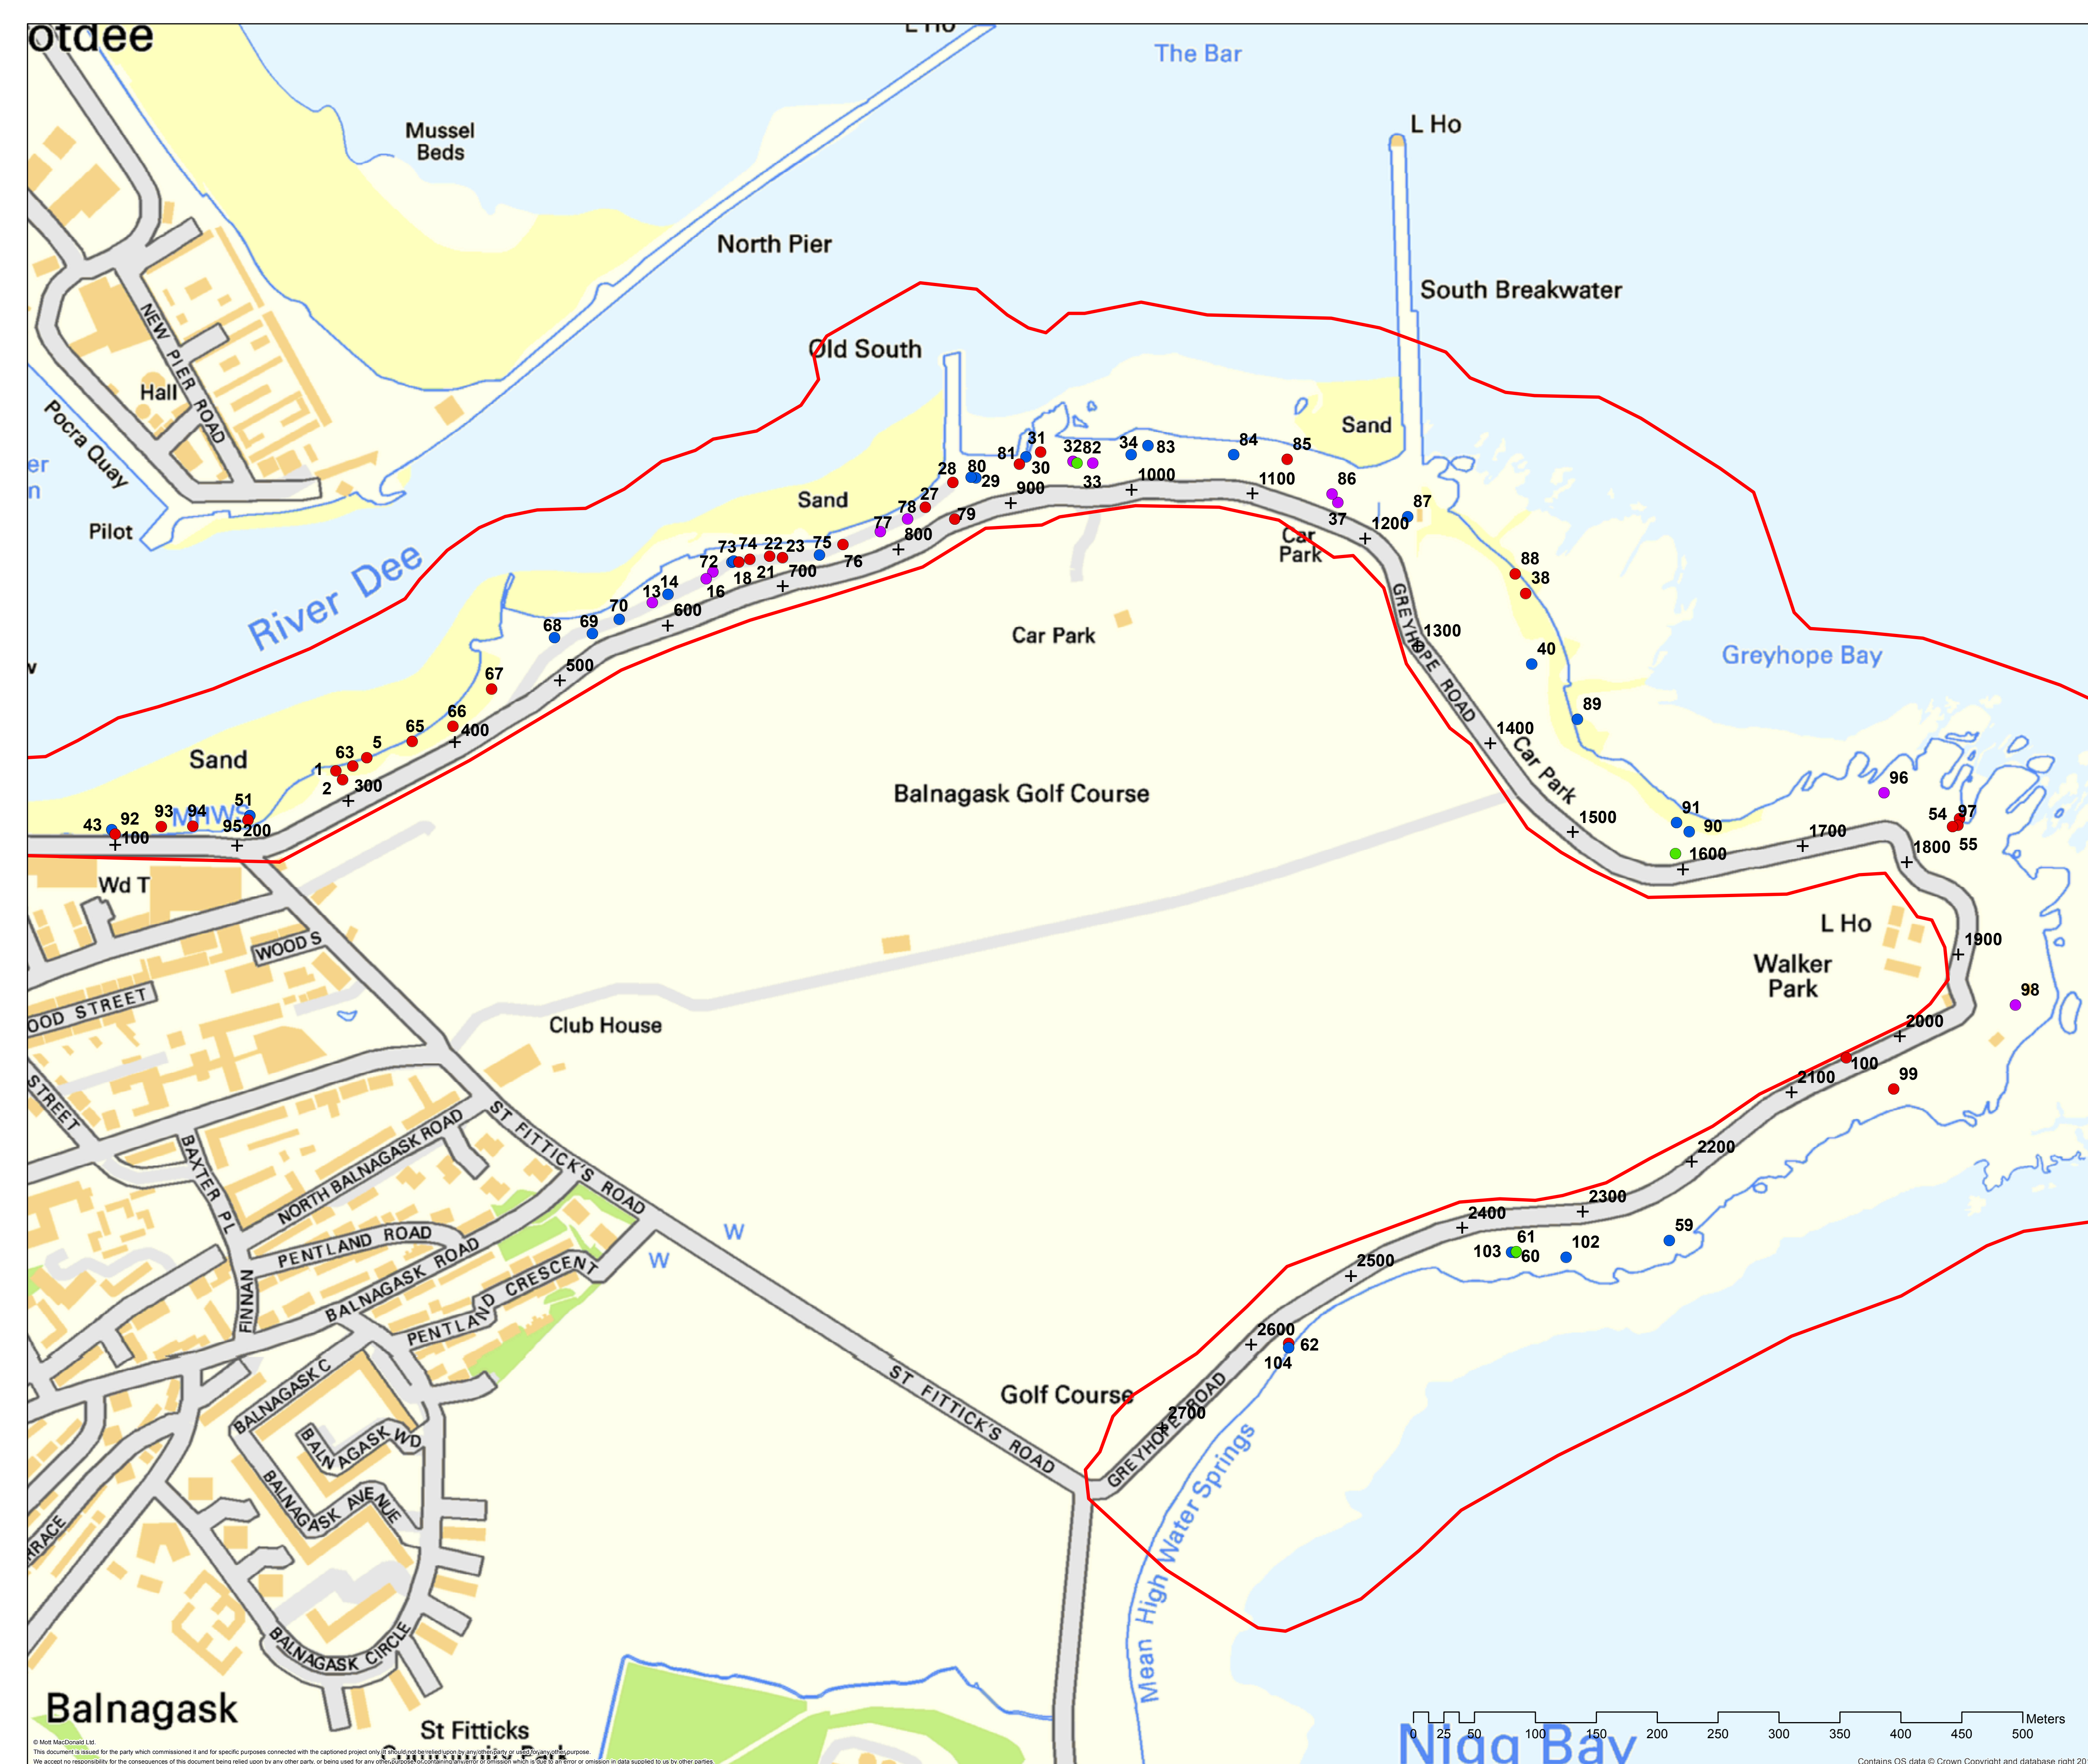
Figure A: Site Walkover Results

Number	Classification	Feature	Description	Comment
1	Current Instability	Start of extensive instability	Translational slip with road at the crest of slope	No slip material accumulations, 6.4m high, 15m ³ material, slope angle 60 to 70. Materials topsoil over clay bound sand.
2	Current Instability	View of slip	See 1	
5	Current Instability	View of slip	Slip undercutting the edge of the road, 0.5m backscarp, 8m high slope, approx.20m ³ material	Materials topsoil over clayey sand
13	Historic Instability	Historic slip	Beneath road, 7m wide, 7.4m high slope, 0.7m backscarp, 35m ³ deposited material	
14	Observation	View of slopes		
16	Historic Instability	East of rocket house	Potential historic slip, fully vegetated, break in slope	
17	Observation	View of water edge	Looking west	
18	Observation	View of water edge	Looking east	
21	Current Instability	Recent slip	Possible slight over hang. 7.9m high back scarp 1.7m 9m wide, approx. 120m ³	thin topsoil over very clayey soil with cobbles and boulders.

22	Current Instability	Recent slip	Natural slope 50 degrees, slip is over hanging. See 21	
23	Observation	Slope	View looking east	
27	Current Instability	Recent slip	View from base of 79	
28	Current Instability	Slip features historic and recent	View from base of 79	
29	Observation	Coastal defence		
30	Observation	Faulted rock	Faulted rock at shoreline	
31	Current Instability	Recent slip	Approx. 100m ³ material	9.2m high. soil pipes. 2.5m back scarp. top soil sand and very sandy clay
32	Historic Instability	Historic slip	Fully vegetated potential historic slip	
33	Historic Instability	View of slope	See 32	
34	Observation	view of slope		
37	Historic Instability	Historic slip between road and path	3 to 4m high slip, 0.5m backscarp, approx. 9m ³ material	3 to 4m high, flat area beneath to path
38	Current Instability	Slip	Up to 4m high slip face. Demolition rubble on beach	No receptor and flat land above with no land use

40	Observation	Vegetated Slope	Looking north	
42	Observation	Slopes	Photo to the east	
43	Observation	Manmade slope	Small slope in front of SEPA building	Condition ok
51	Observation	Poorly vegetated slope		
54	Current Instability	Slip of soils	12m high slope with superficial slips, up to 10m wide at base, approx. 80m ³ material, damp, radar tower above	Old and recent slips. 12m high. Slips superficial. Concrete at the base in blocks.
55	Current Instability	Slip of soils	See 54	
59	Observation	Slopes and ruined building	Photos looking east and west	
60	Structure	Retaining feature in slope		
61	Observation	Seawall/defences		
62	Current Instability	Damage of sea wall		
63	Current Instability	View of Slip	Scarp from slip at road edge. 60-70 deg and sub vert. See 5	300mm topsoil over clayey sand.
65	Current Instability	Slip	Directly beneath road, 1.2 m backscarp, 7m high with runout of deposited material, approx. 40m ³

66	Current Instability	Surface Slip	6.3m high with 1.9m exposed backscarp, 5m wide, approx. 60m ³ , continues round corner	Materials v. clayey sand, debris at base, within last year
67	Current Instability	Slip	Slumped materials visible, translational. See 66	Adjacent to public footpath
68	Observation	Concrete rock protection		
69	Observation	Retaining Wall	8.6m high slope, 1m high wall, 45 to 55 degrees	
70	Observation	Plucked stone from sea defence		
72	Historic Instability	Rocket house	Break in slope, potential historic slip, fully vegetated	
73	Current Instability	Slip	1-2 m high ret. wall	
74	Current Instability	Fresh slip	See 21. 7.9 high, 1.7m high backscarp, 9m wide, soil pipes, wet surface, 50 deg slope, overhanging scarp	
75	Observation	Steep slope	View looking west	
76	Current Instability	Slip	21.5m high, 7m slip, 0.5m backscarp, approx. 75m ³

Number	Classification	Feature	Description	Comment
77	Historic Instability	Historic slip	See 77	
78	Historic Instability	Spring and historic slip	Fully vegetated, from mid slope, 5m high, 10m wide, approx. 25m ³	
79	Current Instability	Slip	9.1 m high slope, 5m wide scarp, approx. 50m ³ material, at edge of road	
80	Observation	Coastal defences and breakwater		
81	Current Instability	Slip	See 31, overhanging, toe wall hidden under material	Distance from road
82	Structure	Pipe	Instability below pipe due to scour	
83	Observation	View of slope	Looking west and south	
84	Observation	Rock	16m high slope	
85	Current Instability	Instability below path	5m high, 5m wide, 0.6m backscarp, approx. 15m ³ material	
86	Historic Instability	Historic slip	See 86	
87	Observation	View of slope		
88	Current Instability	Slip	See 38	
89	Observation	Photo north and south		
90	Structure	Pipe		
91	Observation	Hummocky slope		
92	Current Instability	Remediation of outfalls	4m high slope, concrete interlocking blocks	In poor condition and requires addressing

93	Current Instability	Concrete slope with damage	Underscour/plucking evident	
94	Current Instability	Start of gabions	Condition poor, 4 gabions high, coated wire	Photos looking west, south and east
95	Current Instability	End of gabions	Condition poor	Photos looking south, west, east and showing gabion damage
96	Historic Instability	Historic Slip		
97	Current Instability	Slip	See 54	
98	Historic Instability	Small slips below foghorn		
99	Current Instability	Slip	See 100	Water
100	Current Instability	Slip	1-1.5m high backscarp, 2m high 3m wide, approx. 8m ³ material deposition, 10m high slope, halfway down slope, 5-6m wide, directly under road	Superficial slip on rock
102	Observation	Slopes and ruined building		
103	Structure	Retaining feature in slope		
104	Observation	Sea wall/ defences	Photos looking east and west	No slip material accumulations, 6.4m high, slope angle 60 to 70. Materials topsoil over clay bound sand
