Aberdeen North Beach Coastal Defence

Feasibility Report

31 March 2017

Document reference: 378926 | 005 | B

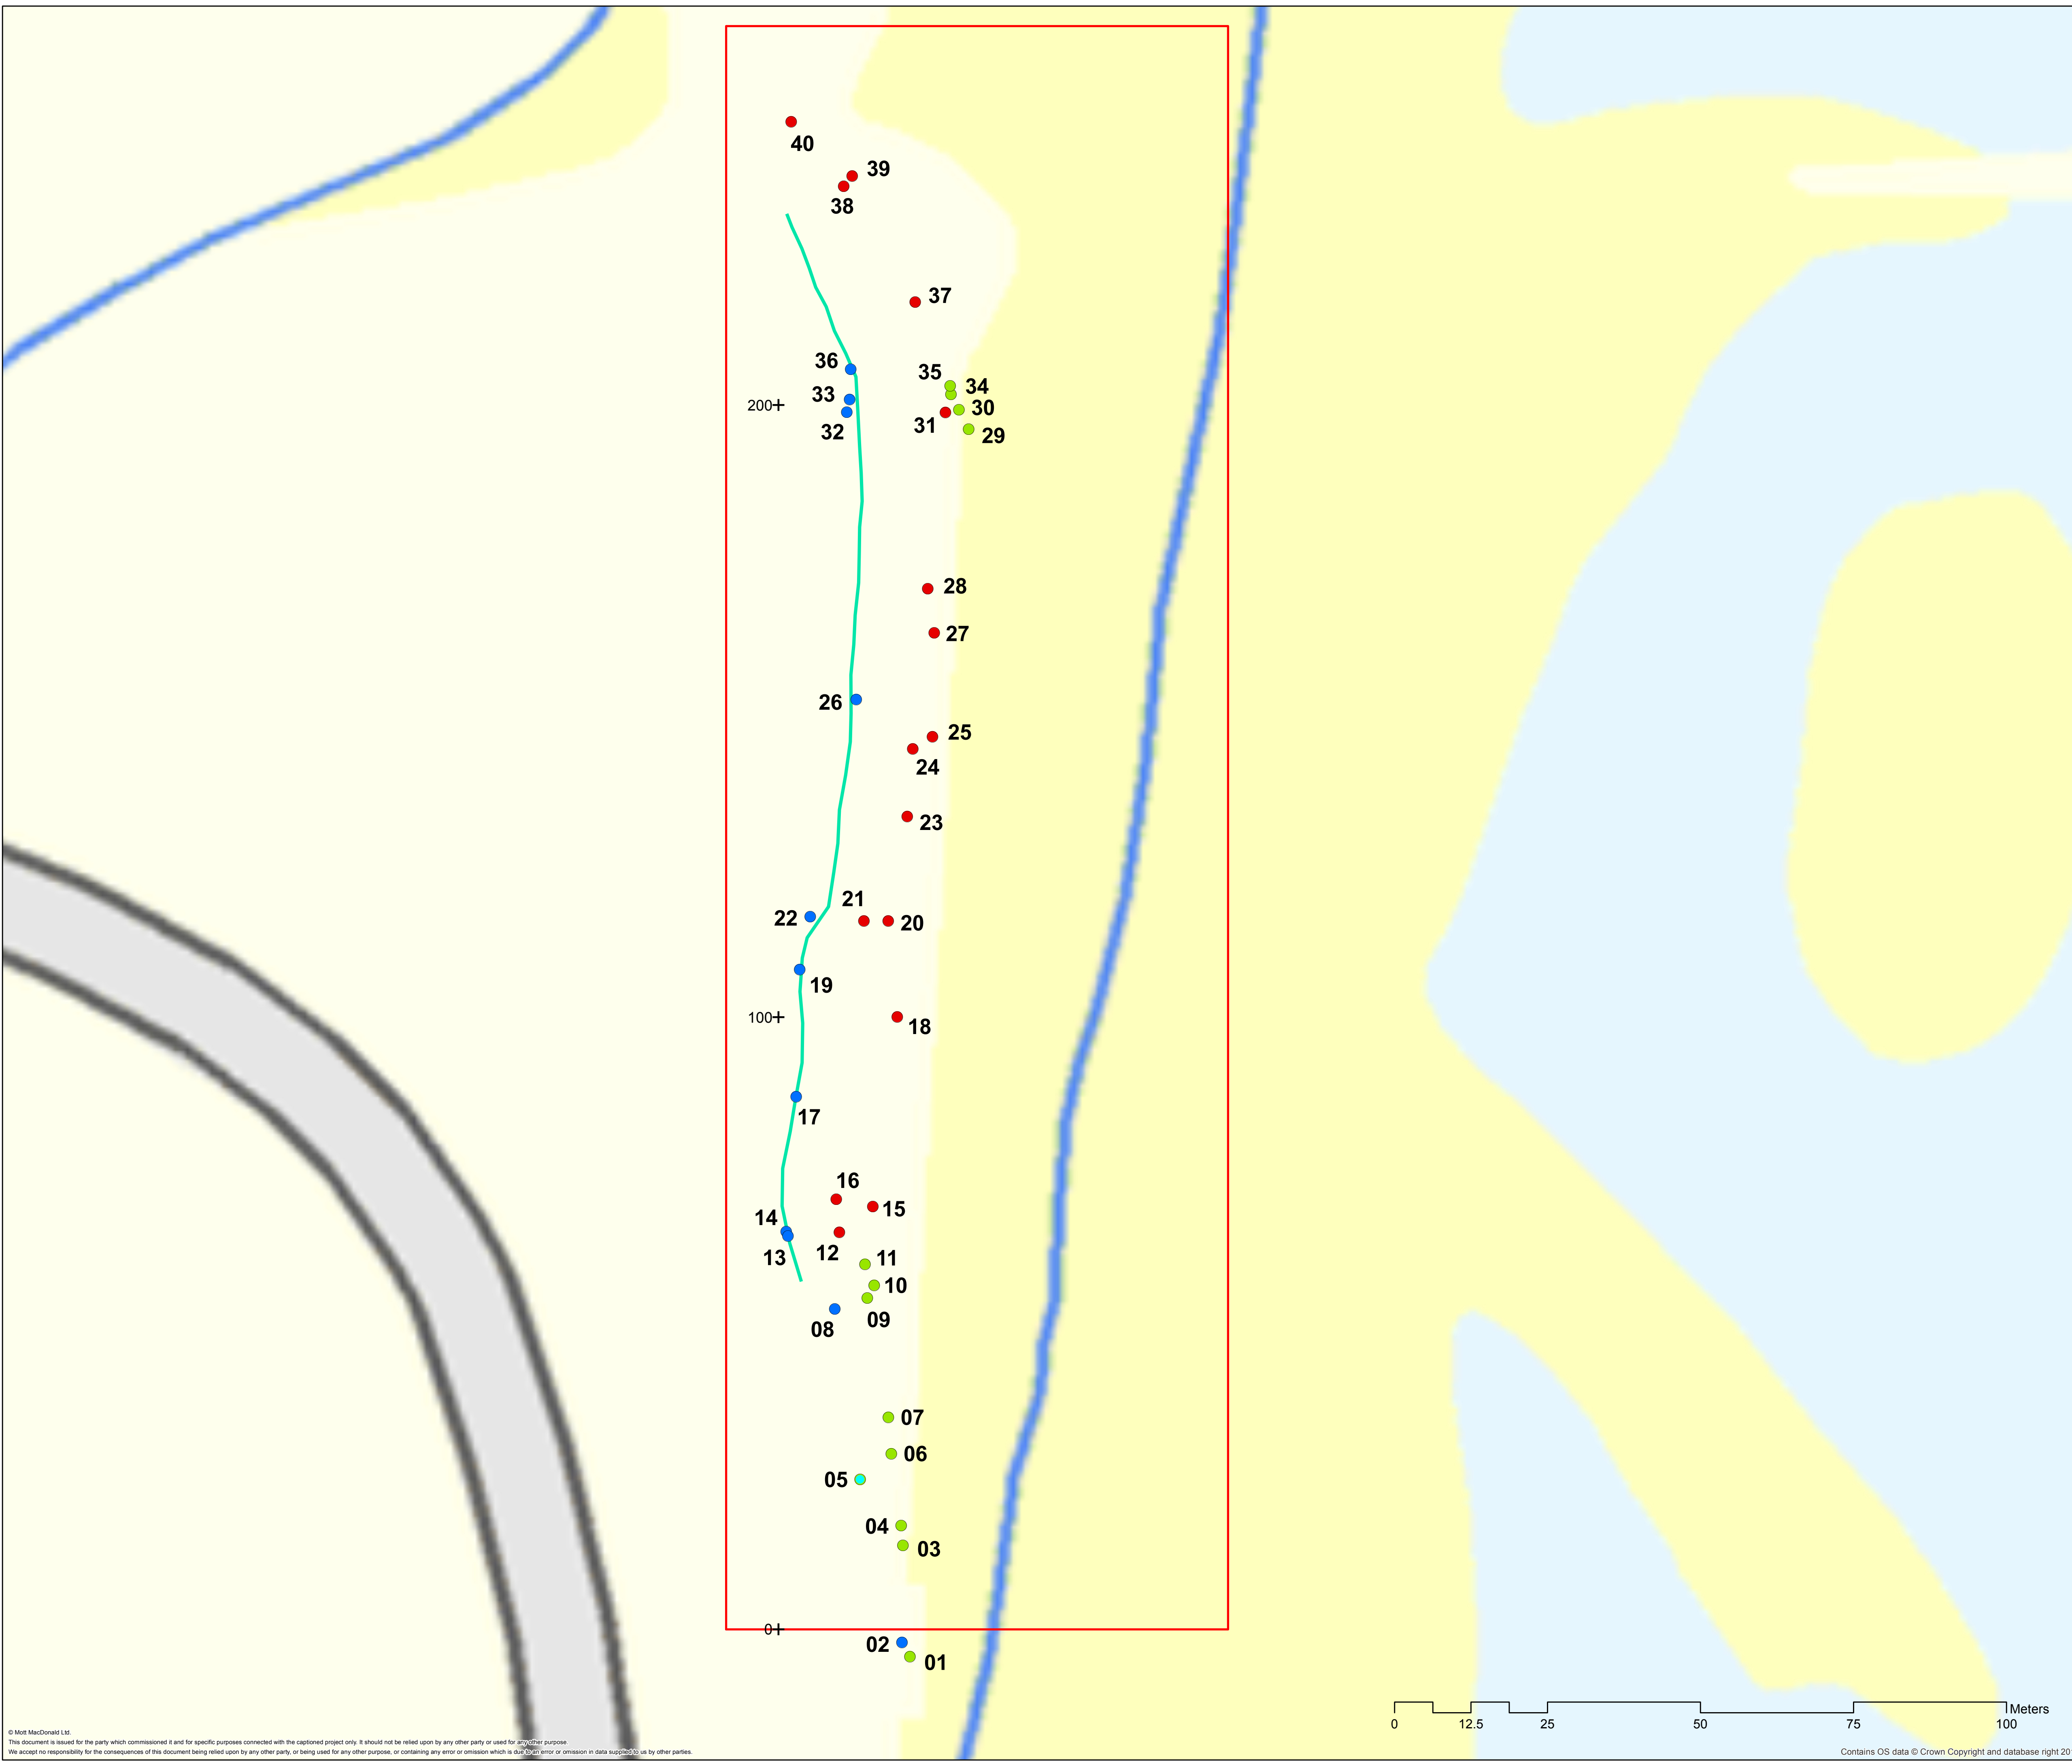
Figure A: Site Walkover Results

Number	Classification	Feature	Description	Comment
01	Structure	Sea wall and rock armour	Sea wall with rock armour either side, path down to beach to north	
02	Observation	Ch0	Start of site	
03	Structure	Concrete groyne / divider		
04	Structure	Rock armour	Grassy crest towards top of rock armour	
05	Structure	Rock armour	5m high slope with rock armour protection, 0.3m to >1m, two toe walls, lower toe wall almost entirely buried in sand	Rock armour covers gabions on slope
06	Structure	Gabions under rock armour		
07	Structure	Concrete groyne / divider	26 degrees slope on concrete	
08	Observation	View from crest	View of instability erosion Section 1	
09	Structure	Exposed piles	Exposed sheet piles to concrete divider	
10	Structure	Concrete groyne / divider exposed sheet piles	26 degrees slope on concrete, corroded sheet piles visible, 870mm high, concrete aggregate large rounded pebbles up to 20mm. 300mm wide

11	Structure	Collapsed gabions	5 no. rows gabions coated double twist wire collapsed / buried, made ground behind, at least 2 distinct layers.	Sloping gabions failed by rotation / slumping by erosion?, filled with rough angular granite blocks 200 to 400mm.
12	Current Instability	Eroded Section 1	55m long section, 6.6m high slope at highest point	Exposed sheet piles at south end of section
13	Observation	View from crest		
14	Observation	View from crest	View north	
15	Current Instability	Eroded Section 1	Made ground visible, finer sand onto very large blocks (brick, granite), finer darker layer onto possible original sand dune. Partly covered by vegetation. Collapsed vegetation on slope	
16	Current Instability	Eroded Section 1	View north towards end of section	
17	Observation	View from crest	View south along coastal path	
18	Current Instability	Eroded Section 1	Stainless steel? square opening gabions collapsed / buried

19	Observation	View from crest		
20	Current Instability	End of eroded Section 1 / start of Section 2	Section 2 extends to exposed discrete piles, 90m long section	
21	Current Instability	Eroded Section 2	Beacon above. View of made ground and gabions	
22	Observation	View from crest	View south	
23	Current Instability	Eroded Section 2		
24	Current Instability	Eroded Section 2	View of slope	
25	Current Instability	Eroded Section 2	3 to 5m high slope	
26	Observation	View from crest		
27	Current Instability	Eroded Section 2	Looking north towards end of section with exposed discrete piles	
28	Current Instability	Eroded Section 2	View of slope	
29	Structure	Concrete toe wall	Toe wall at end of concrete groyne / divider. Expected to extend to rock armour at other end of site, buried	010 bearing 300mm
30	Structure	Exposed sheet pile		
31	Current Instability	End of eroded Section 2 / start of Section 3	Toe wall and exposed discrete piles at concrete groyne / divider

32	Observation	View from crest	View north	
33	Observation	View from crest	View of discrete piles end of eroded Section 2	
34	Structure	Exposed discrete piles	View north. Piles appear to be circular steel piles, with concrete visible to one side	Timber shuttering within concrete
35	Structure	Exposed discrete piles	View south	
36	Observation	View from crest	View of exposed discrete piles	
37	Current Instability	Eroded Section 3	View of made ground material being eroded out onto beach	
38	Current Instability	Eroded Section 3	View south and view north	
39	Current Instability	Eroded section 3	4 to 5m high slope	
40	Current Instability	End of eroded Section 3	Made ground material in slope (bricks, coping, metal), at entrance to River Don on corner
