**A/16677 – STRUCTURAL SURVEY OF POULTRY SHED, LITTLE  
CLINTERTY, CLINTERTY, ABERDEEN**

**STRUCTURAL INSPECTION REPORT**

**October 2016**

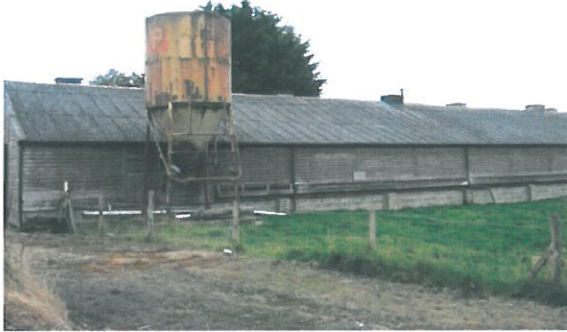
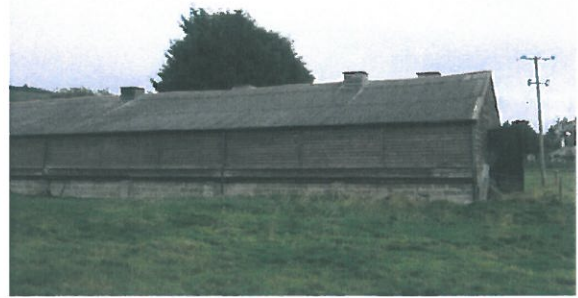
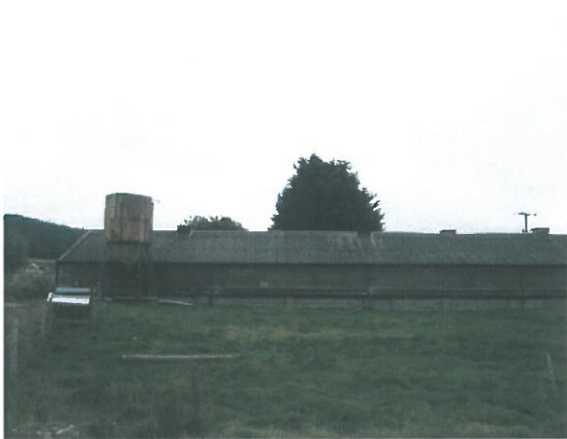
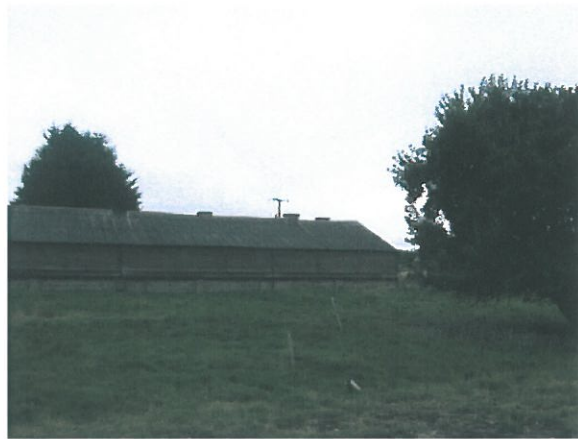
3.1 West Elevation

Note evidence of sagging in roof at apex.

- 4.1     The building is in a reasonable condition for its use but does require extensive repair works.
- 4.2     The roof structure appears to be sagging which we understand is due to deterioration of the purlins. The building will have been exposed to moisture variations in internal temperature, and this has caused timber decay to the structural members.

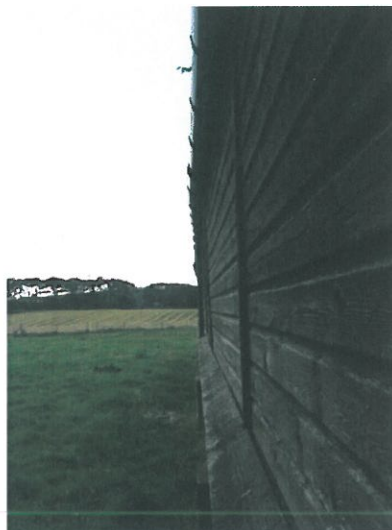
3.4 East Elevation showing signs of bowing in wall.

the building is that this is lightweight to withstand snow and wind loading. We would therefore suggest that robustness detail and strengthening be carried out.

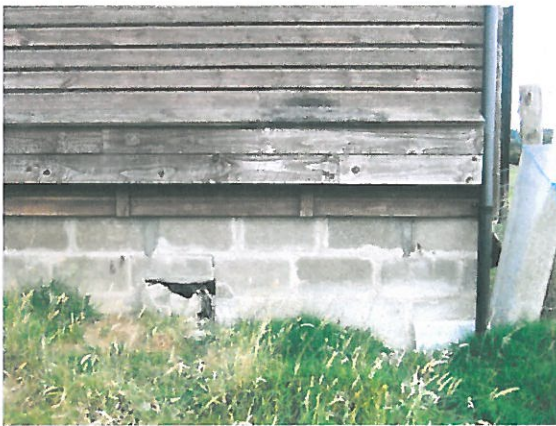
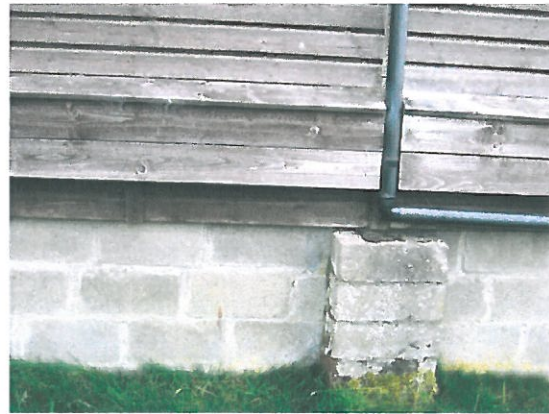
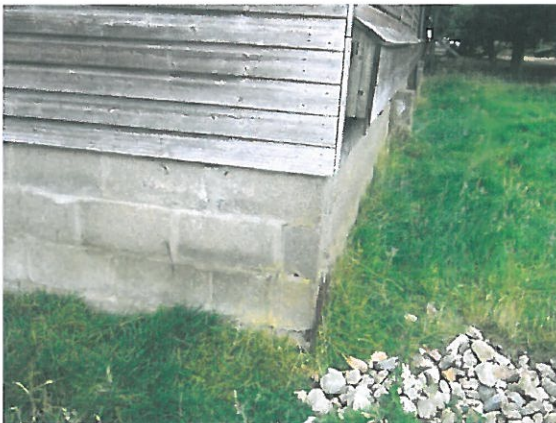
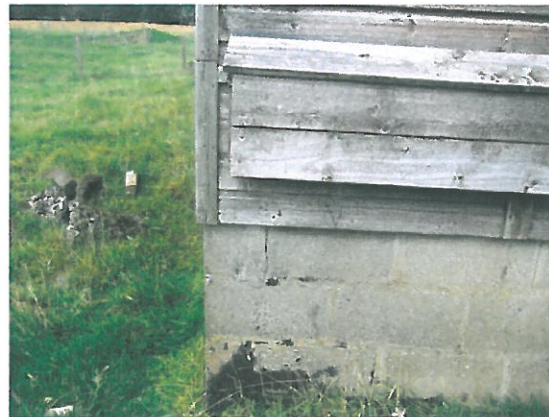
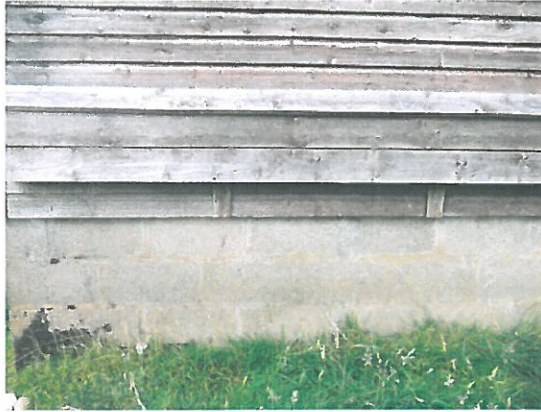
3.6 Minor Cracking in blockwork wall.

- 4.6     There is evidence of the blockwork wall at ground level spalling and this will require further investigation and repair.
- 4.7     Cracks are noted in the base wall and these should be repointed.

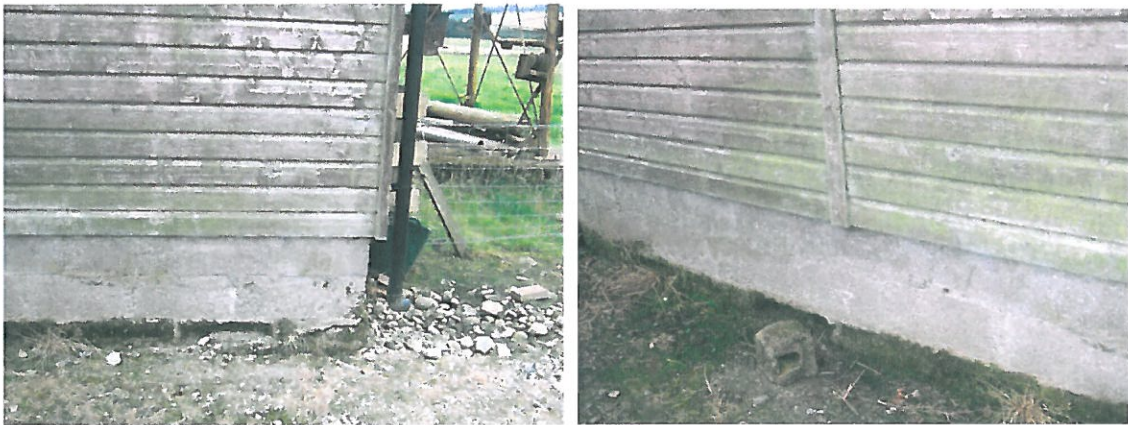
3.7 North Gable wall showing signs of deterioration at ground level.

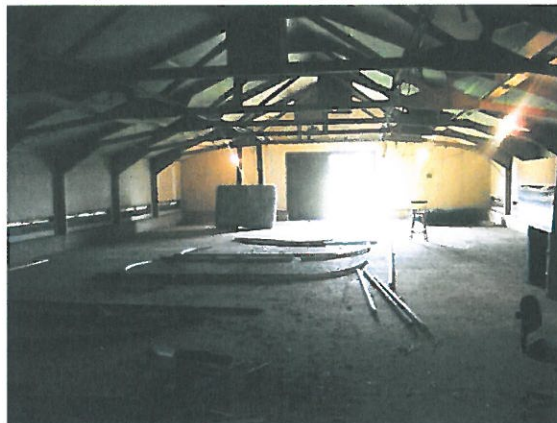
3.8 Internal view to South gable.

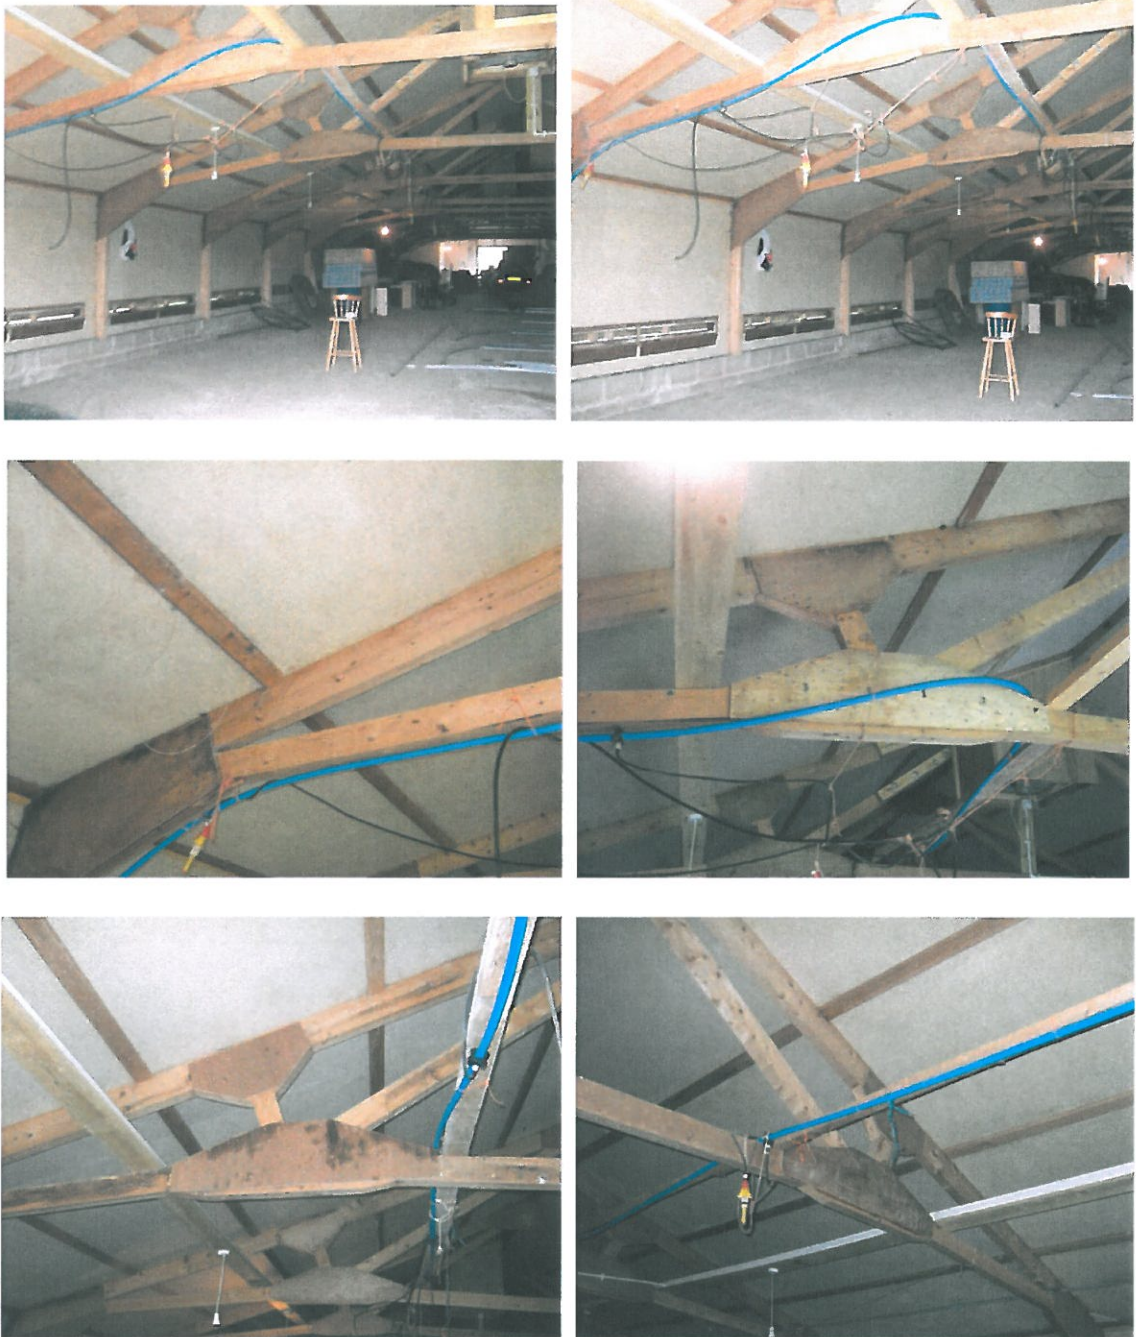
3.9 Views on truss frame

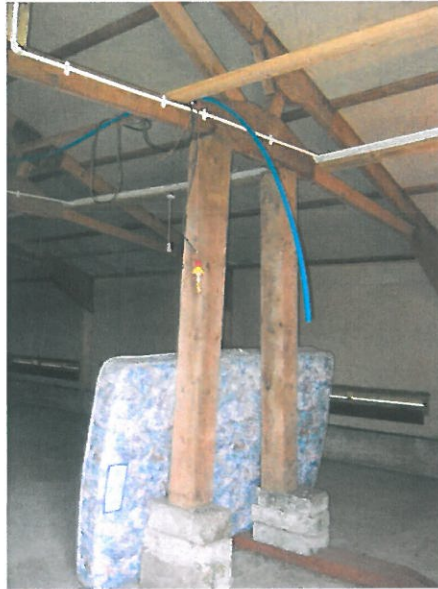
3.10 Propping to truss due to previous failure.

- 4.3     There is evidence that the roof structure frame has had repairs and this may be due to the fixings and members which have had water ingress through the roof.

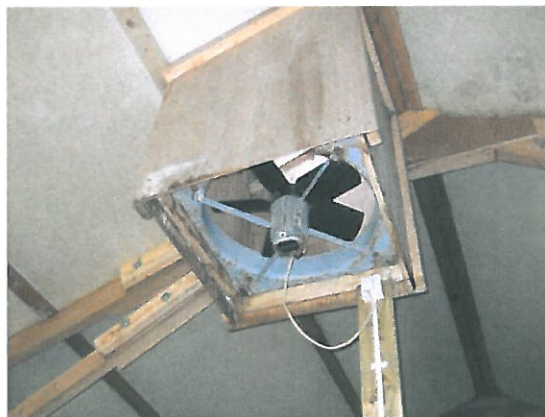
3.11 Strengthening to truss noted.

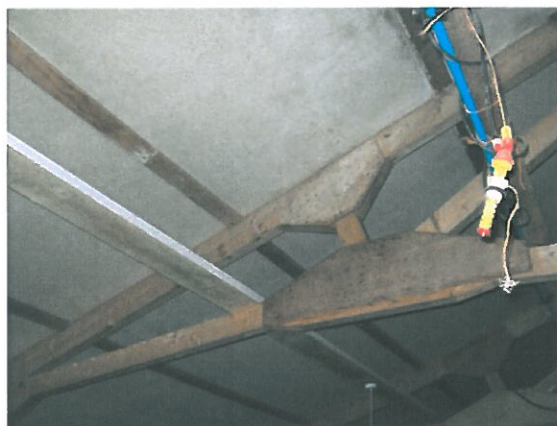
3.12 Evidence of water staining.

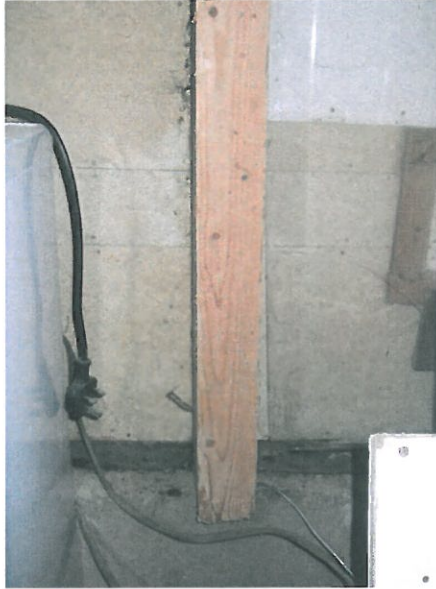
3.13 Seating for frame onto blockwork wall.

- 4.8     The connection of the frames to the foundation wall requires to be installed as at present it is not connected.
- 4.9     The building can be considered more of a shed type structure, in that it has a lack of robustness in relation to wind and snow loading imposed onto it. Our design review of

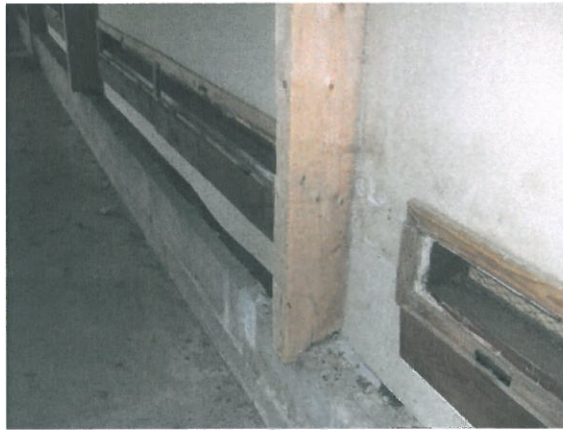
3.14 Deterioration of timber frame post at wall head.

- 4.4     There is evidence that the base of the timber frames on the wall head are showing signs of deterioration.
- 4.5     We understand that the roof requires to be resheeted due to the condition of the roof sheeting. This would involve removal of asbestos sheeting and thereafter disposing of this in the correct manner.
