Condition Surveys

Aberdeen City Council

26 July 2024

ACC BALNAGASK RAAC OPTIONS APPRAISAL

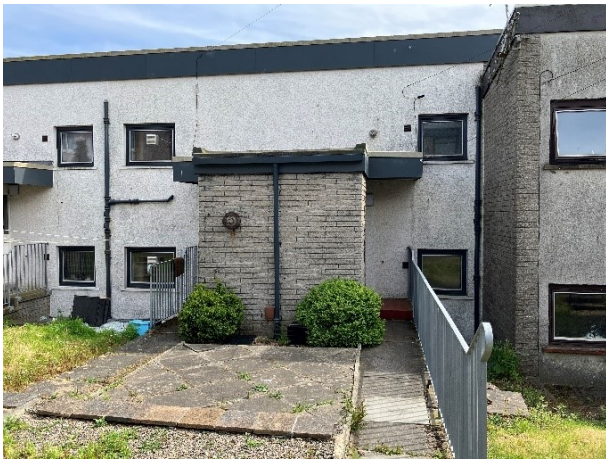
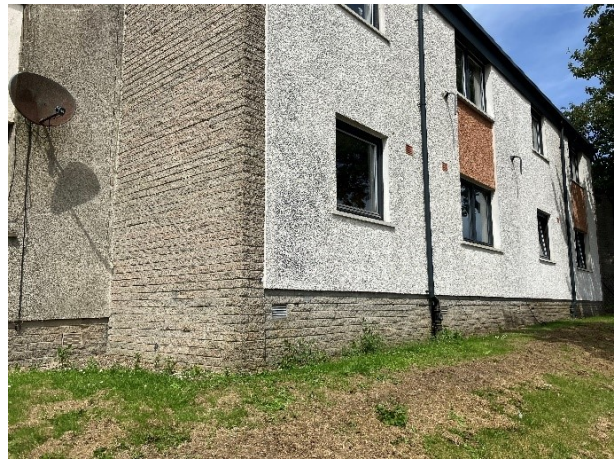
Externals

To the front entrance, concrete slabs are damaged and displaced presenting potential trip hazards, which should be replaced and re-bedded to align with the surrounding footpath, patio, and retaining wall. Fascia and soffits are in fair condition but show signs of cut edge corrosion, which requires cleaning and cut edge protection.

The door is in satisfactory condition, however, the mechanical door closer is missing. The decoration of the front door and side light is fair condition but requires redecoration, including the removal of historic fixings. The timber window frames exhibit worn decoration with minor damage, requiring repair and redecoration.

The front garden is overgrown with vegetation, with debris and rubbish within the garden. This should be maintained especially whilst vacant to reduce potential vandalism to the property. The galvanized handrails and retaining wall void grid are stained, requiring cleaning. Additionally, the perimeter timber fence requires redecoration.

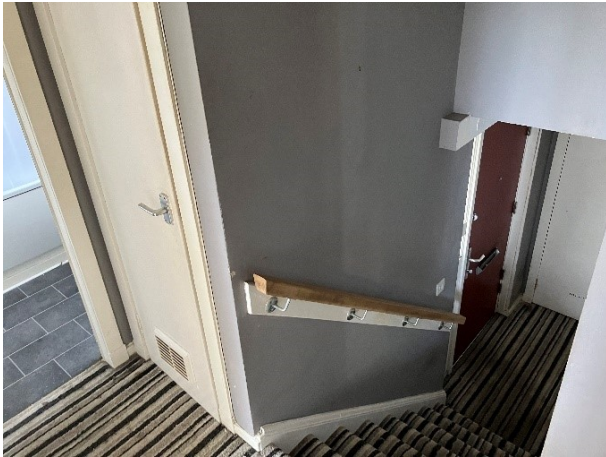
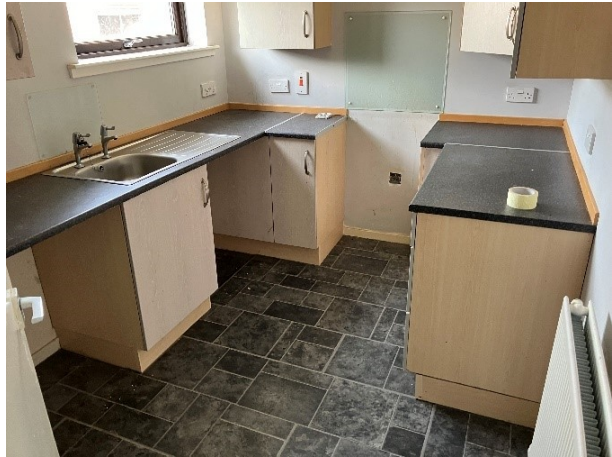
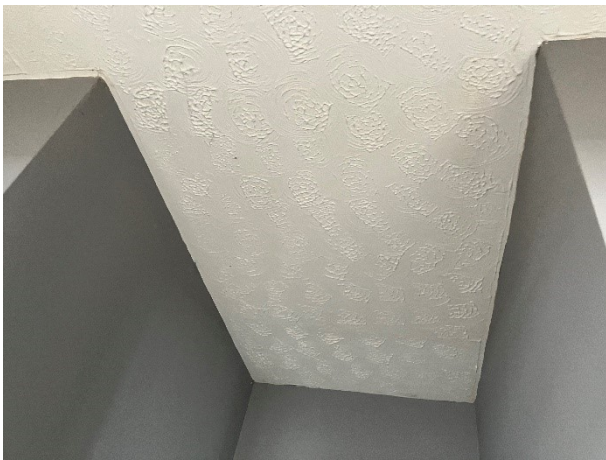
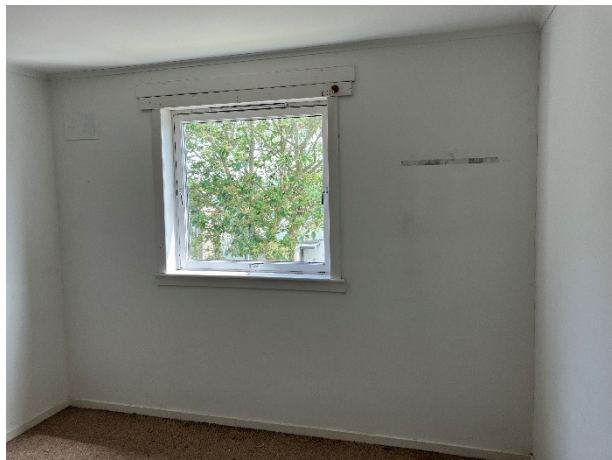
Internals

The timber boxing-in of bathroom services within the bathroom is water damaged and should be repaired. The boxing-in above the front door is suffering from damp and mould and should be cleaned of all mould and redecorated.

There are several visible holes in the plaster wall within the boiler cupboard and service penetrations lack fire stopping. It is advised all penetrations and holes are properly infilled and adequately fire stopped between floors. Cupboard doors and electrical access hatches catching on the floor require easing and adjustment.

The timber window frames, including the timber surround and sills, show signs of age and damage, and require repair and redecoration. Additionally, the mastic to the window frames is missing and perished and should be replaced. The associated ironmongery is loose and should be adjusted or replaced as necessary. To the bathroom, the vanity unit handles, and the bath panel requires replacing due to damage. The silicone sealant on the wet wall panels are perished or missing should be removed and replaced.

The flooring has not been removed in this property. However, the vinyl flooring in the kitchen is grubby and there is water damage to the bathroom vinyl.

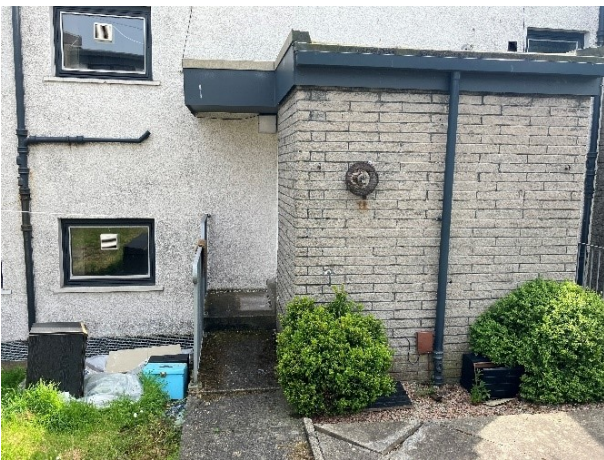
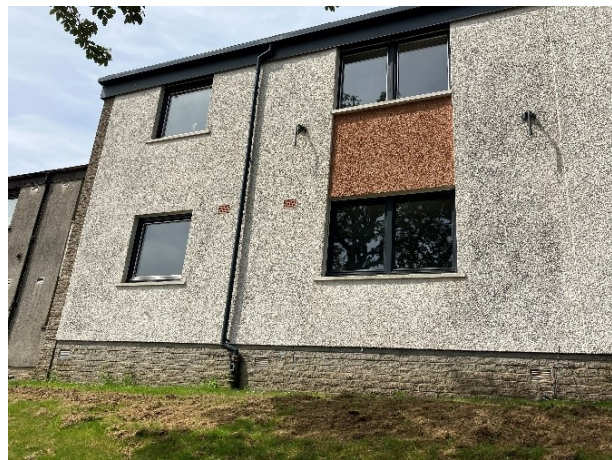
Externals

Debris is visible at the lower roof level, and it is presumed that the upper level is similar, requiring routine clearance. The soffit and fascia decoration is in fair condition, as well as the decoration to the rainwater goods, however, all require redecoration.

The door is in satisfactory condition, however, the seals to the doors are loose and the mechanical door closer is missing. The decoration of the front door and side light is fair condition but requires redecoration, including the removal of historic fixings. The timber window frames exhibit worn decoration with minor damage, requiring repair and redecoration.

To the front entrance, the concrete steps are loose presenting a potential trip hazard, with visible gaps to the footpath. Furthermore, the concrete slabs are damaged and displaced presenting potential trip hazards, which should be replaced and re-bedded to align with the surrounding footpath.

The front garden is overgrown with vegetation, with debris and rubbish present within the garden. This should be maintained especially whilst vacant to reduce vandalism to the property. The galvanized handrails and retaining wall void grid are stained, requiring cleaning. Additionally, the perimeter timber fence needs redecoration.

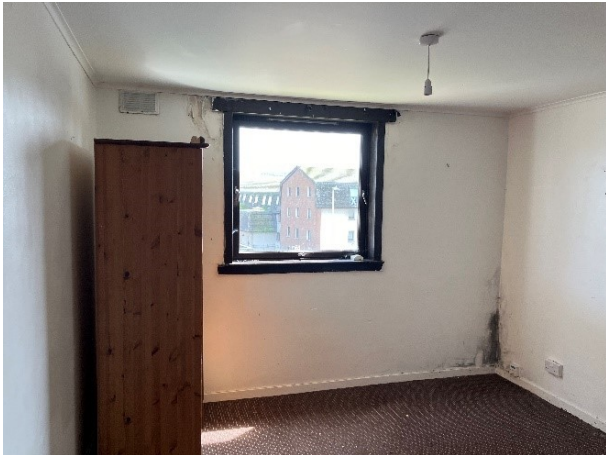
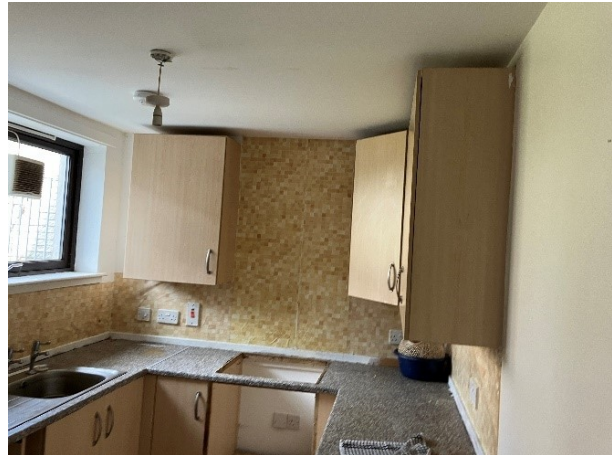
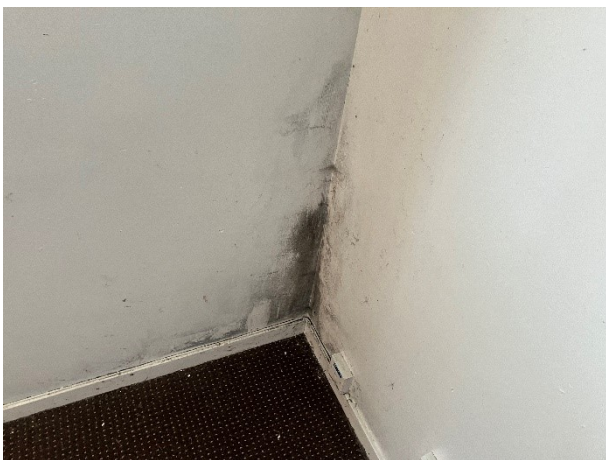
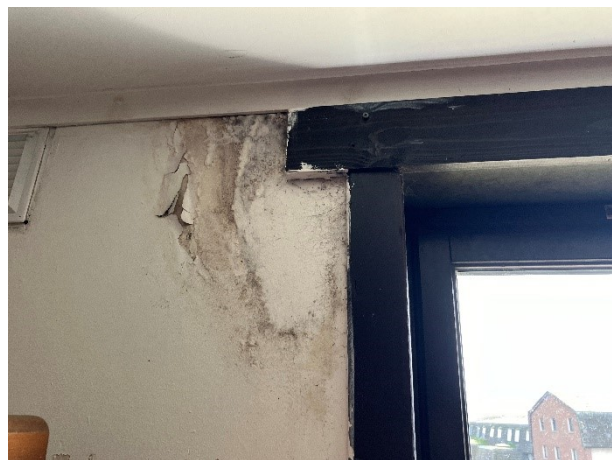
Internals

Within the kitchen, the sink appears blocked and is holding water. Plumbing to the sink should be investigated and repaired so the water is left free flowing. The worktop is damaged and generally worn and is advised to be replaced.

In the living room, the plaster wall and cornice have damp and mould issues, especially to the windows, with damage noted around the vent grille. Architraves are also damaged in areas and require repair. The bedroom wall shows similar signs of historic damp damage, necessitating repairs to the wall surface and surrounding areas. The bedroom door is stiff and unable to close properly and requires adjustment. The metal door thresholds to a number of rooms are warped and require replacement.

Furthermore, the services boxing-in above the entrance door is damaged requiring repair and redecoration and the mastic to wet wall panels is missing or perished, particularly around the bath where black mould is present.

The timber window frames, including the timber surround and sills, show signs of age and damage and require repair and redecoration. Additionally, the mastic to the window frames is missing and perished and should be replaced.

All carpeted flooring has been retained. This is usually removed by the Tenants in social housing. However, the carpet is tired and worn and therefore should be removed. The vinyl flooring in the kitchen is grubby and unlikely to be salvageable and should be replaced.

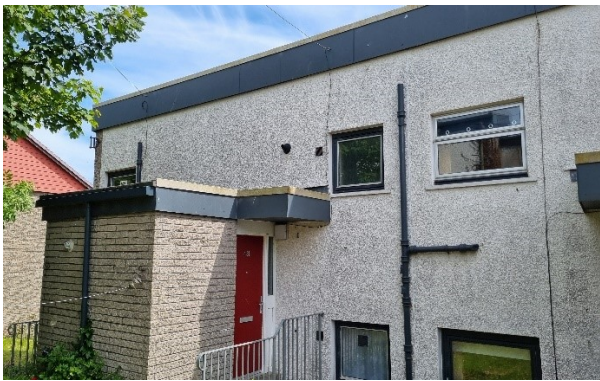
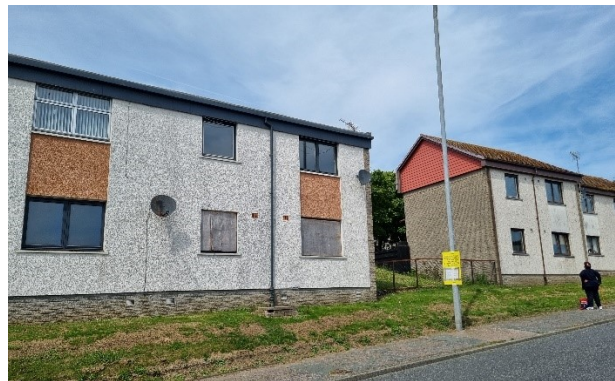
External

To the front entrance and external areas of the property the felt roof above the entrance exhibits signs of wear and staining, warranting replacement. The aluminium fascia and soffits are stained and grubby, necessitating a thorough clean-down. The door is in satisfactory condition, however, the mechanical door closer is missing.

The decoration of the front door and side panel is fair condition but requires redecoration, including the removal of historic fixings. The timber window frames show signs of fading and minor damage; therefore, repairs should be undertaken, followed by surface preparation and redecoration. The front garden is overgrown with vegetation, which should be maintained especially whilst vacant to reduce potential vandalism to the property.

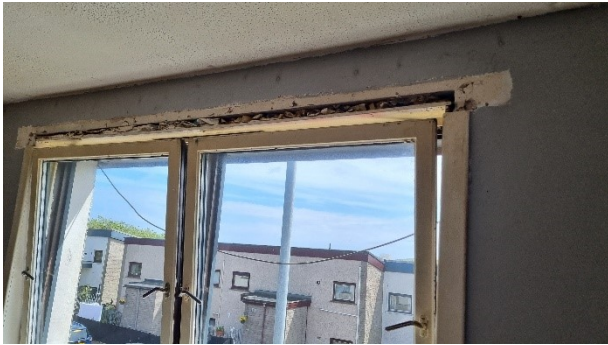
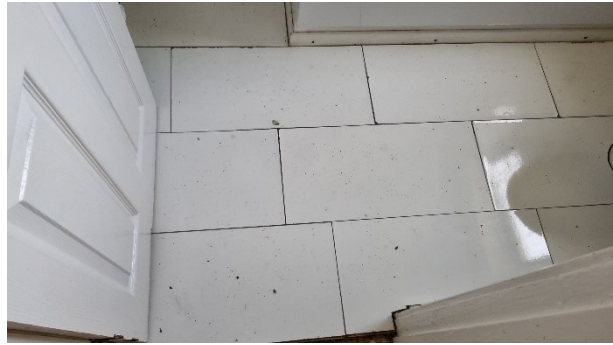
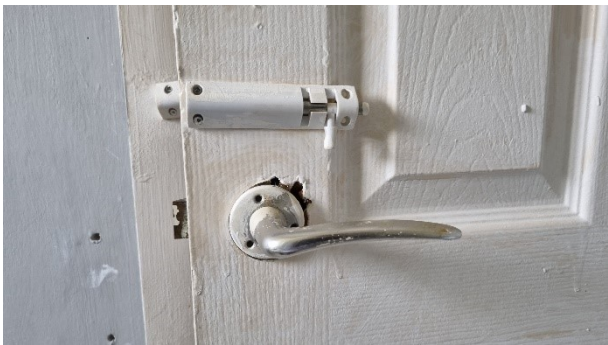
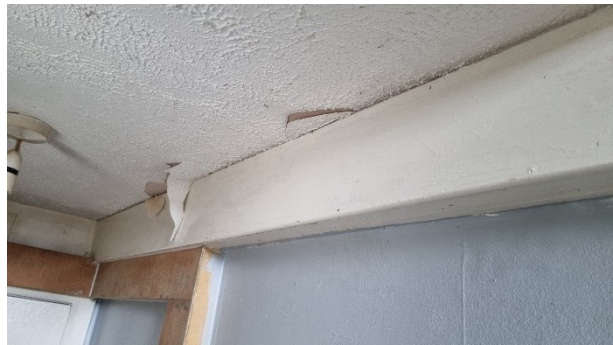
Internal

The cavity wall above the living room window is exposed and infilled with newspaper. This must be made safe by removing the paper and the area made good and draft proofed.

There is damage at low-level to the kitchen plasterboard wall near the kitchen door. The timber trimmer behind the kitchen sink is discoloured and rotten, requiring replacement with a suitable plastic or metal alternative, and in the bathroom, the silicone sealant on the wet wall panels where perished or missing should be removed and replaced.

The door to the bathroom is damaged and should be replaced with new ironmongery. A new door blank has been installed to the bedroom without ironmongery, therefore, all ironmongery including the clasp and strike plate should be attached. Isolated damage to the skirting boards was also noted in the living room and in need of replacement. Kitchen unit doors are hanging loose, must be realigned with the hinges adjusted as necessary. The timber window frames, including the timber surround and sills, show signs of age and damage and require repair and redecoration. The ironmongery, showing signs of age and stiffness, should be eased and adjusted or replaced if beyond repair. Additionally, the mastic to the window frames is missing and perished and should be replaced.

The flooring has been removed other than to the bathroom and kitchen. However, the vinyl flooring in the kitchen is grubby and unlikely to be salvageable and therefore should be replaced. White melamine tiles are installed in the bathroom, which are unsuitable and have begun to swell around the edges. These tiles should be replaced with a more appropriate flooring type, such as vinyl.

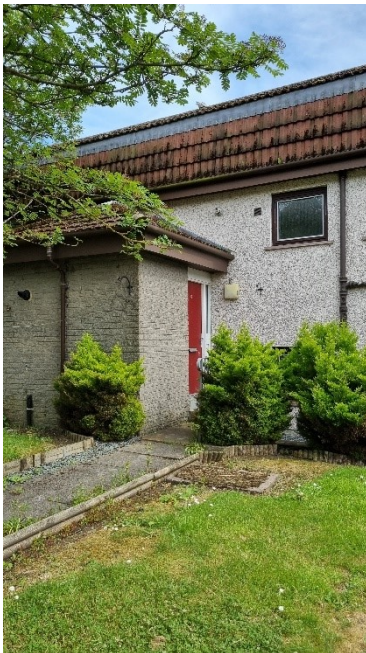
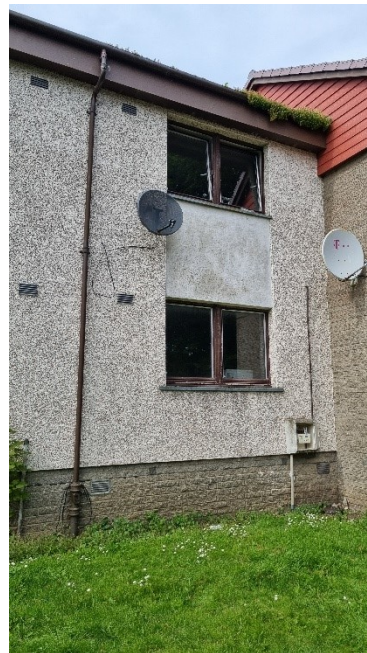
Externals

Vegetation and moss is visible on the upper and lower roofs. Render is missing on the rear wall below the first-floor window. The aluminium fascia and soffits are stained and grubby, requiring a thorough clean. Significant vegetation growth was seen in the rear gutter. All gutters and downpipes should be inspected and cleared of any debris, allowing water to flow freely. Furthermore, the rainwater goods, particularly the downpipes, are in poor condition and require redecoration.

The front door is damaged and in disrepair, necessitating the installation of a new external door, including new ironmongery. The mechanical door closer to the front entrance is missing and should be replaced with a new metal one. The timber window frames show signs of fading and minor damage; therefore, repairs should be undertaken, followed by surface preparation and redecoration.

The area below the retaining wall void is full of debris and should be cleared out.

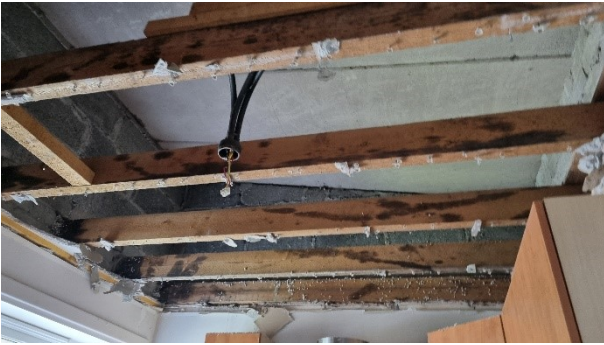
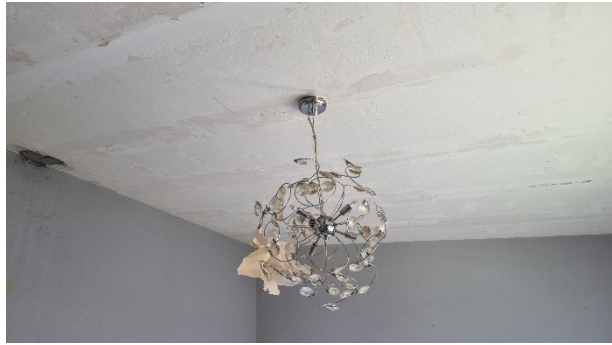
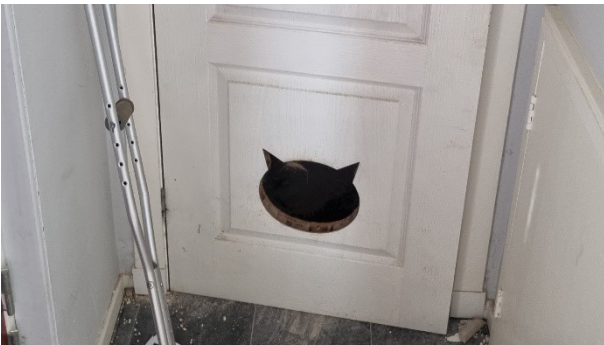
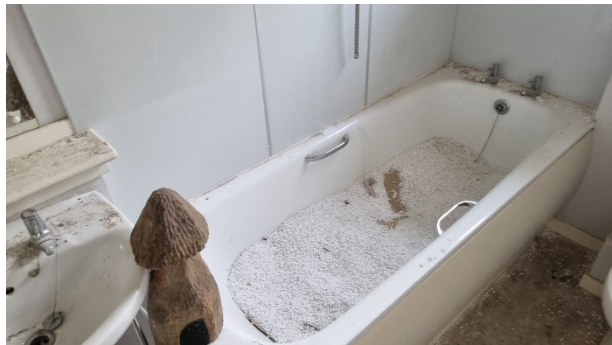
Internals

The ceiling has been fully removed to view the RAAC above. The RAAC ceiling has fine line cracks, and evidence of patch repairs. The RAAC to the living room and bedroom has been painted, and it is likely these were exposed without a flat ceiling. Once any remedial works are finalised with the RAAC, the ceiling should be replaced with plasterboard and suitable insulation complying with modern standards.

The vinyl flooring in the kitchen is unlikely to be salvageable and should be replaced. The bathroom flooring has been removed and should be replaced with a new vinyl sheet. Silicone to wet wall panels is missing or perished, with black mould present, indicating a need for removal and replacement of silicone sealant around the bath.

The hallway cupboard door has been removed from its hinges and should be re-hung and the entrance cupboard door has a cat-shaped hole cut into it and will require replacement.

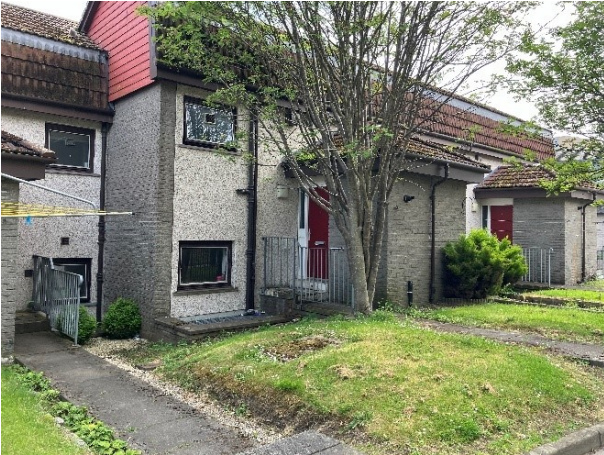
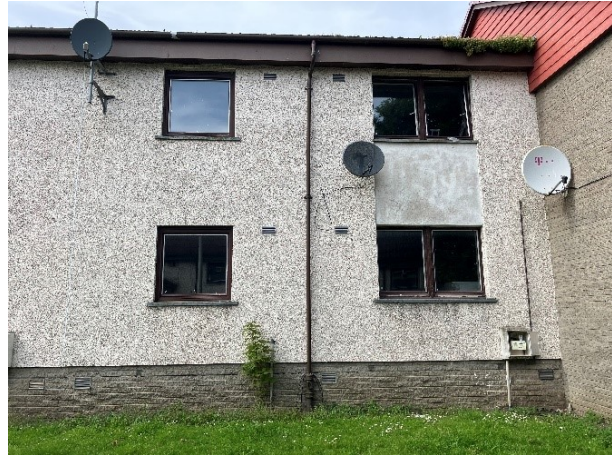
Externals

Vegetation and moss are visible on the upper and lower roofs. The aluminium fascia and soffits are stained and grubby, requiring a thorough clean. Significant vegetation growth was seen in the rear gutter. All gutters and downpipes should be inspected and left free and clear of any debris, allowing water to flow freely. Furthermore, the rainwater goods, particularly the downpipes, are in poor condition and require redecoration.

To the front elevation 1no. window has a smashed pane to the outer pane only. The timber window frames show signs of fading and minor damage; therefore, repairs should be undertaken, followed by surface preparation and redecoration. The door is in satisfactory condition. The decoration of the front door and side panel is fair condition but requires redecoration, including the removal of historic fixings.

The front garden should be maintained especially whilst vacant to reduce vandalism to the property.

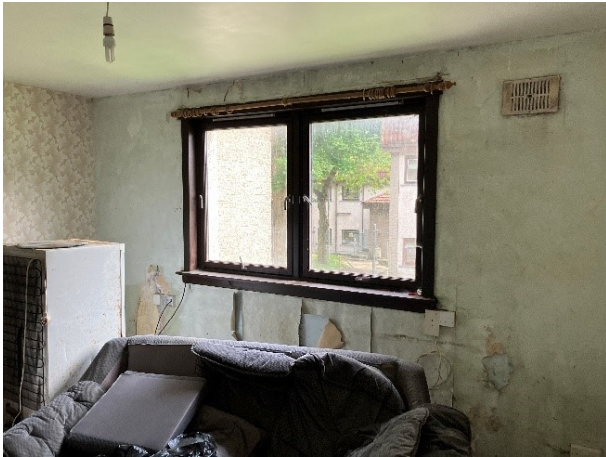
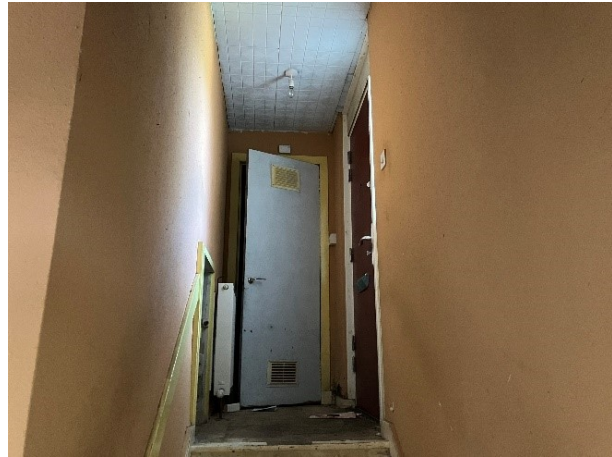
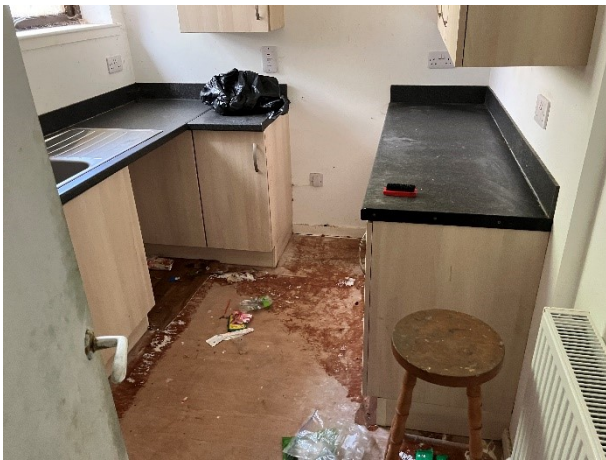
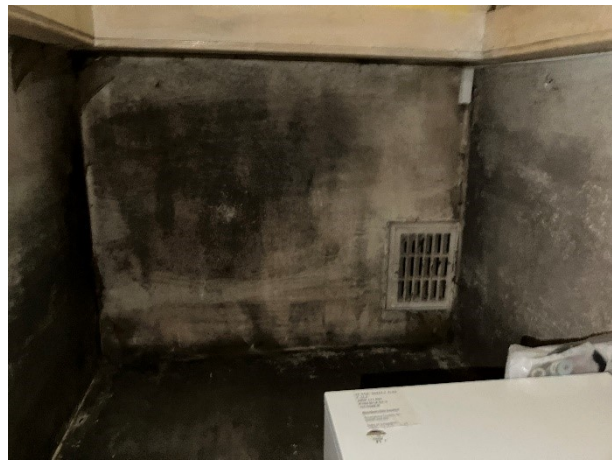
Internals

Evidence of black mould throughout the property, which is likely due to a lack of insulation, this should be addressed by cleaning affected surfaces with a stiff bristle brush and allowing walls to fully dry prior to redecoration. Where the mould cannot be removed, the plaster should be hacked off and the area relined.

Mastic to wet wall panels is missing or perished, with black mould present, indicating a need for removal and replacement of mastic sealant around the bath.

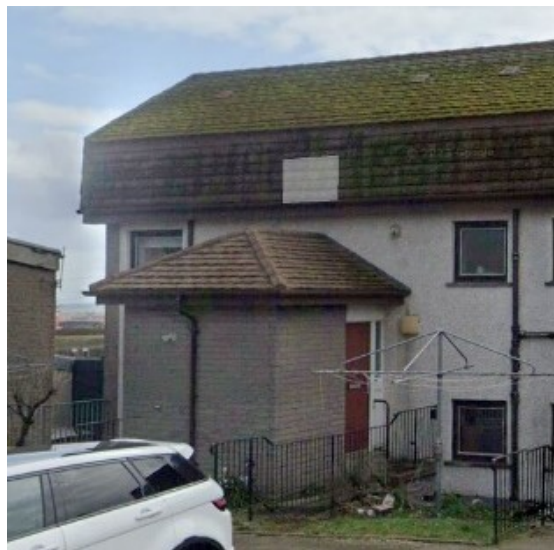
Externals

Vegetation and moss is visible on the upper and lower roofs. Significant vegetation growth around rainwater goods needs to be removed. All gutters and downpipes should be inspected and left free and clear of any debris, allowing water to flow freely. Furthermore, the rainwater goods, particularly the downpipes, are in poor condition and require redecoration. Aluminium fascia and soffits are stained and grubby and require cleaning.

The kitchen and bathroom. window both have a smashed pane. The timber window frames show signs of fading and minor damage; therefore, repairs should be undertaken, followed by surface preparation and redecoration. The door is in satisfactory condition. The decoration of the front door and side panel is fair condition but requires redecoration, including the removal and making good previous fixings.

To the front entrance, the concrete doorstep, is severely cracked and requires renewal. The steel handrails are showing signs of corrosion beneath the flaking paint. The handrail should be cleaned down, remove all flaking paint and redecorate. Debris and vegetation have accumulated around the front garden. This should be maintained especially whilst vacant to reduce vandalism to the property

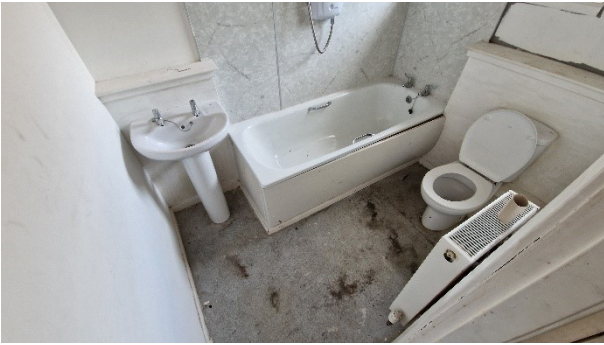
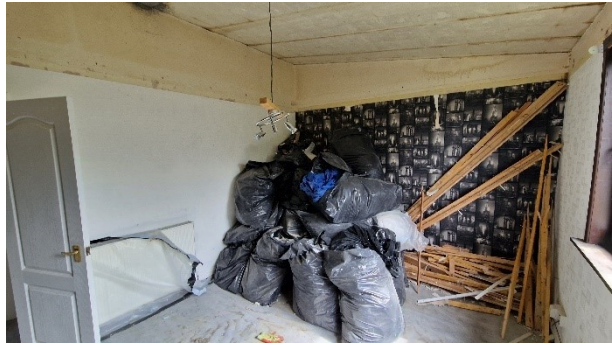
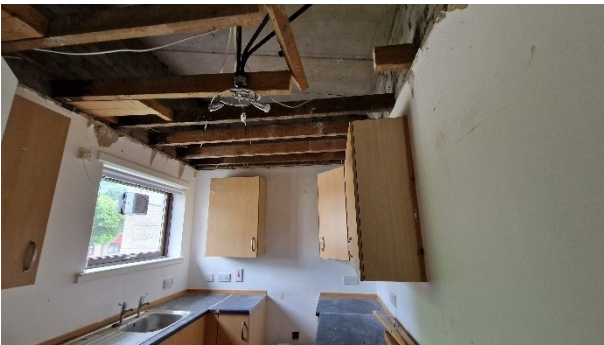
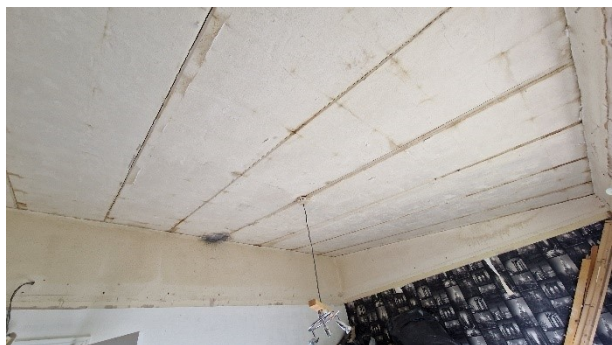
Internals

The ceiling has been fully removed to view the RAAC above. The RAAC ceiling has fine line cracks, and evidence of patch repairs. The RAAC to the living room and bedroom has been painted, and it is likely these were exposed without a flat ceiling. Once any remedial works are finalised with the RAAC, the ceiling should be replaced with plasterboard and suitable insulation complying with modern standards.

The vinyl flooring in the kitchen and bathroom is unlikely to be salvageable and should be replaced with new vinyl sheet. Flooring has been left in other parts of the property which should be removed. Silicone to the wet wall panels is missing or perished, with black mould present, indicating a need for removal and replacement of mastic sealant around the bath. The wet wall has also been damaged during the dountaking of the ceiling. These panels will need to be replaced. Furthermore, the bath panel has been dislodged and requires

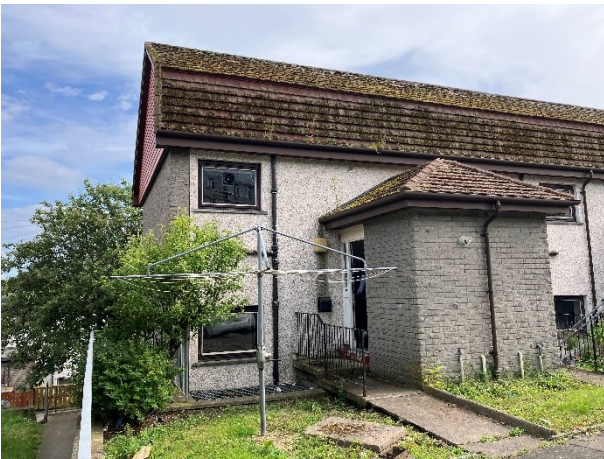
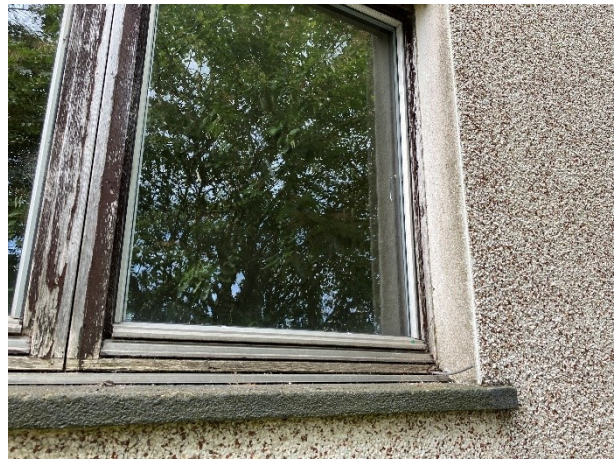
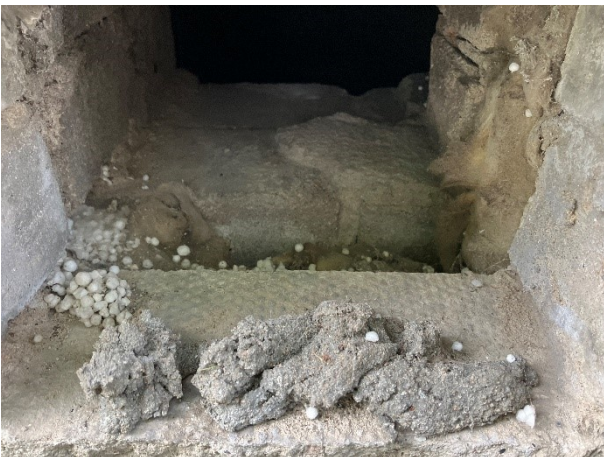
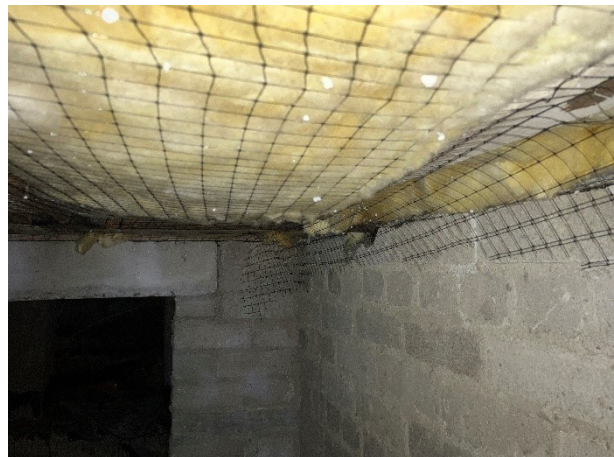
Externals

Vegetation and moss is visible on the upper and lower roofs. Significant vegetation growth around rainwater goods needs to be removed. All gutters and downpipes should be inspected and left free and clear of any debris, allowing water to flow freely. Furthermore, the rainwater goods, particularly the downpipes, are in poor condition and require redecoration. Aluminium fascia and soffits are stained and grubby and require cleaning.

To the front garden, two missing service box lids should be replaced. These could cause a trip hazard and allow for debris and small animals to get into the pipework. Debris in the void area created by the retaining wall should be cleared out. The front garden should be maintained especially whilst vacant to reduce vandalism to the property

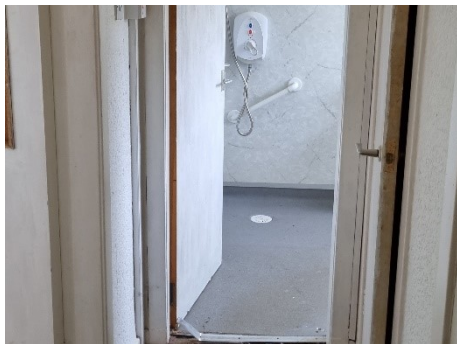
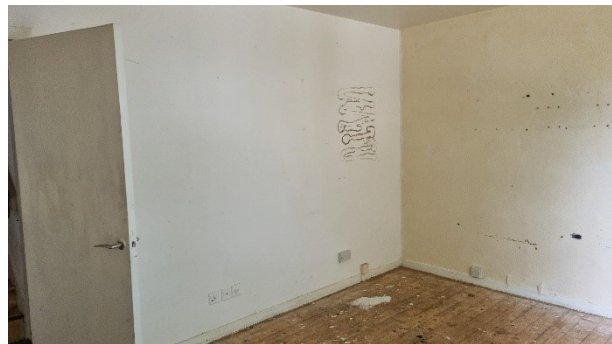
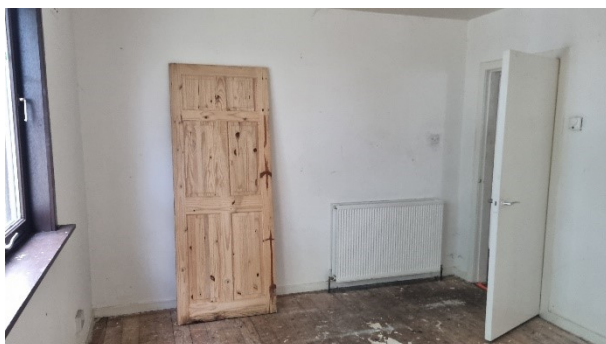
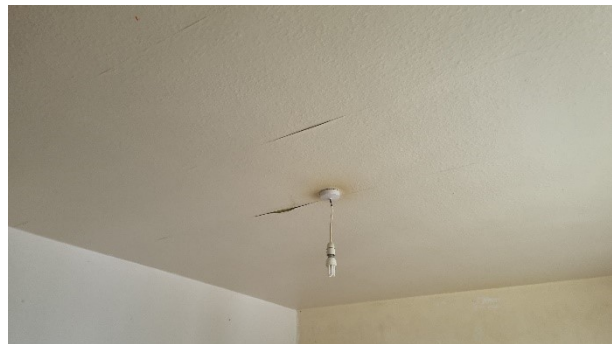
Internals

Evidence of black mould throughout the property, which is likely due to a lack of insulation, should be addressed by cleaning affected surfaces with a stiff bristle brush and allowing walls to fully dry prior to redecoration. Historic water ingress above the living room window, which appears dry, needs making good. Damage to wet wall panels from previous fixtures means that it is no longer watertight and the damage panels should be replaced before use.

The timber window frames, including the timber surround and sills, show signs of age and damage and require repair and redecoration. The ironmongery, showing signs of age and stiffness, should be eased and adjusted or replaced if beyond repair. Additionally, the mastic to the window frames is missing and perished and should be replaced.

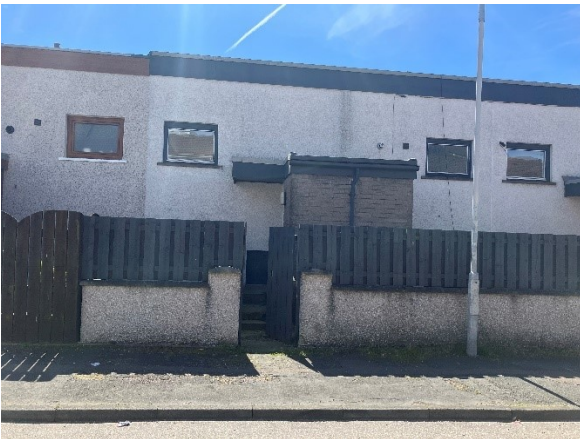
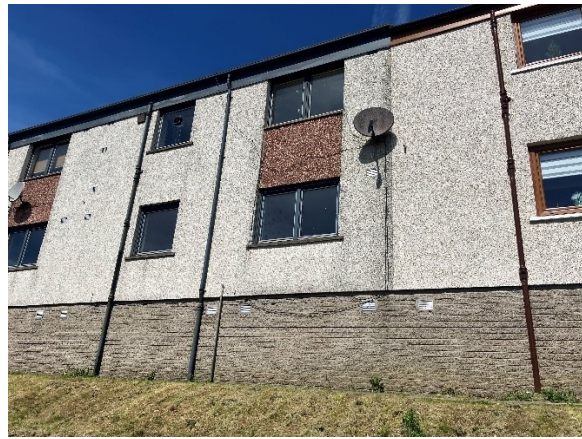
Externals

Debris is visible on the lower roof level and is presumed to be the same on the upper roof, necessitating routine clearance from both roof levels. Timber fascias are detaching from the wallhead in areas, requiring repairs. All gutters and downpipes should be inspected and cleared of any debris, allowing water to flow freely. Furthermore, the rainwater goods are in fair condition and require redecoration.

Redundant fixings are visible on the front elevation roughcast. These should be removed and the holes infilled.

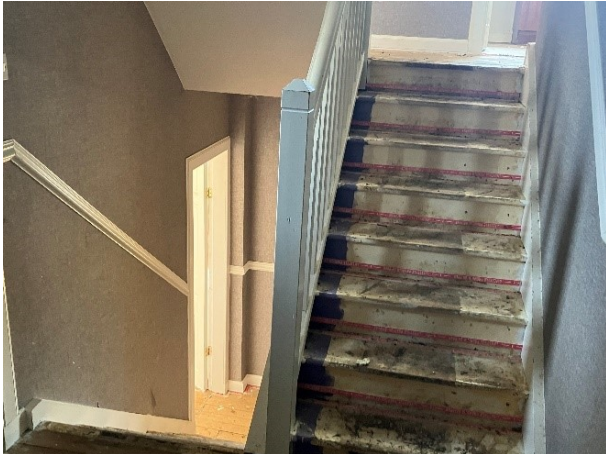
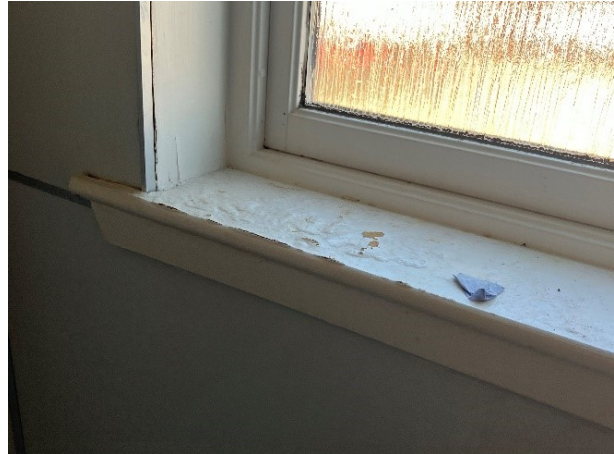
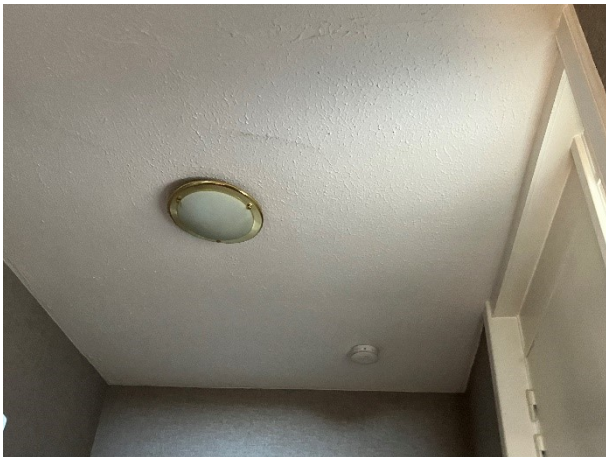
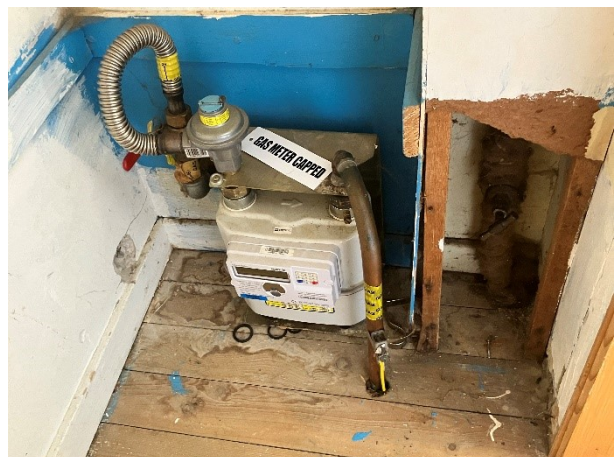
Internals

The timber window frames, including the timber surround and sills, show signs of age and damage and require repair and redecoration. The ironmongery, showing signs of age and stiffness, should be eased and adjusted or replaced if beyond repair. Additionally, the mastic to the window frames is missing and perished and should be replaced. It is advised all penetrations and holes are properly infilled and properly fire stopped between floors.

The flooring has been removed other than to the bathroom and kitchen. However, the vinyl flooring in the kitchen is unsanitary and unlikely to be salvageable and therefore should be replaced. White melamine tiles are installed in the bathroom, which are unsuitable and have begun to swell around the edges. These tiles should be replaced with a more appropriate flooring type, such as vinyl.

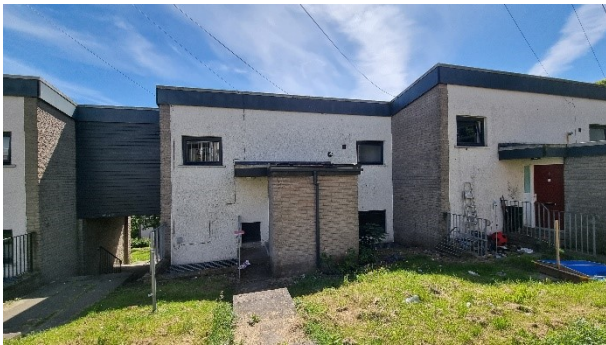
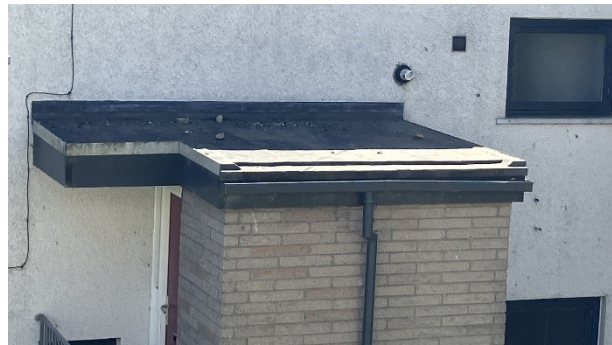
Externals

Debris is visible on the lower roof level the felt is also aged, showing signs of wear. It is presumed to be the same on the upper roof, necessitating routine clearance from both roof levels and potentially the need to re-cover. The rear gutter has significant vegetation growth. All gutters and downpipes should be inspected and cleared of any debris, allowing water to flow freely. Furthermore, the rainwater goods, particularly the downpipes, are in poor condition and require redecoration. Aluminium fascia and soffits are stained and grubby and require cleaning.

Minor cracks were noted around the brickwork of the front door opening, and two large holes in the cavity wall were seen to the undercroft created by the 4th bedroom. The holes were insufficiently large enough to determine any construction information but was large enough for debris to be discarded. All debris must be removed and brick re-bedded and secured. Graffiti was also observed on the front elevation of the property, which should be cleaned off, and the area repainted if required. The painted timber cladding to the bedroom that forms the undercroft is in satisfactory condition, but has an open grain in the timber, which could lead to water ingress, therefore, this should be redecorated.

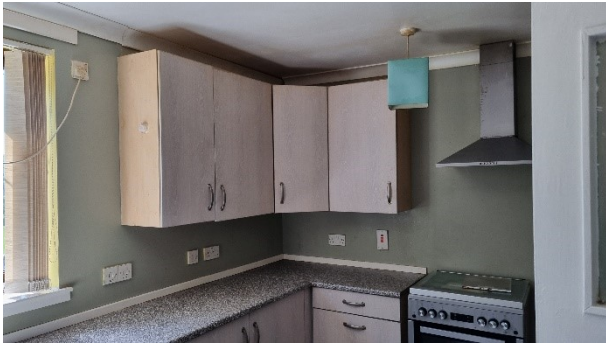
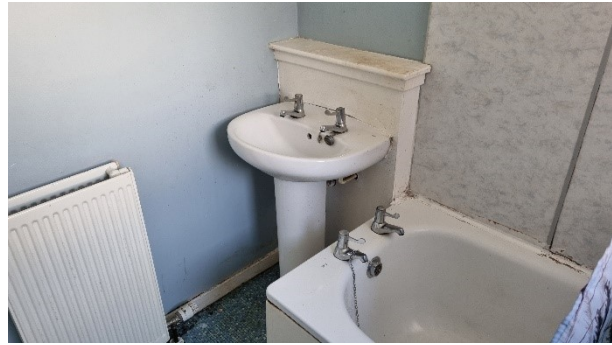
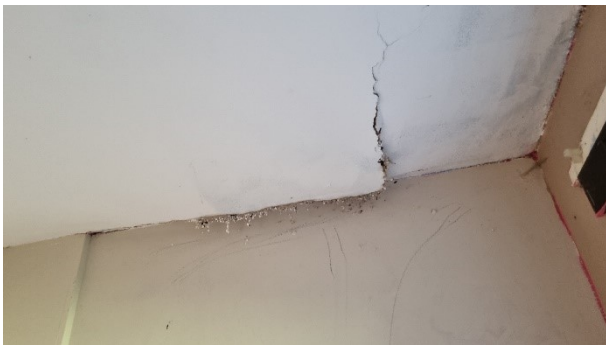
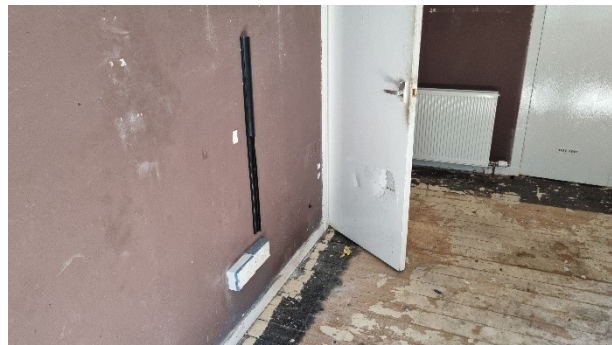
Internals

The ceiling in the 4th bedroom on the ground floor shows cracking throughout, with a section to the plasterboard to the rear of the room hanging loose. It was unclear what caused this, and there were no signs of water ingress, however the bath sits directly above this damage. Furthermore, this is one of the floor voids where polystyrene beads were noted. It is advised the ceiling is carefully removed, investigate the potential cause for the damage, and remove all polystyrene beads. Thereafter, infill with new insulation and install new plasterboard ceiling.

Black mould was observed throughout the property, likely due to poor insulation; affected surfaces should be cleaned with a stiff bristle brush and allowed to dry before redecoration. There was also mould particularly around the bath. The silicone to wet wall panels is also missing or perished.
