7.3 THE BEACH BALLROOM

INTRODUCTION

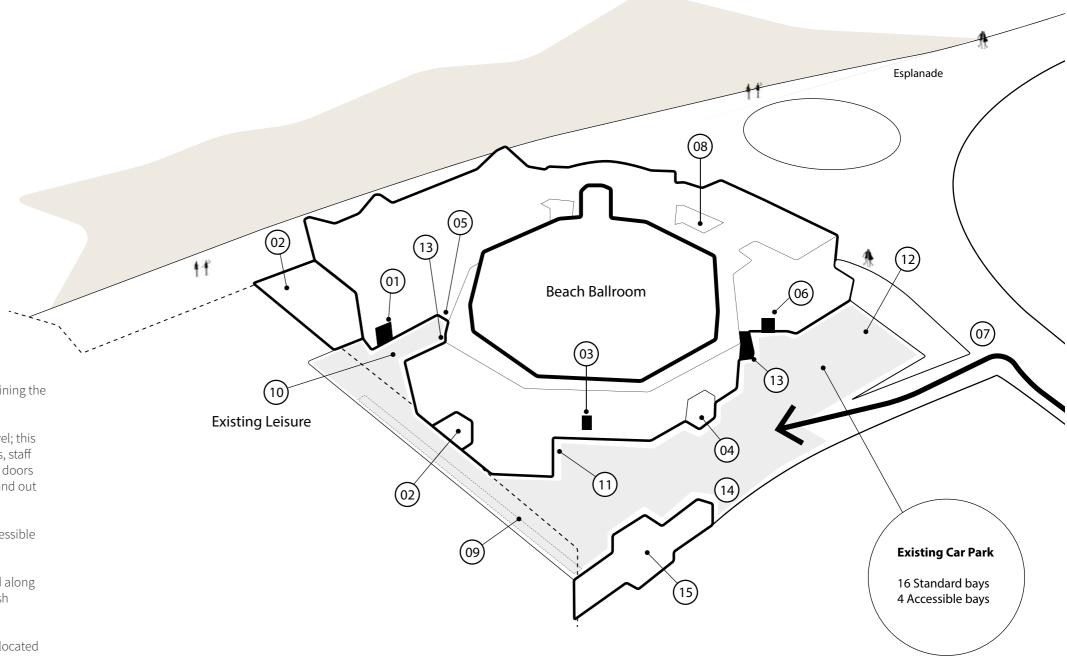
Analysis of Existing Building Servicing: L1 (View from Rear)

Vertical CAT ladder roof access is achieved using the small external courtyard located centrally within the building at LG level. This provides insufficient maintenance accessibility and does not meet escape / health and safety requirements. Any proposed developed moving forward will need to consider improved/compliant maintenance access as well as sufficient barrier protection.

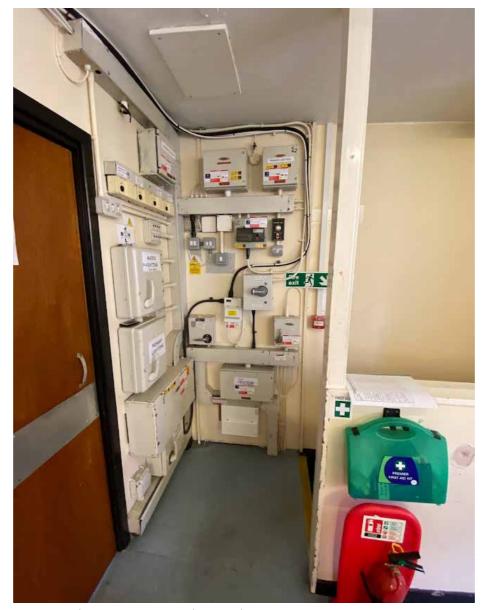
Unprotected escape staircase and exposed services

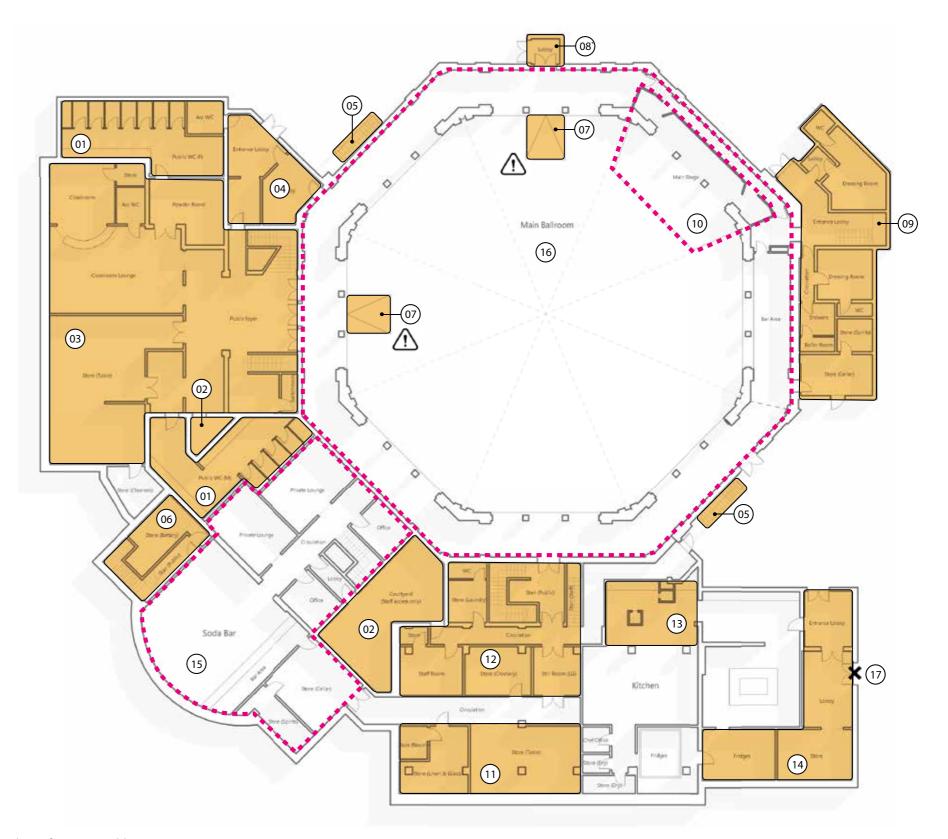
Analysis of Existing Building: LG

- 01 It is acknowledged that the public toilets as highlighted, have been upgraded recently, however the quality of finishes should be enhanced for a building of this importance and setting

- Existing courtyard is extremely restrictive and serves no purpose other than to provide roof maintenance access which is noted as being inadequate and unsafe

- Ramps within the Ballroom manage the changes in level but are a retrofit solution and not considered holistically; they also present a trip hazard.
- This small porch extension provides a secondary exit from the Ballroom but is unlikely to satisfy regulations relating to maximum occupancy, escape widths etc in the event of escape. Externally, it does not compliment the original architecture.

- The main Ballroom decor is dated and has a feeling of poor upkeep. Although the carpet was replaced within the last 10 years, it only adds to a general lack of cohesion in terms of interior strategy. The lighting is understated and limited in scope, resulting in a very dark periphery behind the main octagon pillars

- 17 Link to Leisure Centre not used.

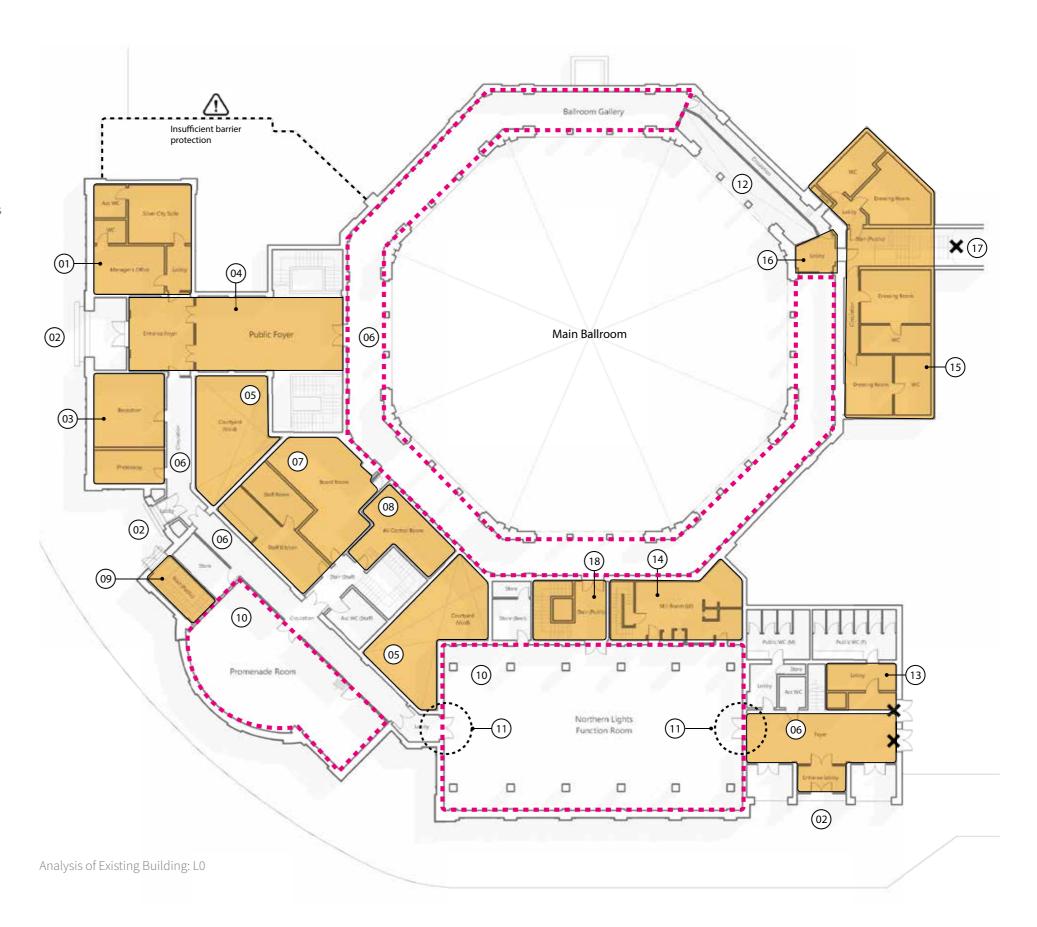
- O1 Potential for lettable space at prime location from esplanade. Current useage not maximised and some areas assigned as general storage. Silver City suite would be better relocated adjacent to function rooms to improve flexibility

- The Northern Lights interior fitout is dated and of low quality finishes e.g. plastic chandeliers. The 1970 bar extension and overall colour scheme should be replaced with a contemporary design which is flexibile for variety of uses. Consider removal of retrofit bar areas in favour of flexible movable bars.

The existing L1 bridge link to the current Leisure Centre is cordoned off and access is restricted. Consider demolition of link in conjunction with new proposed Stadium and Leisure Centre development

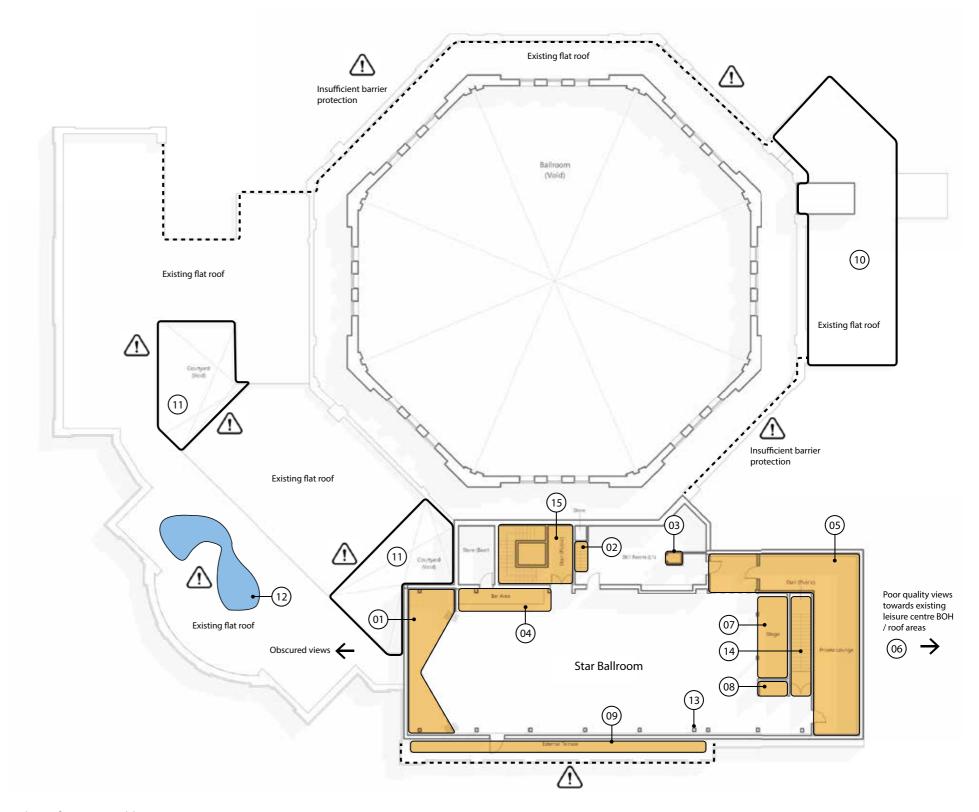
Analysis of Existing Building: L1

- O1 South end of Ballroom is cordened off with curtain screening which reduces usable space and does not maximise opportunities for views towards the beach

- Existing facade envelope is showing signs of corrosion due to the marine environment and general poor upkeep / maintenance. Weathering of materials likely to worsen over time. Single glazed curtain walling will continue to contribute to poor EPC rating (G-).

- Existing public stair is narrow and not sufficiently fire separated from other areas of the building. Enclosure contains non fire rated glazed panelling and no protected lobbies.
- No protected lobby to separate escape stair from adjacent spaces; all levels.

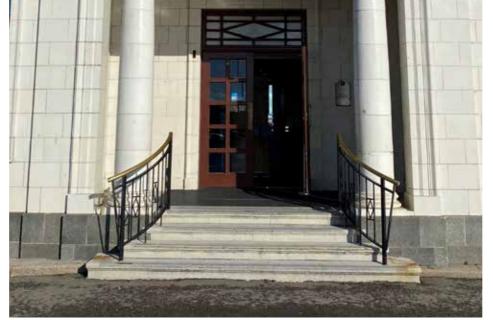
Inaccessible Entrance for Wheelchair Users (left), Constrained and Underutilised Courtyards (centre, right)

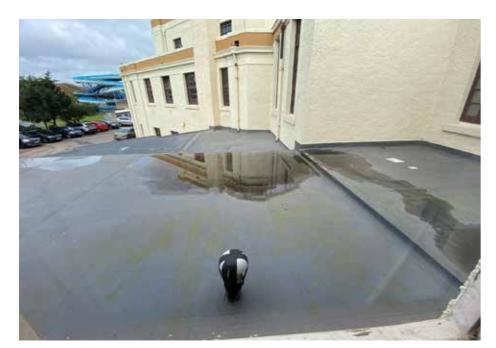
Ponding on L1 roof (left)

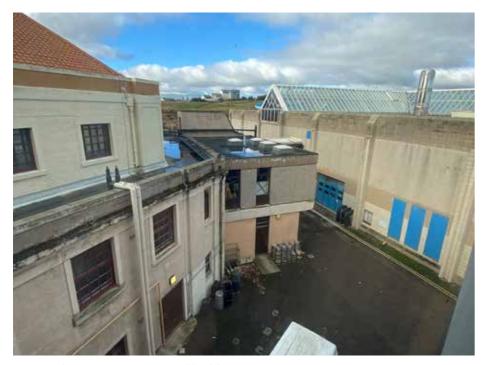
Poor quality extension to original building

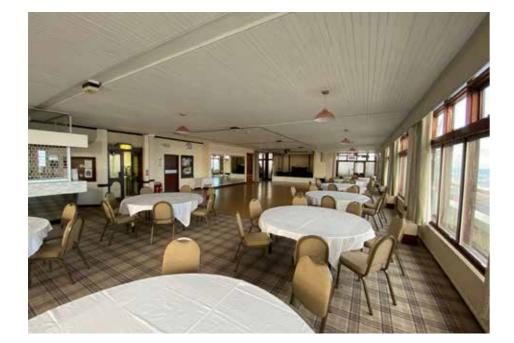
Dated, low quality furnishings and fittings
