Aberdeen North Beach Coastal Defence

Phase 1 Desk Study

20 January 2017

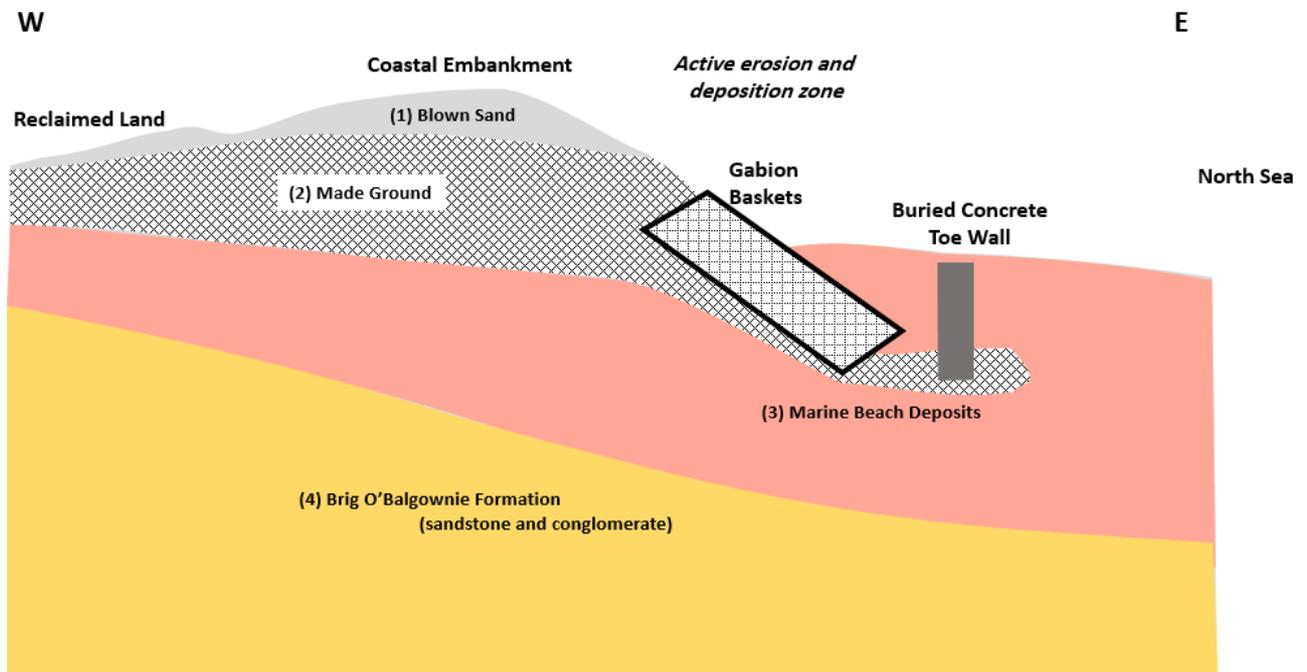
Figure 2.2: Illustrative Preliminary Ground Model

There is active erosion at the site due to its coastal location, as well as deposition, with made ground material deposited on the beach from erosion of the embankment and typical beach blown sand deposition.

Strata ID	Thickness (m)	Description	Comment
(1) Blown Sand	Unknown	Fine-grained uncemented sand	-
(2) Made Ground	Unknown	-	Associated with sea defences i.e. rock filled gabions, coastal embankment construction and infilled reclaimed land i.e. demolition rubble
(3) Marine Beach Deposits	Unknown	Gravel, sand, silt and clay	-
(4) Brig O'Balgownie Formation	Unknown	Conglomerate and sandstone	-
