LOCAL REVIEW BODY OF ABERDEEN CITY COUNCIL

- 2 The Mill, Clinterty - proposed demolition of former mill building and erection of replacement dwelling house - 160426
- 3 Delegated Report, Plans and Decision Notice and letter of representation (Pages 7 - 52)

160426: Proposed demolition of former mill building and erection of replacement dwelling house at The Mill, Little Mill of Clinterty, Kingswells, Aberdeen

**PROPOSED DEMOLITION OF FORMER MILL BUILDING AND
ERECTION OF REPLACEMENT DWELLING HOUSE AT THE MILL,
LITTLE MILL OF CLINTERY, KINGSWELLS, ABERDEEN
REF: 160426**

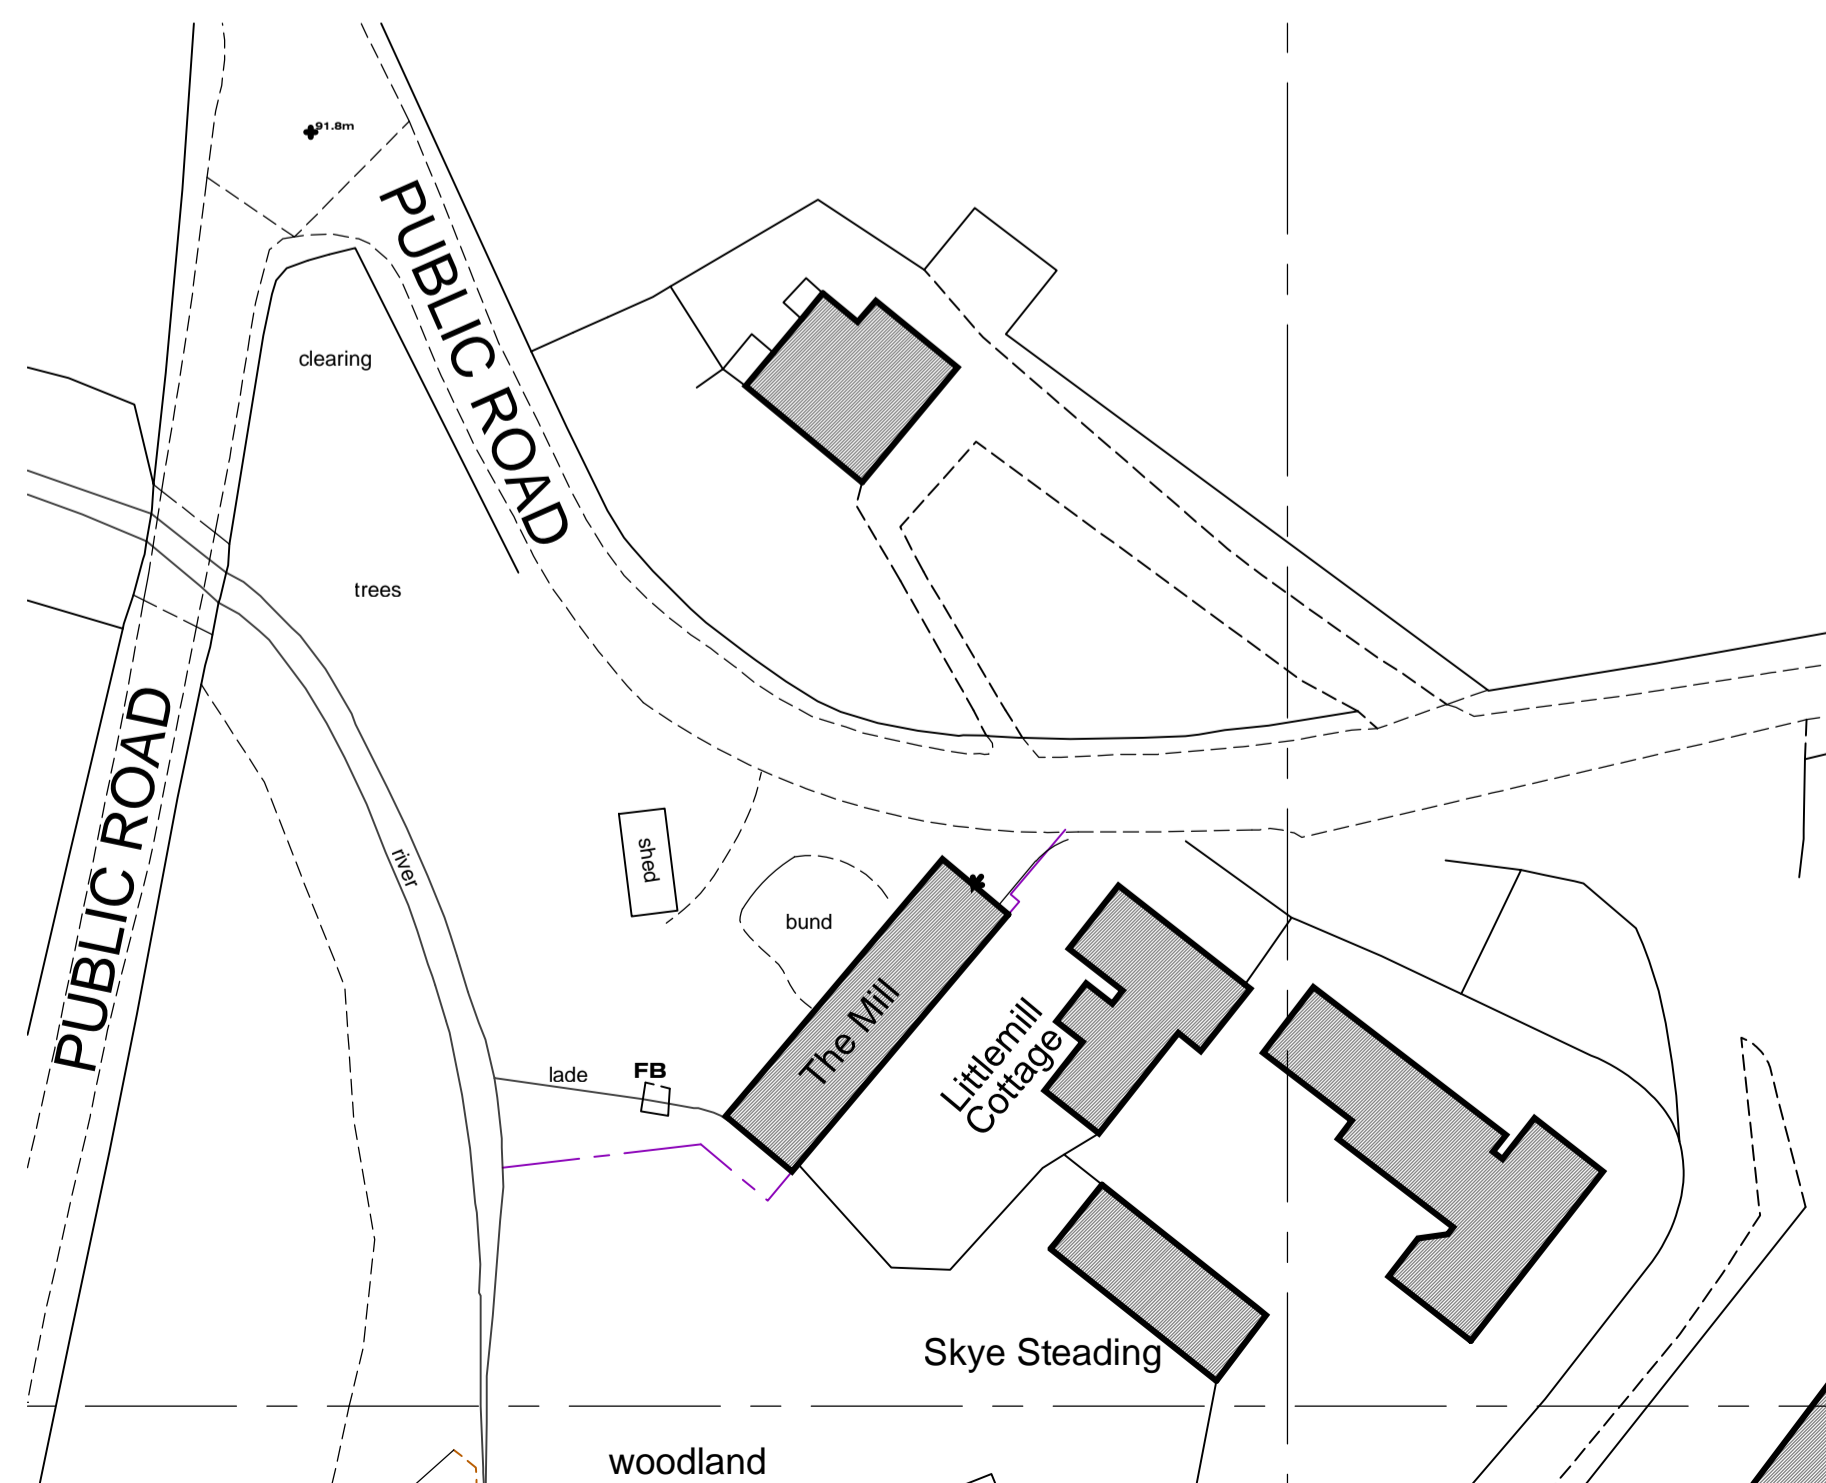
Block Plan : Scale 1 : 500

The block plan above shows the proposed replacement dwelling house, with the buildings that we propose to demolish shown with dashed lines. We propose to retain the footprint of the existing building as far as possible.

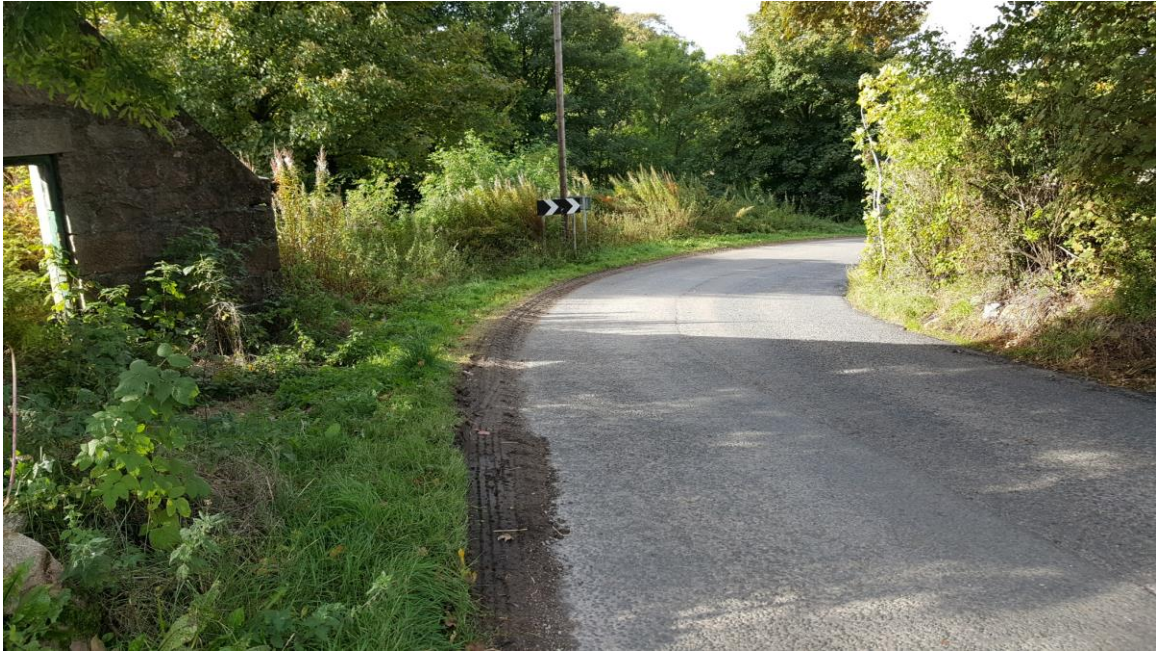
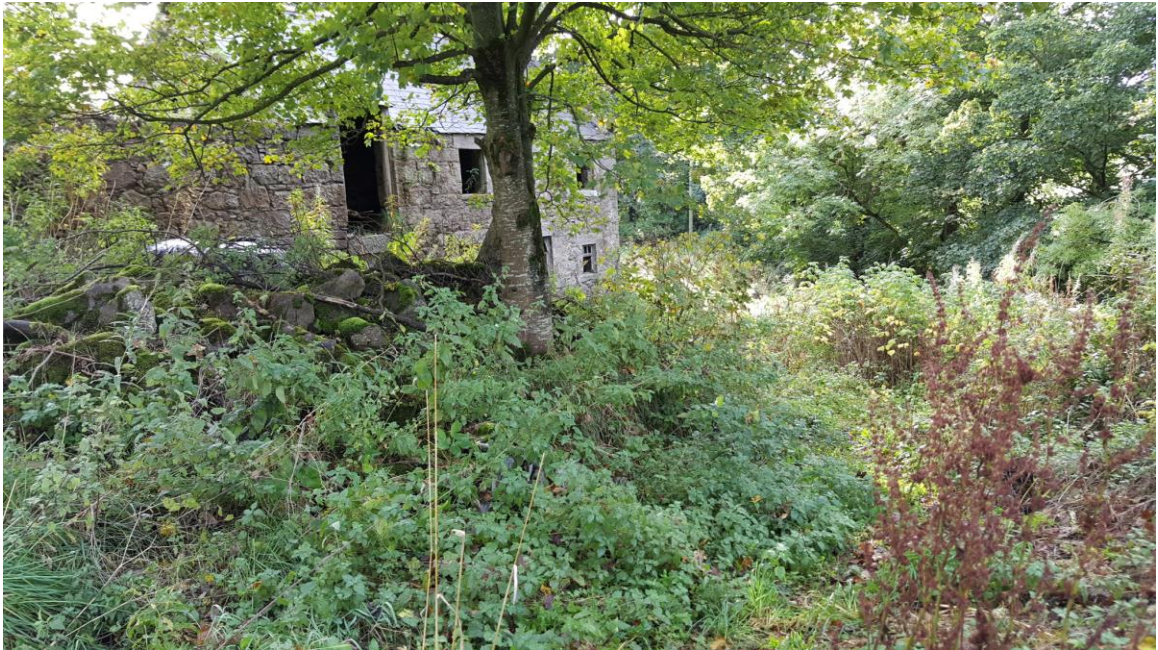
*Top – view onto the public road from the north-east corner of the site, looking west.
Bottom - view of the tree between the buildings, and the steading itself, from the access*

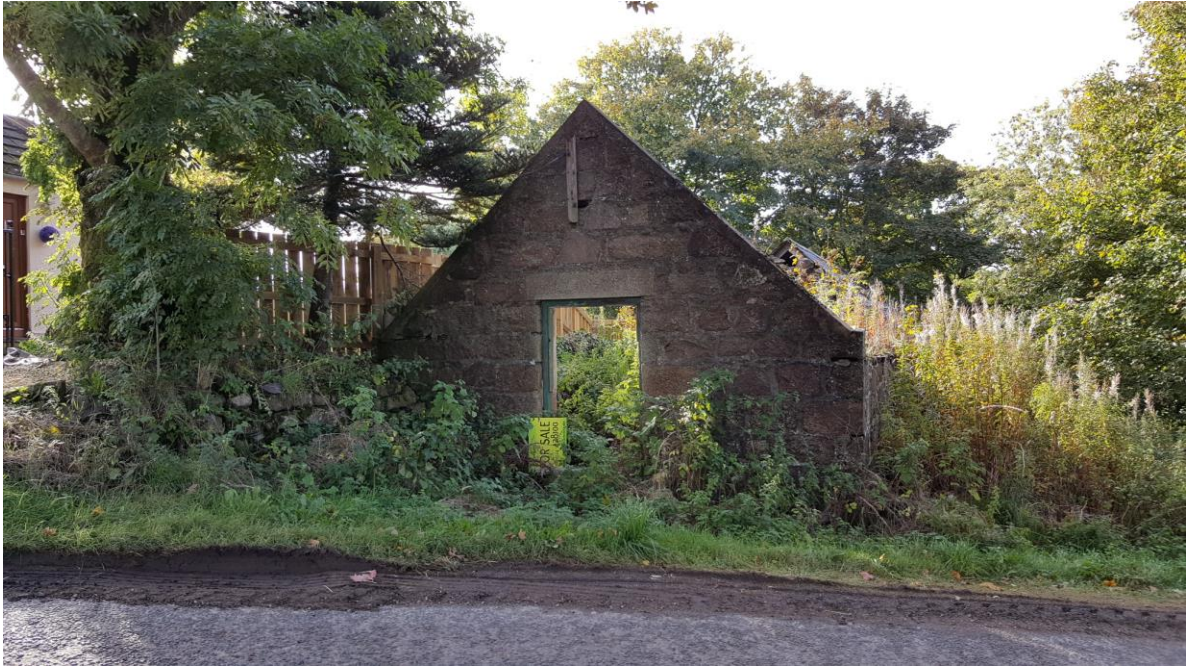
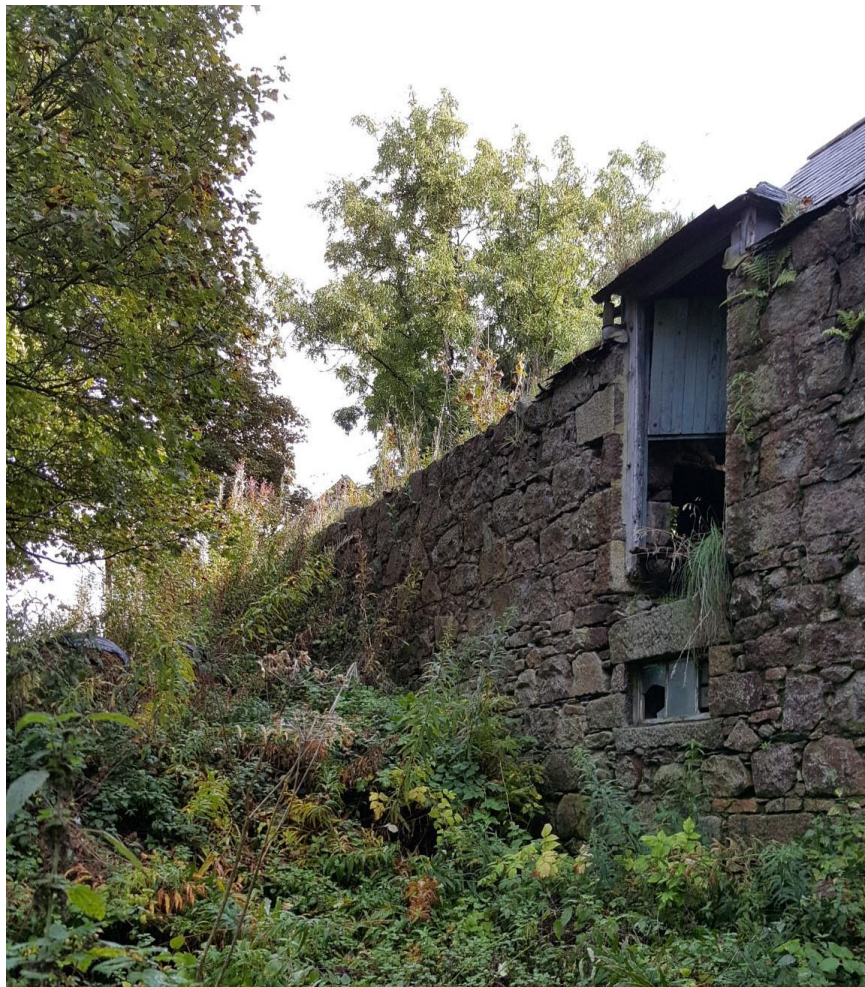
*Top – view of the gable end of the steading from the road at the east corner
Bottom - view of the steading from the southern corner looking back up to the north*

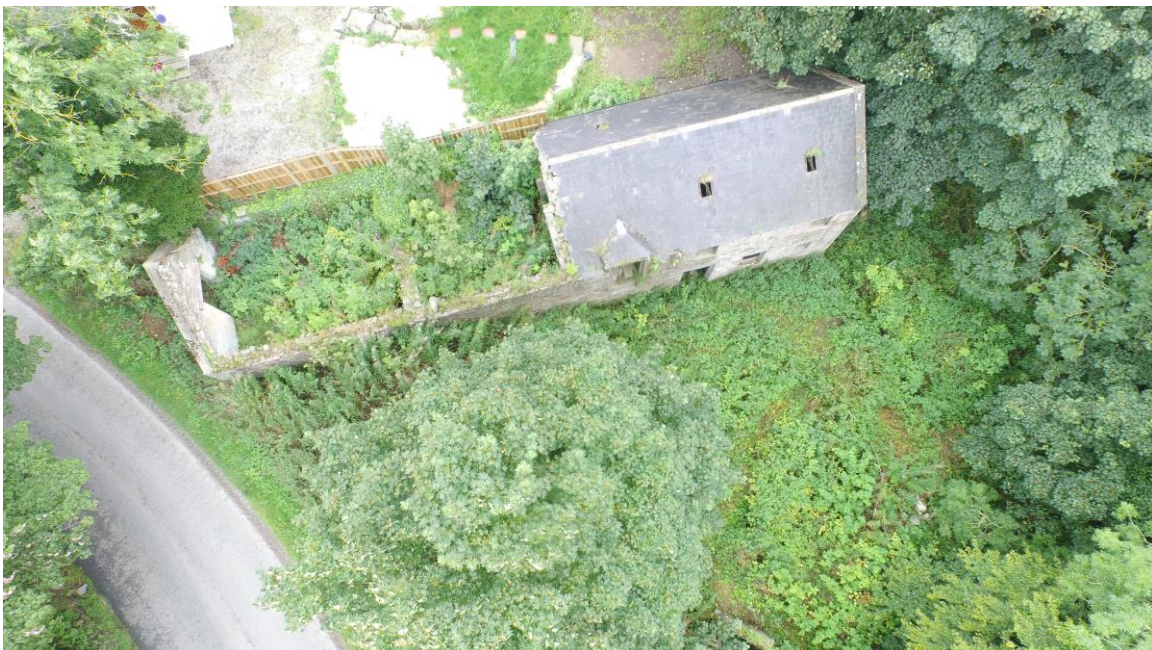
Aerial view of the existing building and woodland

The image below shows an aerial view of the property obtained by the applicant. The back of the building is directly on the boundary line, upon which the neighbour has formed a timber fence to screen their property from the unsightly appearance of the building. This proximity of the building to the boundary line is a negative feature of the property which will have had an impact upon the market value of both properties, and would have an undesirable effect on the amenity of both parties.

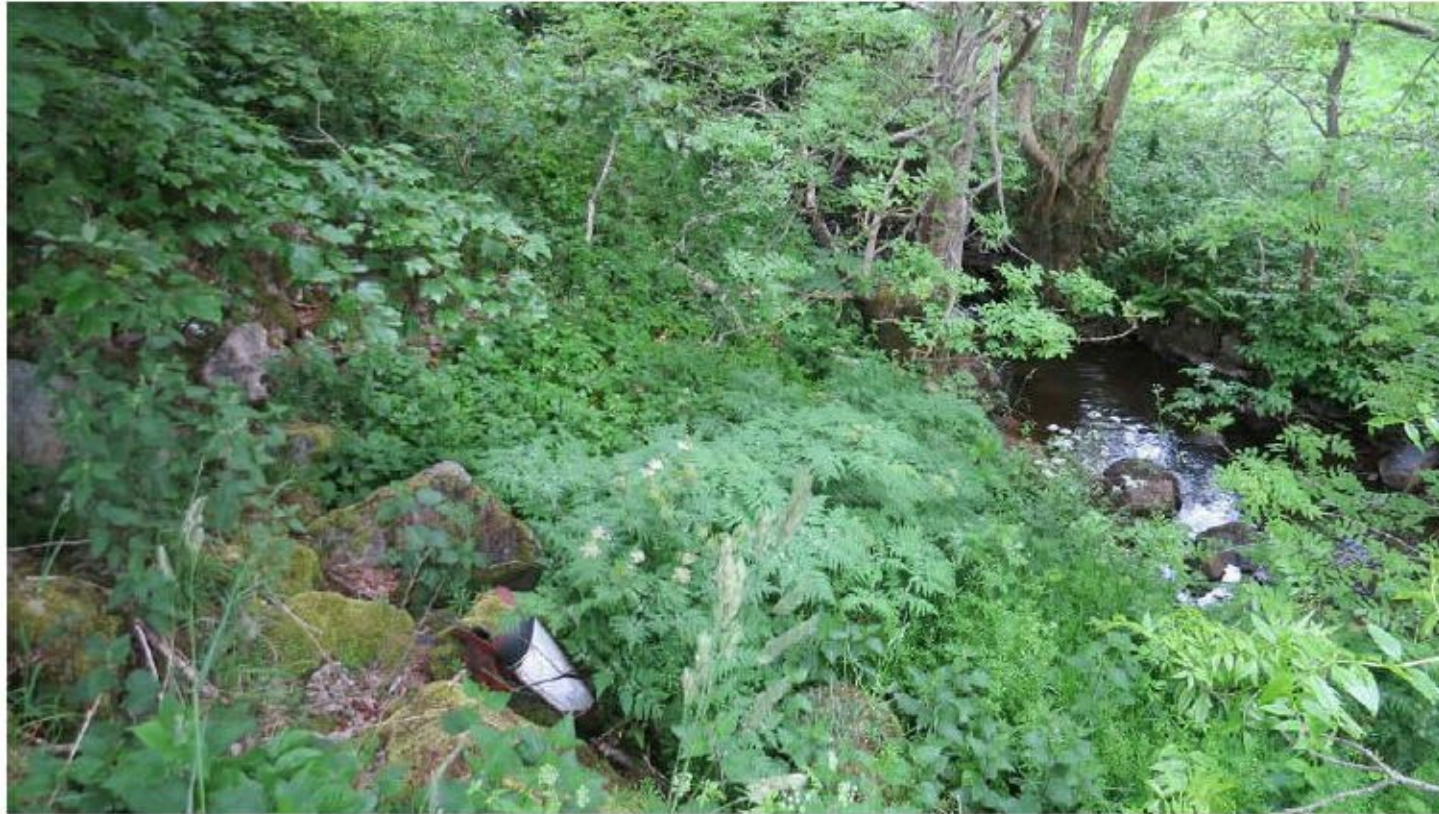
Photo 1: View northeast from the bridge over the burn. Stone edge to burn and dense rudderal flora.

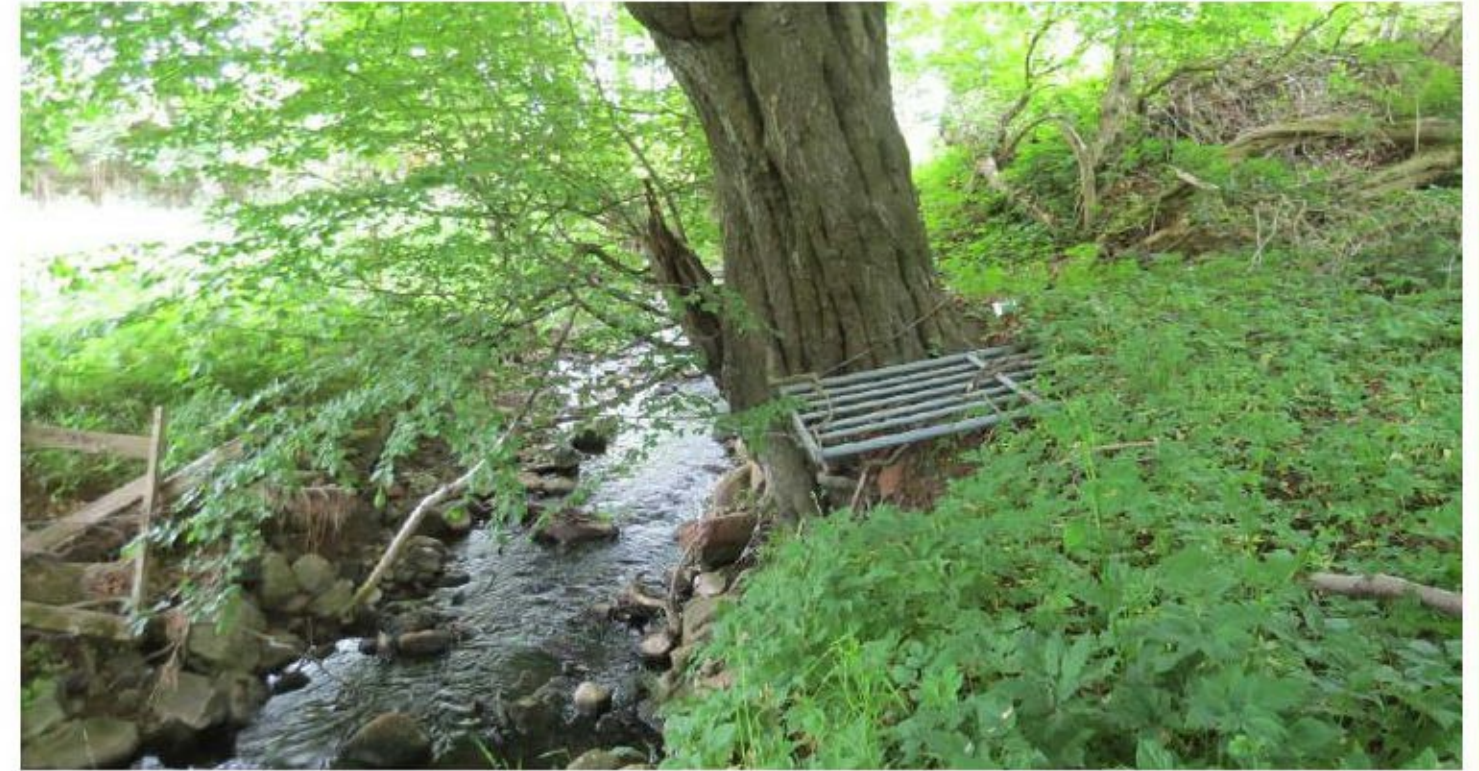
Photo 3: View south past mature beech tree. The banks of the burn do not have water vole habitat and there was no signs of water voles.

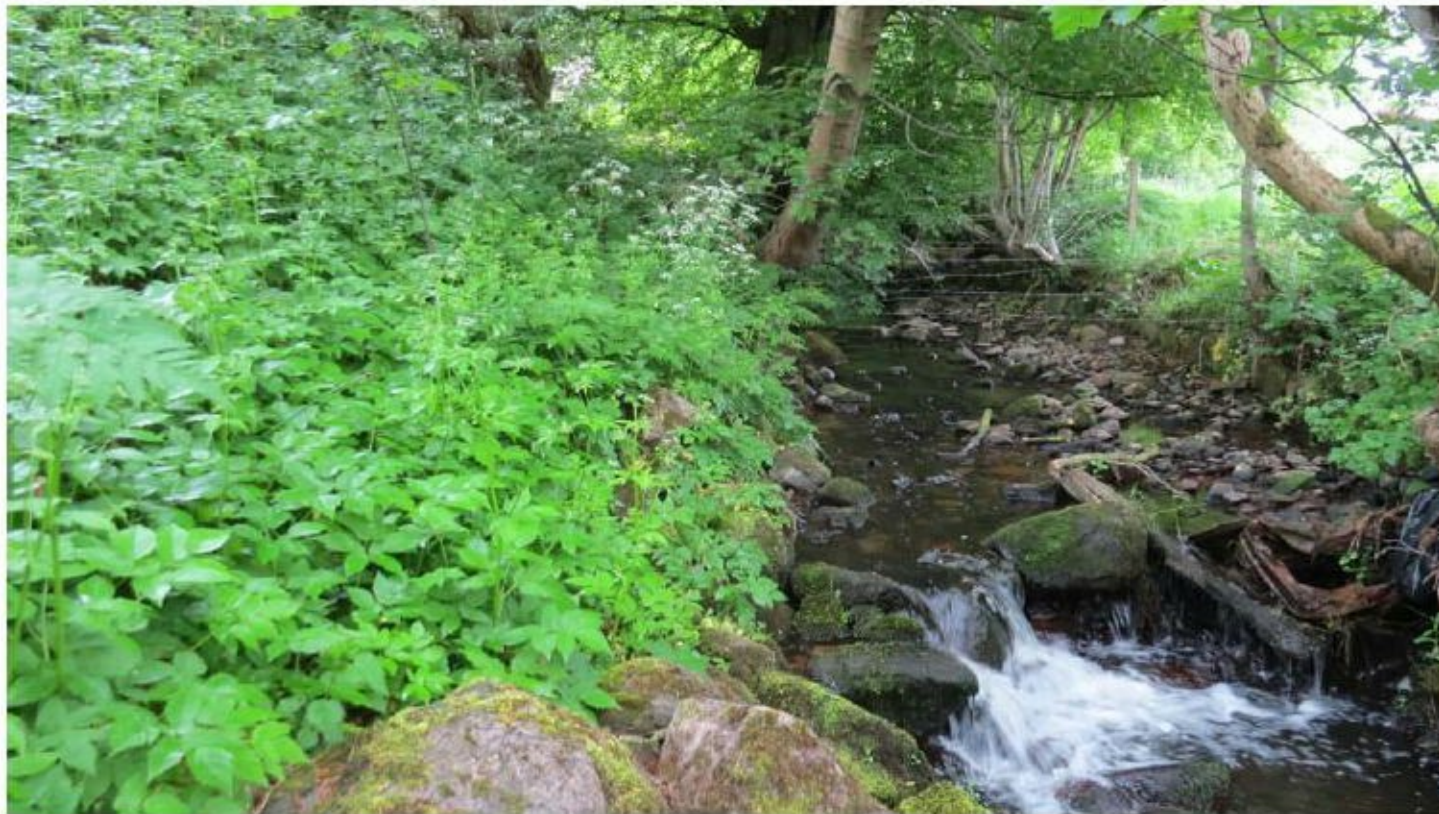
Photo 2: View along burn showing stone banks and dog's mercury with umbels as the rudderal vegetation.

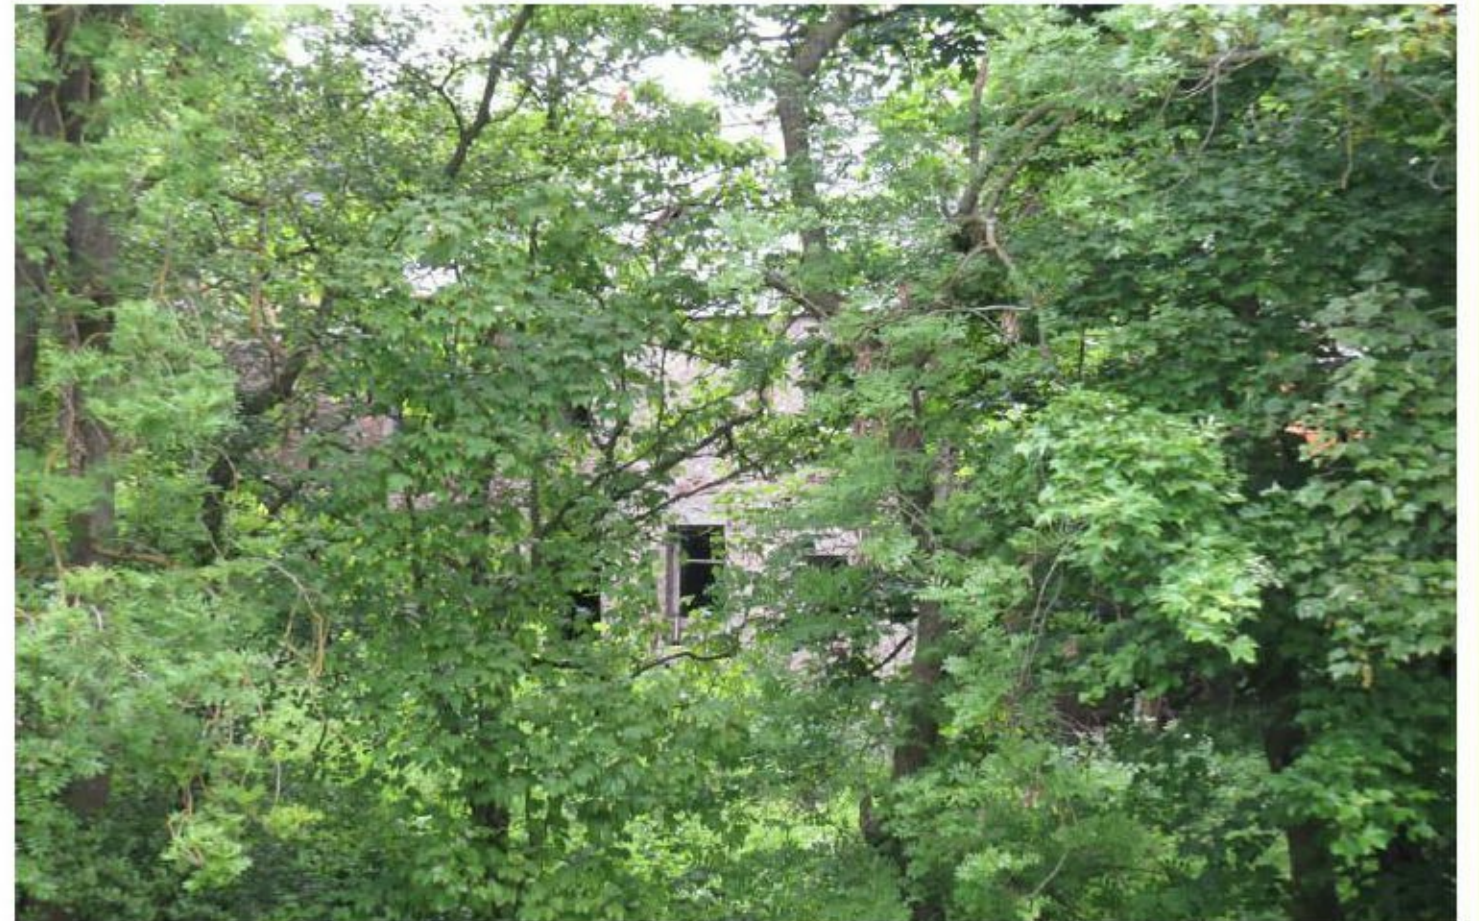
Photo 4: View west through trees along burn side. Dense deciduous trees screen the building from this direction.

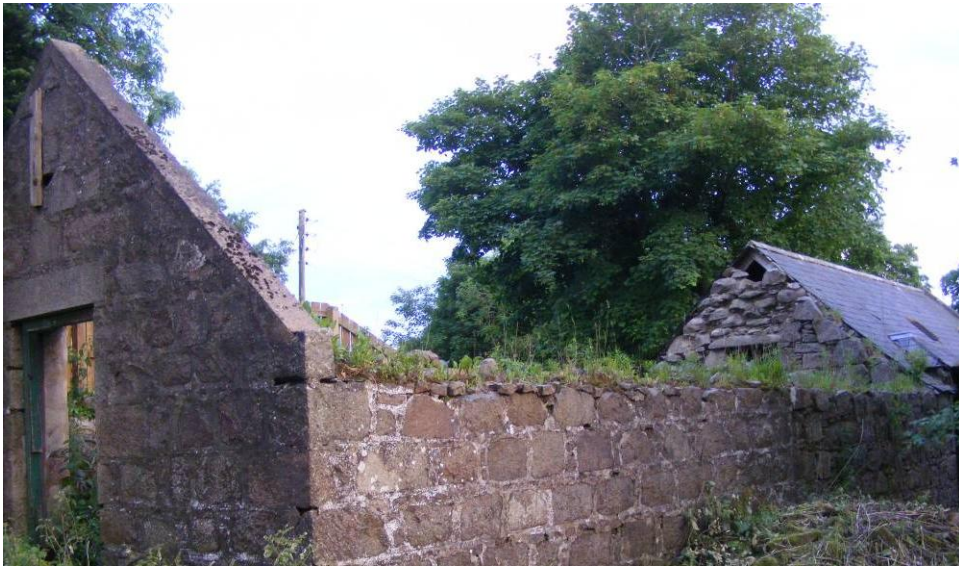
Photo 3: Northwest corner of ruin. Remaining wall generally well-sealed.

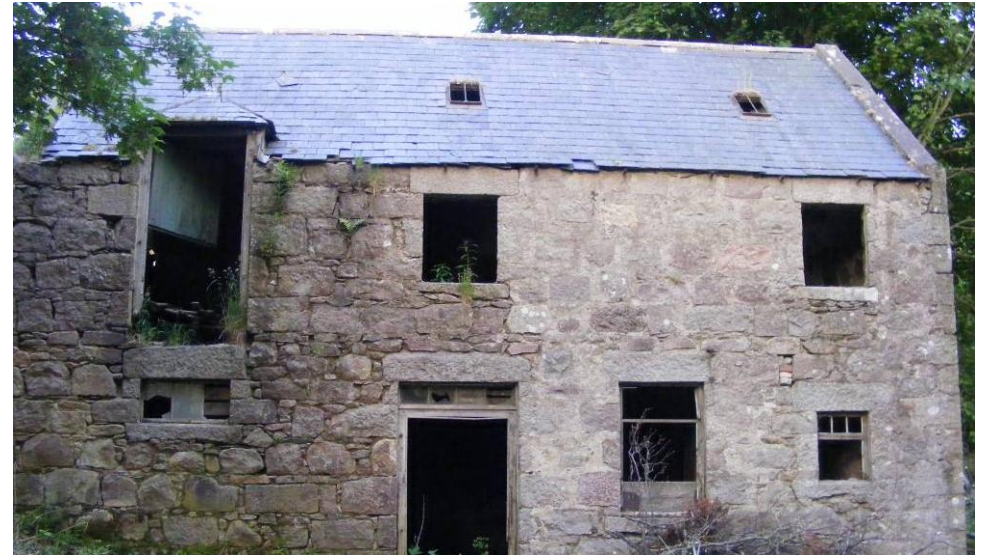
Photo 5: West elevation of mill. Plants are growing from cracks in places show wall is damp. Some loose and missing slates on roof provide limited bat roost potential. No evidence of bats found.

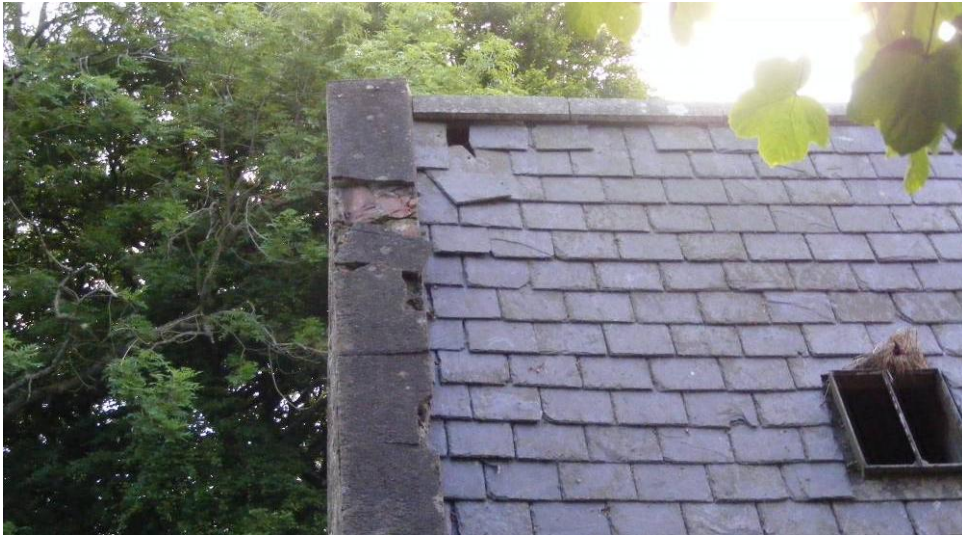
Photo 8: South gable end. A loose slate has caused a small hole in the roof contributing to the dampness inside the mill and in the roof. Lifted and missing slates provide limited roosting potential. No evidence of bats was found.

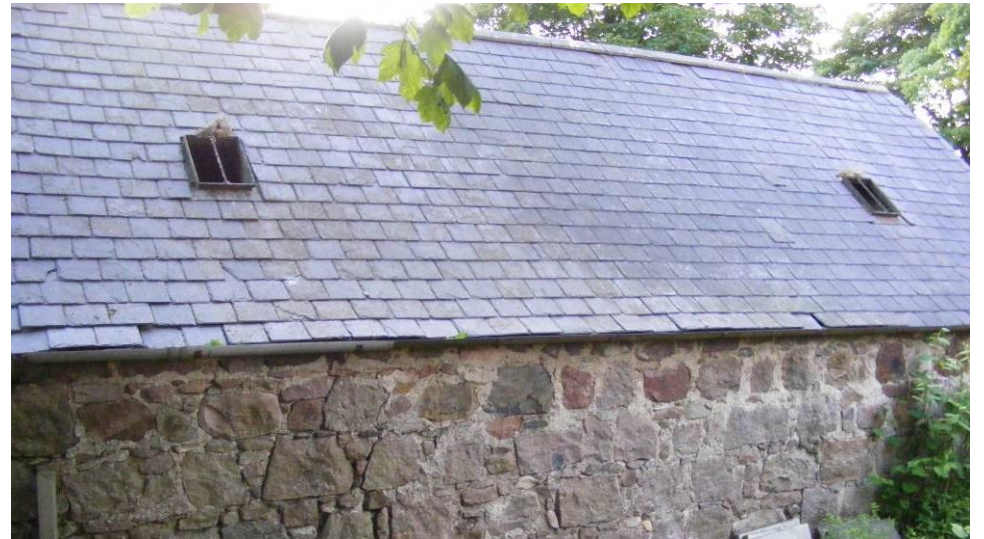
Photo 10: Eastern elevation of Mill building. Roof has several missing slates but is mainly in good condition. Windows are broken allowing water inside contributing to the damp. Ridge appears intact.

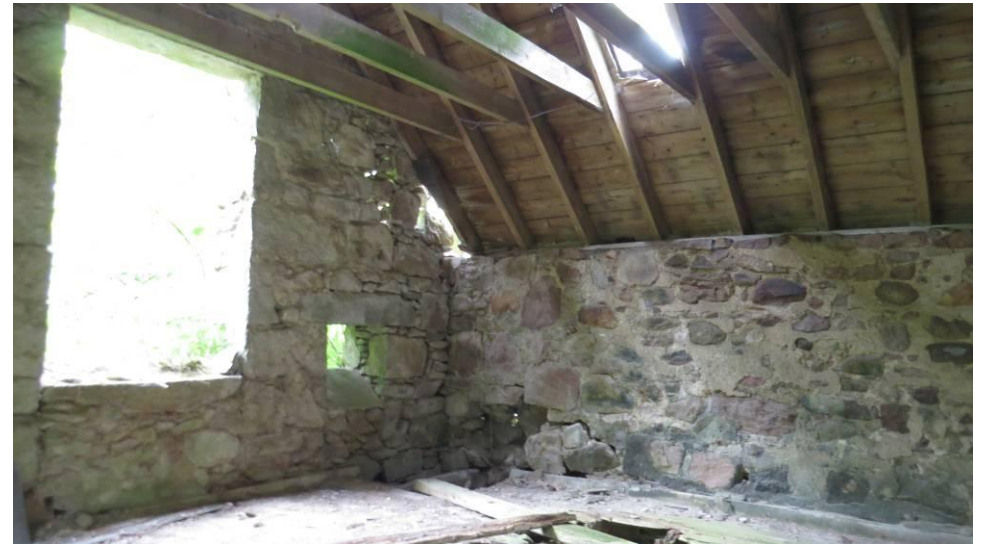
Photo 11: North gable. Large hole in northeast corner of the wall. Roof and floor rotten in places. The building is in poor condition and becoming dangerous.

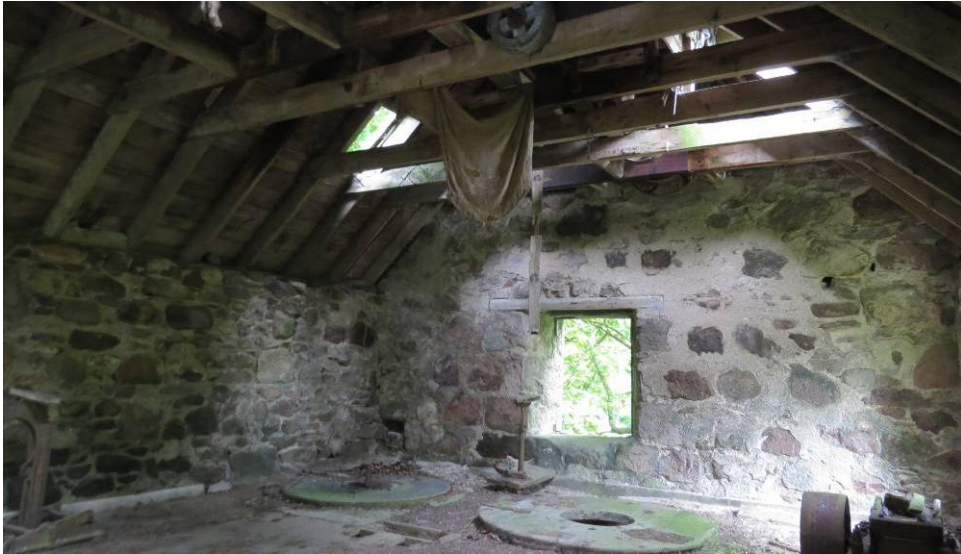
Photo 13: South gable. Roof rotten and collapsing in places. Algae on floor and walls are further evidence of damp with rainwater entering the building. There is no enclosed roof space and limited bat roost potential.

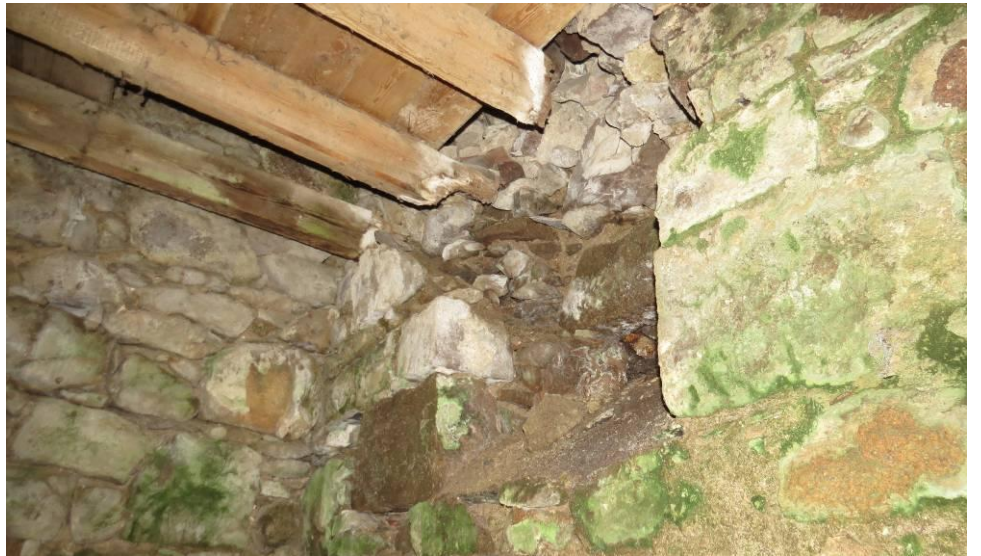
Photo 15: Lower floor ceiling beams rotten and dangerous. The wall is very damp with no bat roost potential.
