Beach Master Plan Report – 25.08.21

ENGINEERING SITE APPRAISAL

AECC City Vision - Aberdeen Beach Regeneration Beach Boulevard Aberdeen

Project No: P15077

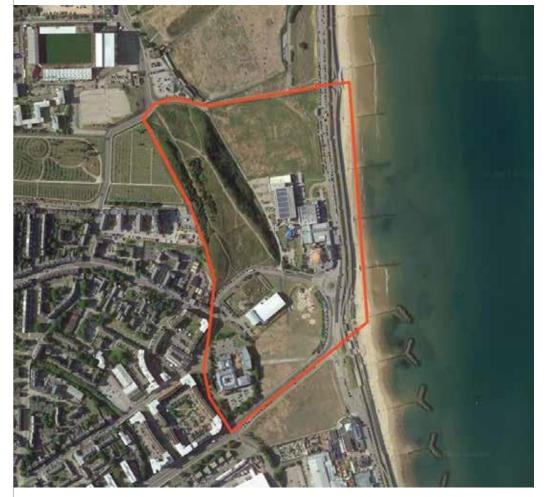
Figure 1: Red line boundary shown on OS aerial map extract.

A red line boundary and aerial photograph is shown in Figure 1.

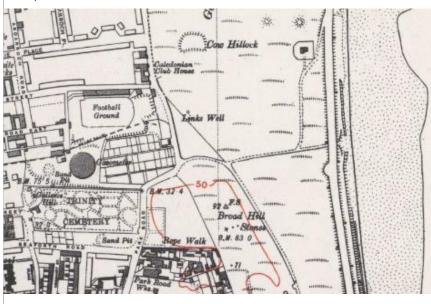
Figure 5: Historic map extract from 1938.

During the late 1930's and 1940's the site remained largely unchanged. The surroundingarea has expanded to include leisure facilities.

HISTORIC MAPPING		
Map Date	Description	
1843-1882	The site itself has had a number of former uses, as demonstrated in Figures 4 to 6. The Queens Links region was formerly used as a race course (equestrian), and includes a tramway and beach battery closer to the coast. Kings Links overlaps with a former rifle range but was predominantly left as scrubland.	
	The surrounding area has a history of heavy industrial usage and includes chemical, gas, iron and granite works nearby.

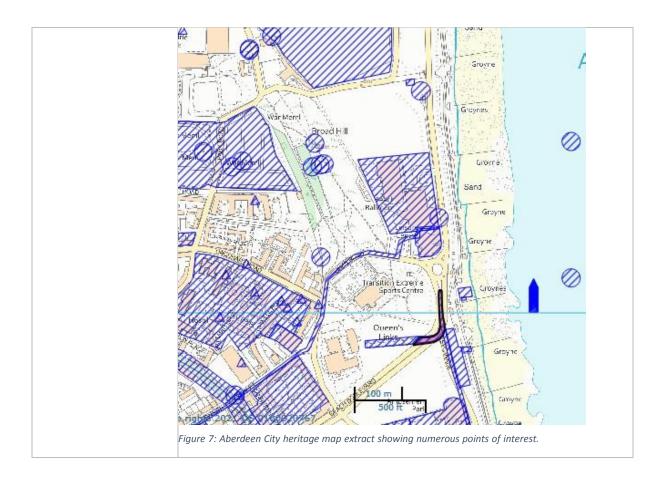
Figure 8: Canmore map extract showing numerous points of interest.

The following items have been identified as points of interest on the Aberdeen City Council Historic Environment Record (HER) map and Canmore:

- Remains of a tramway.
- Large proportion of Queens Links used as late 19th to early 20th century bottle dump and tip.
- 20th Century ballroom
- WW2 heavy anti aircraft gun battery
- Site of gunpowder magazine
- Lighthouse / rocket house
- Boundary stones and battery gun remains on Broad Hill

Archaeological Archaeological Irial trenching will be required, with potential delays to development depending on the significance and complexity of any artifacts of interest that are found.

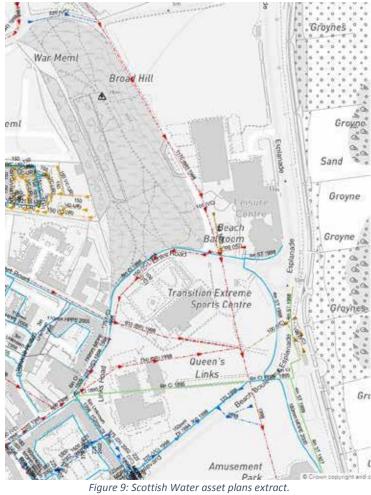
The Scottish Water record drawing for the site and surrounding area is shown in Figure 9.

DRAINAGE		
Foul Drainage	A combined sewer runs north south through the centre of the site with a number of attributing sewers connecting into it. Points of connection and available capacity will need to be confirmed with Scottish Water.	
Foul Drainage Pumping / Off-site Works	Existing facilities are drained via gravity therefore it is anticipated that a pumping station will not be required.	
Surface Water Drainage	Methods of infiltration are unlikely to be a feasible surface water drainage option due to the proximity to the sea.	
	There are no water courses in or around the site.	
	Surface water sewers are present within / close to the site and it is likely that these will be required as part of the overall surface water drainage strategy. Consultation with Scottish Water is required to determine availability and capacity of assets.	
Attenuation Required	Surface water attenuation will be required as part of the site layout.
