SERVICE UPDATE

<u>Name of Function:</u>	Operations, Waste & Recycling Service
<u>Date:</u>	21/12/22
<u>Title of Update:</u>	Altens East Recycling & Resource Facility Fire Update
<u>Report Author:</u>	Pam Walker, Waste & Recycling Manager
<u>Chief Officer:</u>	Mark Reilly, Chief Officer, Operations & Protective Services
<u>Contact Details:</u>	PWalker@aberdeencity.gov.uk

The purpose of this briefing is to provide an update to the Committee members on the contingency arrangements and the rebuild progress following the serious fire at Altens East Recycling & Resource Facility on 8th July 2022.

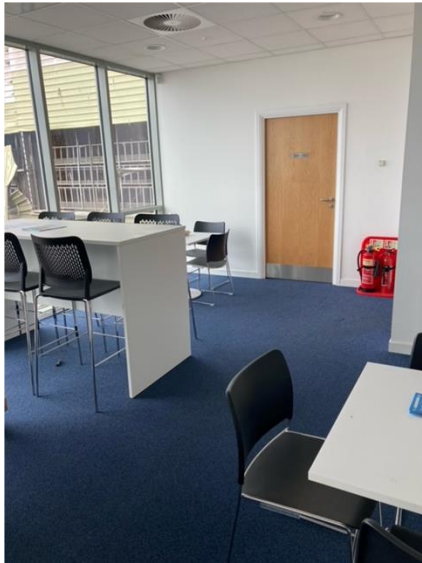
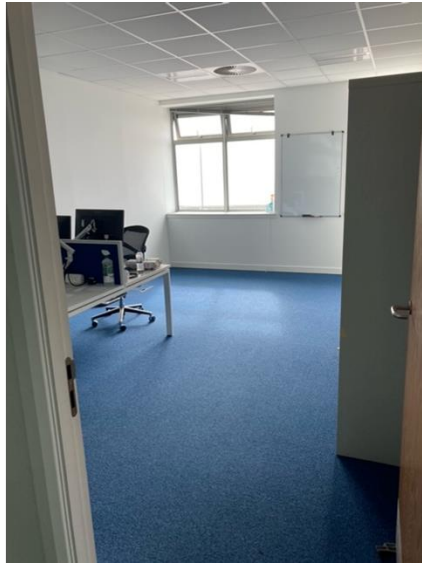
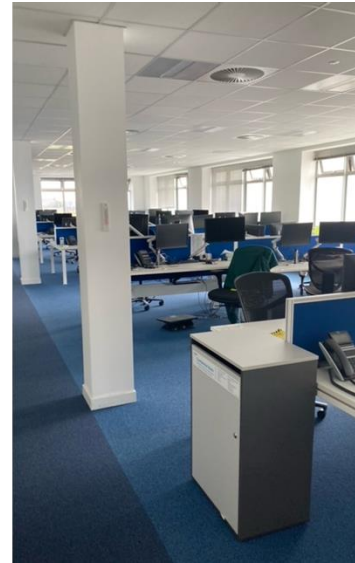
Altens offices post-fire – firewall did its job very well

The office building did not suffer any fire damage, but was affected by smoke/heat, there was a very effective fire wall between the office and MRF building which responded very well. However, it is apparent that the building has suffered some movement as a result of the fire and there is evidence of cracks in walls and movement in door frames, etc. Further structural surveys will be required to assess to extent of that damage. The office is attached to the main MRF building and as such this has caused movement.

The demolition process will detach the MRF from the office and once that is done further surveys will be carried out. In the meantime, dehumidifiers and heaters have been installed to protect the building from further damage and the ceiling tiles have been removed to allow for further inspection. The building is currently inaccessible due to the demolition works.

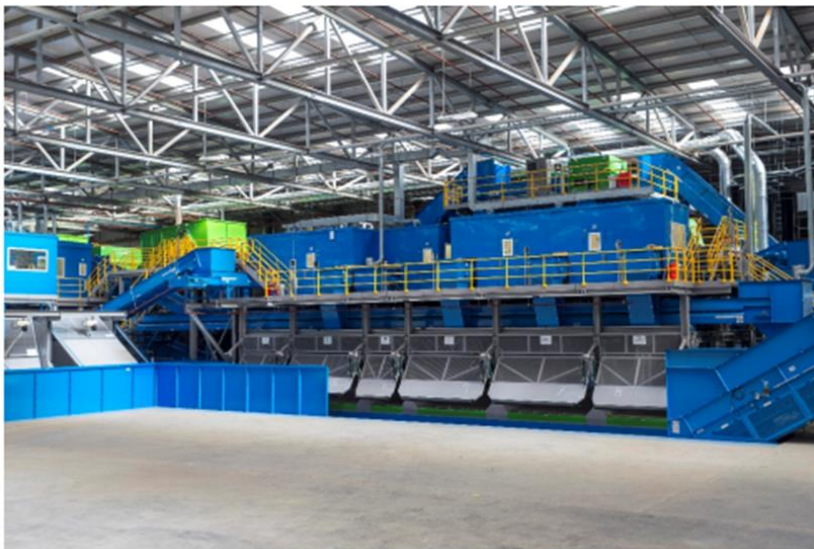
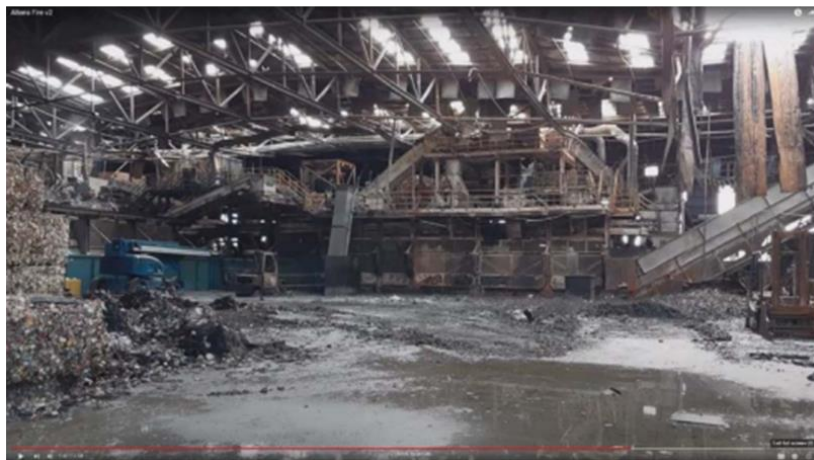
Inside MRF before and after fire

The building and the equipment contained within (conveyors, sorting equipment, baler, etc) are all destroyed. Demolition of the MRF including removal of the equipment is underway. SUEZ and ACC have commenced the work on preparing the specification for the replacement facility. The MRF will be rebuilt to a similar standard as before although there may be scope to make some amendments to the process to take account of future and current legislative requirements and changes. Being that the facility was only 5 years old the facility was of high standard.

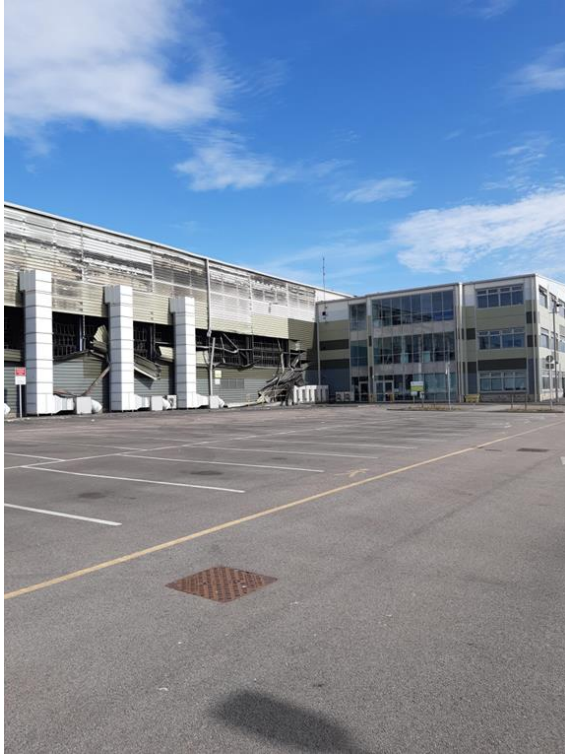
External photo, post fire.

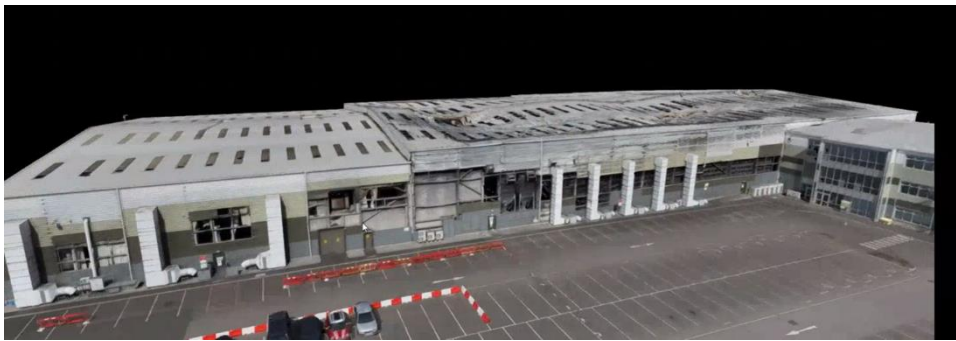
Overall site – note the condition of the RDF building on the left compared to the MRF building.

The adjoining RDF facility was less damaged than the MRF part of the building, however, this will also require further structural surveys to confirm its future. It is currently thought that it may be salvageable in some form but this is not yet confirmed. Again, further surveys will be carried out when the MRF building has been demolished and detached from the RDF shed. The equipment within the RDF shed (shredder, eddy current/magnet and bale wrapper) were also fire damaged and are currently undergoing further surveys to determine whether these are repairable or not.
