Greyhope Road Coastal Embankment

Phase 1 Desk Study

16 March 2017

Aberdeen City Council
Marischal College
Broad Street
Aberdeen
AB10 1AB

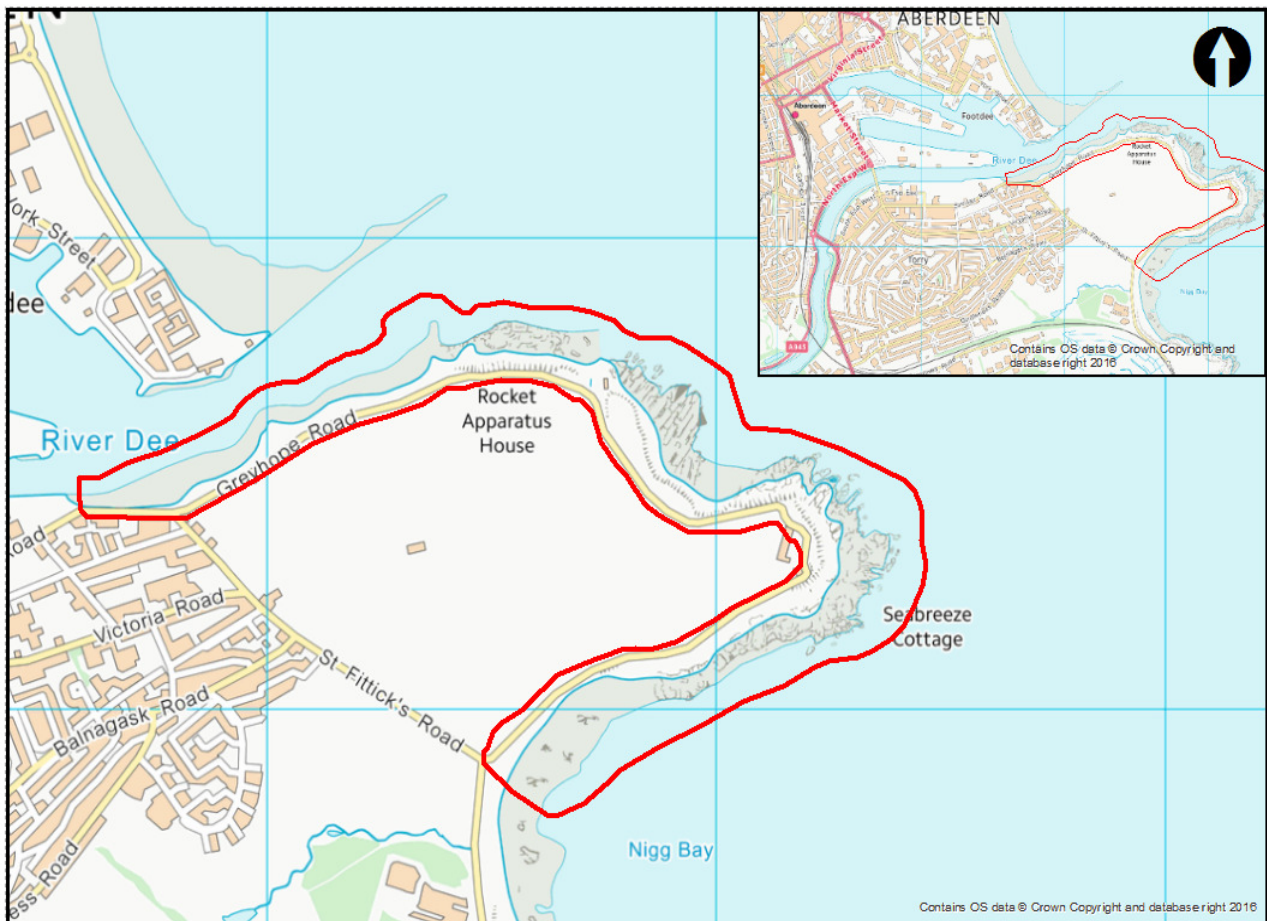
Figure 1.1: Indicative Site Boundary

Aberdeen City Council (ACC) have commissioned Mott MacDonald Ltd (MML) to undertake an initial assessment of the condition of a section of coastal embankment at Greyhope Rd, Torry, Aberdeen and produce a Stage 1 Desk Study as part of an assessment of the site. A site plan is included as Figure 1.1.

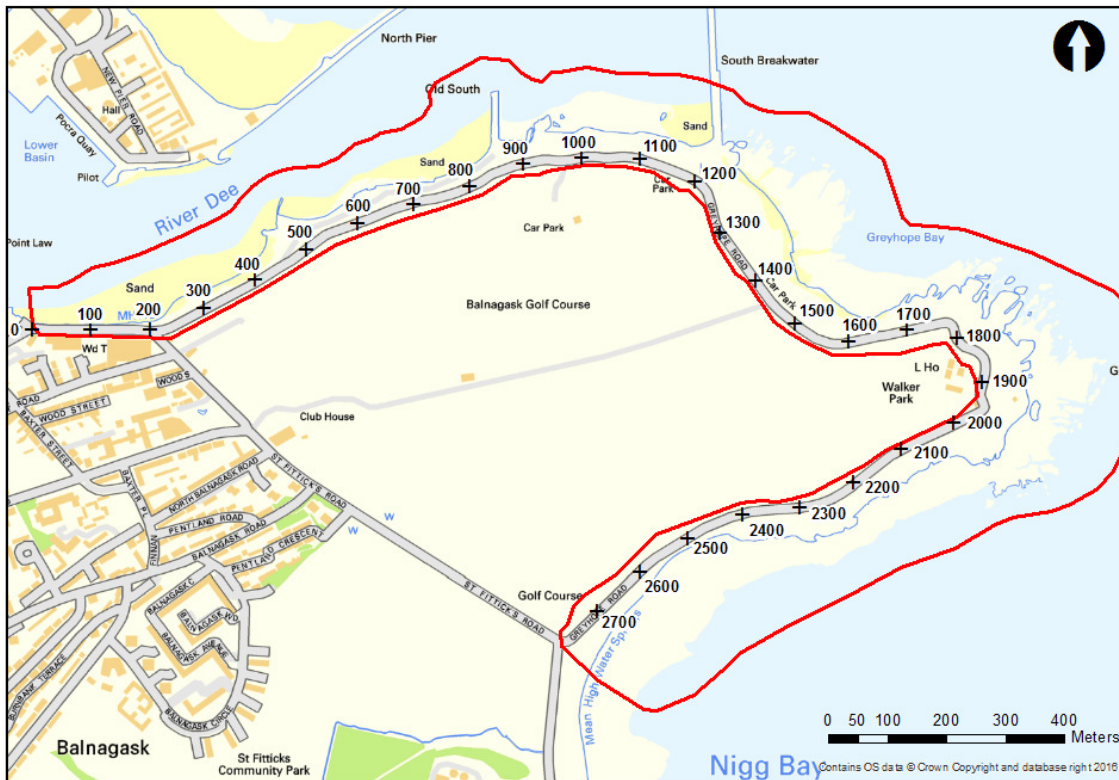
Figure 2.1: Site Plan Showing Chainages

A desk-based assessment of the site and ground conditions has been undertaken using information from readily available sources outlined in Section 1.2. To aid with description of the site, chainages have been assigned to Greyhope Road, as shown in Figure 2.1.

Note: Chainages in 100m intervals and noted as 'Ch100' in report text

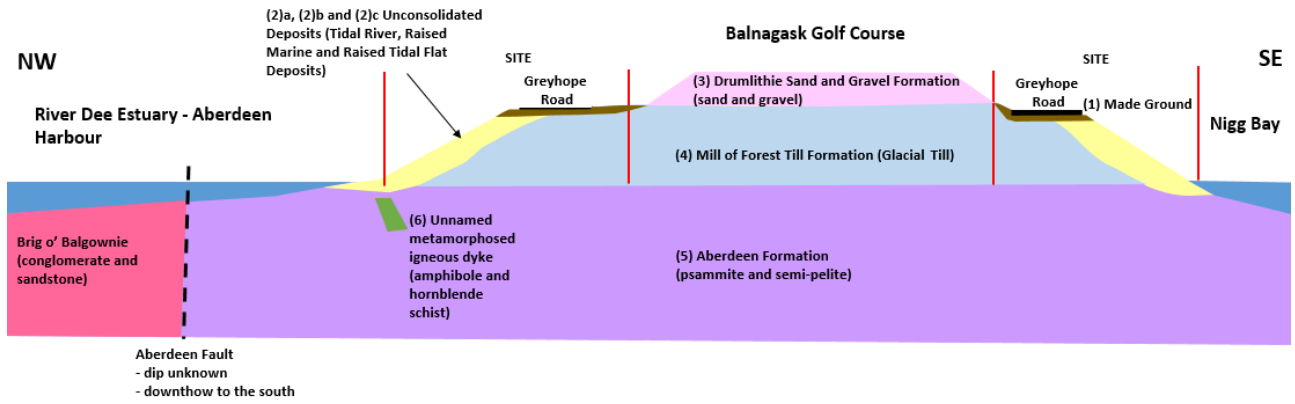
Figure 2.3: Illustrative Preliminary Ground Model

The preliminary ground model for the site has been compiled using available published information, and is shown in Table 2.2 and Figure 2.3.

Strata ID	Thickness (m)	Description	Comment
(1) Made Ground	Unknown	Unknown	Associated with historical development of the site and Greyhope Road.
(2) Unconsolidated deposits	(2)a Tidal River Deposits	Clay, silt and sand with localised peat and gravel	Present in the north of the site within the River Dee estuary

(2)b Raised Marine Deposits	Gravel, sand, silt and clay	Present along the north and south west of the site.
	(2)c Raised Tidal Flat Deposits	Silt, clay and sand	Present in the east of the site.

(3) Drumlithie Sand and Gravel Deposit	Unknown	Sand and gravel with clay and silt lenses	Present throughout the east and south of the site.
(4) Mill of Forest Till Formation	Unknown	Glacial till, described as sandy diamicton, red-brown with clasts predominantly of sandstone	Present in the north east, east and south east of the site.

(5) Aberdeen Formation	Unknown	Interlayered psammite and semipelite	May be present as outcrops along the coastline, based on interpretation of aerial photography and site photographs.

(6) Unnamed metamorphosed igneous dyke	Unknown	Amphibole and hornblende schist	Recorded on the north east coast.

The review of available geological records indicates the site to be underlain by unconsolidated deposits, glacial till, underlain by psammite and semi-pelite metamorphosed igneous rocks of the Aberdeen Formation. BGS borehole records indicate there is granite present along the northern boundary of the site, however its extent is unknown.
