Aberdeen Greyhope Road Coastal Embankment

Phase 2 Recommendations Report

01 June 2017

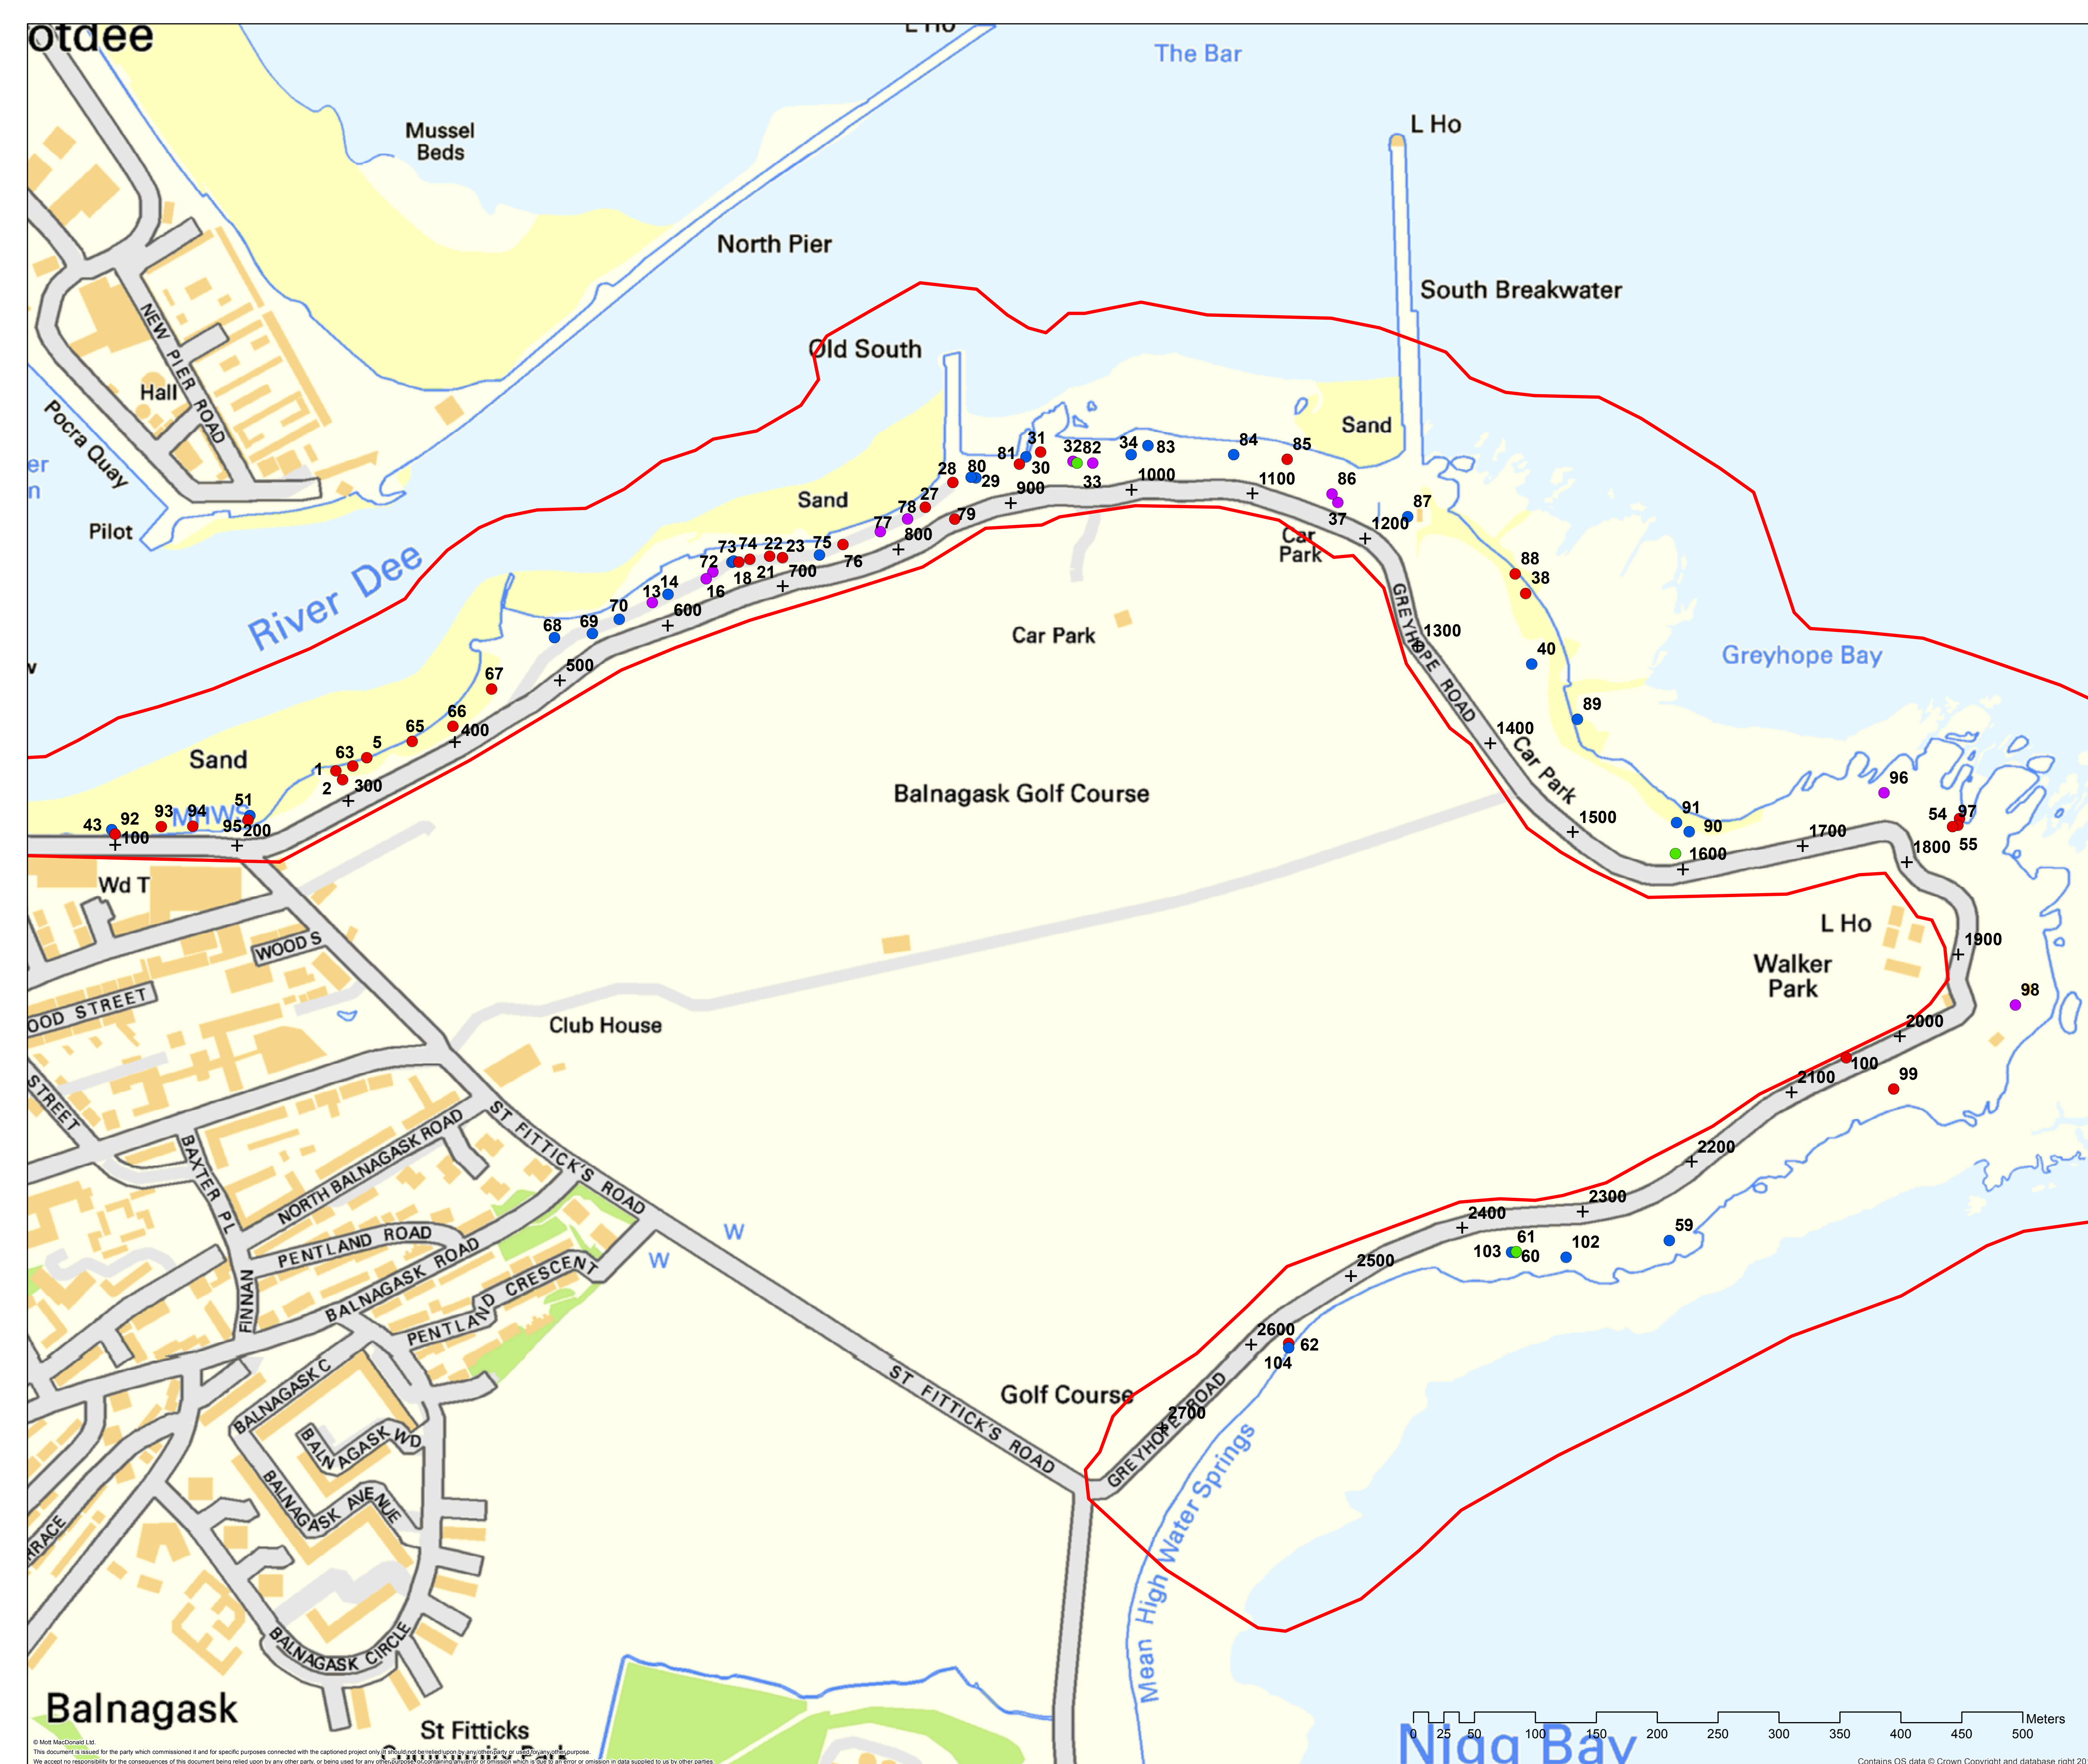
A. Site Walkover Results Plan

- Current Instability
- Historic Instability
- Observation
- Structure
- + Chainage (m)
- ▭ Site Boundary

Title
Aberdeen Coastal Embankments
Grehope Road
Site Walkover Results

The slope stability risk assessment report identified significant risk to Greyhope Road from slope instability. The following sections outline potential remediation measures that could be considered for instability areas. Areas are described in terms of chainage as shown on the Site Walkover Results plan included in Appendix A.

2.1.1 Concrete Blocks (Ch100 to 150)

It is assumed that the concrete blocks installed at the north west end of the site are a temporary measure to stabilise the road and slope. The blocks are showing signs of instability and it is considered they could be replaced by a permanent retaining structure, i.e. concrete revetment.

2.1.2 Northern Slope Instability (Ch200 to 1200)

2.1.3 Southern Slope Instability (Ch200 to 2100)
