TECHNICAL REPORT P6799

MANAGEMENT-LEVEL ASBESTOS SURVEY FOR THE PRESENCE OF ASBESTOS-CONTAINING MATERIALS (HSG 264):

Burnside Poultry Unit, Little Clinterty, Kinellar, Aberdeenshire AB21 0TL

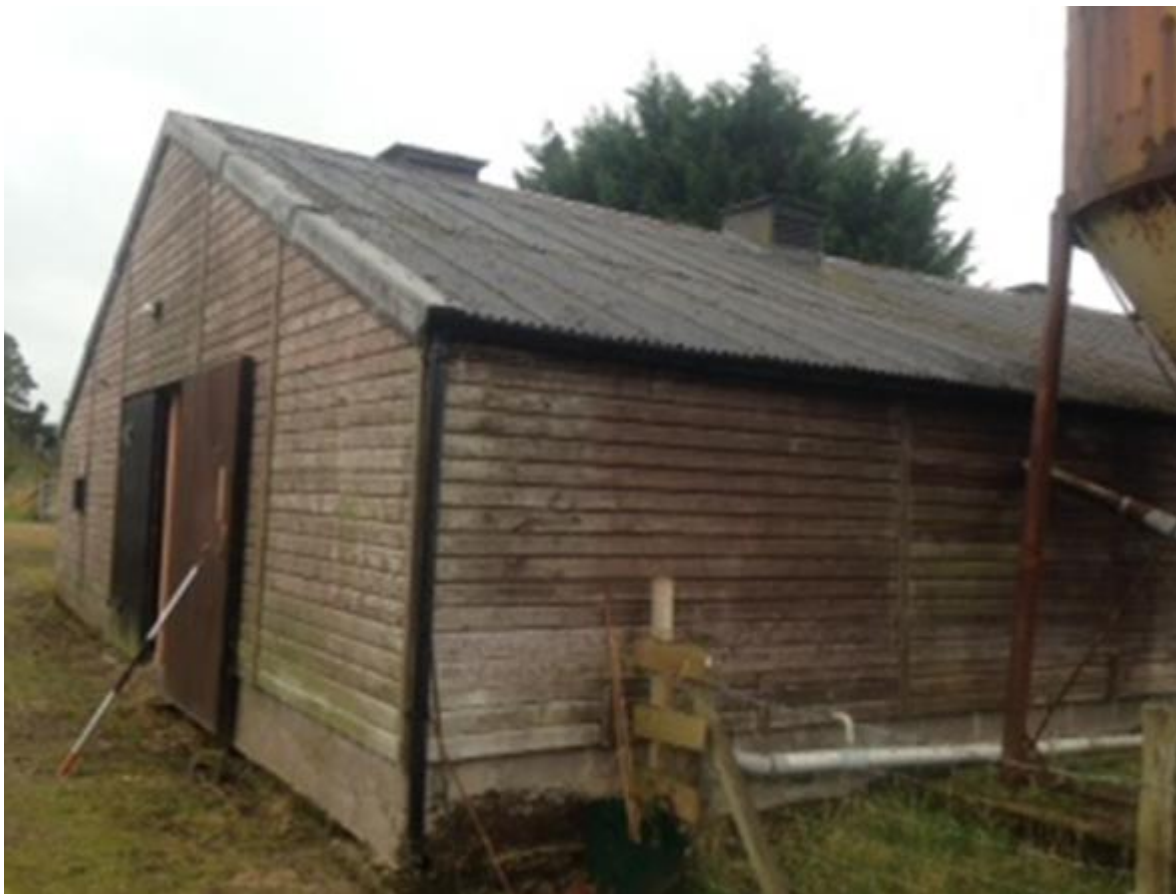
Figure 2. View of barn structure from north

The external structure comprises blockwork to 0.6m height with timber cladding external walls above this. Rainwater goods are plastic. The roof, apex and flashings etc are formed from corrugated asbestos cement sheeting (Ref: Samples 67443, Certificate A20653, Appendix 1). In places these have been patched with non-asbestos panelling. The roof apex has asbestos cement vents.

Samples were tested for water sorption capacity, to establish the category of material under the Control of Asbestos Regulations 2012, and the external asbestos materials were confirmed as being classed as "asbestos cement". Figures 2 & 3 illustrate the asbestos cement roofing elements. Figure 5a at appendix 2 shows a schematic of the extent of the roofing asbestos

Location/Item	Risk Summary	Action/Timescale
External roof sheeting	Low	<p>No action required if premises is to be unused.</p> <p>If premises are to be used, the roof sheeting will require a condition survey/ reinspection on a 3-yearly basis.</p> <p>Prior to demolition remove the asbestos roof sheeting</p>
Internal wall cladding	Low	<p>If premises to be used/occupied, the internal fabric should be subject to a priority asbestos risk assessment.</p> <p>Restricting access of contractors/others behind plasterboard fabric to front of barn structure is prudent given the likelihood of asbestos cement debris.</p> <p>An “environmental clean” of all surfaces may be appropriate at this stage, depending on the nature of the occupancy, and/or encapsulation of all accessible internal surfaces. A condition survey/ reinspection will require to be undertaken on a regular basis (typically 6 or 12-monthly) depending on risk assessment.</p> <p>Alternatively, consideration may be given to removal outright of this material at this stage particularly if any internal refurbishment works is proposed, or activities likely to present risk of damage to wall fabric.</p> <p>The wall cladding will require to be removed prior to any demolition.</p>

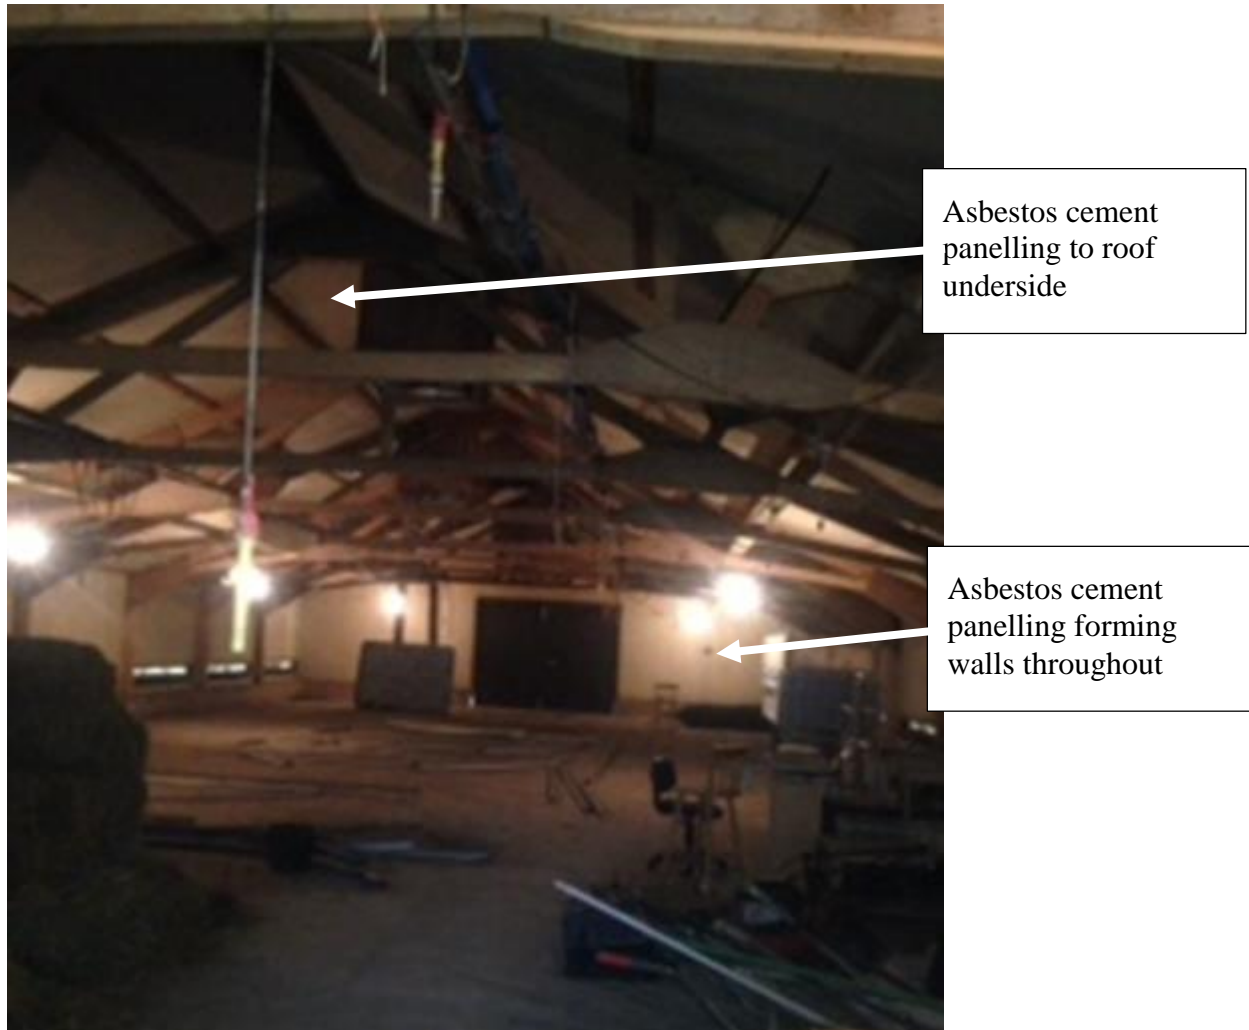
Figure 4. Internal view of barn looking south from entrance

The internal asbestos cladding is typically in 2m x 3m sections and nailed in place to timber structure behind. The asbestos internal panelling is unpainted but in relatively good condition, with limited damaged locations, such as light fittings, penetrations in ceiling panelling etc.

Roof vents have been installed/refurbished at various locations; some debris from the asbestos panelling is evident internally on floor surfaces, and is presumed to have resulted from installation of roof vents.

Internal panelling to roof underside cladding	Low	<p>If premises to be used/occupied, this fabric should be subject to a priority asbestos risk assessment.</p> <p>Given the low accessibility of these surfaces and their orientation, where an environmental clean is being carried out on the internal wall cladding, an environmental clean of the roof underside surfaces and/or encapsulation of all accessible internal surfaces may, or may not, be appropriate, depending on the nature of the occupancy/risk assessment.</p> <p>A condition survey/ reinspection will require to be undertaken on a regular basis (typically 6 or 12-monthly) depending on risk assessment.</p> <p>Alternatively, consideration may be given to removal outright of this material at this stage in tandem with the wall cladding, particularly if any internal refurbishment works is proposed, or activities likely to present risk of damage to roof underside.</p> <p>The roof underside will require to be removed prior to any demolition</p>

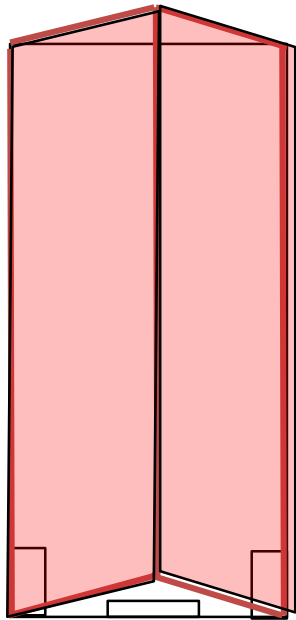
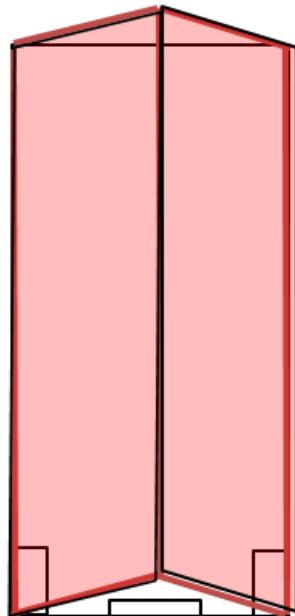
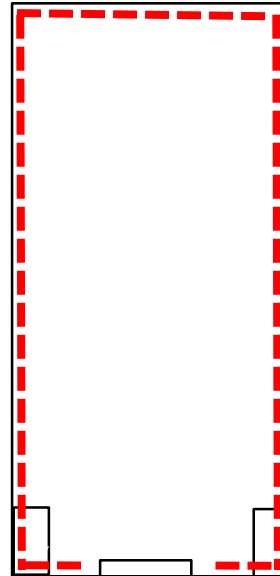
Fig 5a. Plan view showing asbestos cement roof sheeting

External corrugated roof sheeting (~450 sq m) and associated elements (apex, flashings, roof vents etc)
