**TECHNICAL REPORT P6799.02:  
STAGE 1 SITE INVESTIGATION**  
Burnside Poultry Unit, Little  
Clinterty, Kinellar,  
Aberdeenshire AB21 0TL

P6799.02		Page 1 of 28		Ethos Environmental Ltd	
Burnside Poultry Unit				Stage 1 Site Contamination Assessment	
Mr Graham Buchan				November 2016	
Form No	30-014	Date of Issue	27/04/2016	Issue no.	5.0

An assessment of site contamination has been carried out for the Burnside Poultry Unit site at Little Clinterty, Kinellar Aberdeenshire AB21 0TL. This involved review of historic maps, regulatory documentation etc plus site walkover. Due to the extensive presence of asbestos materials some sampling of asbestos debris was undertaken in tandem with an asbestos building survey undertaken at the same time on the main agricultural shed standing (reported at P6799.01).

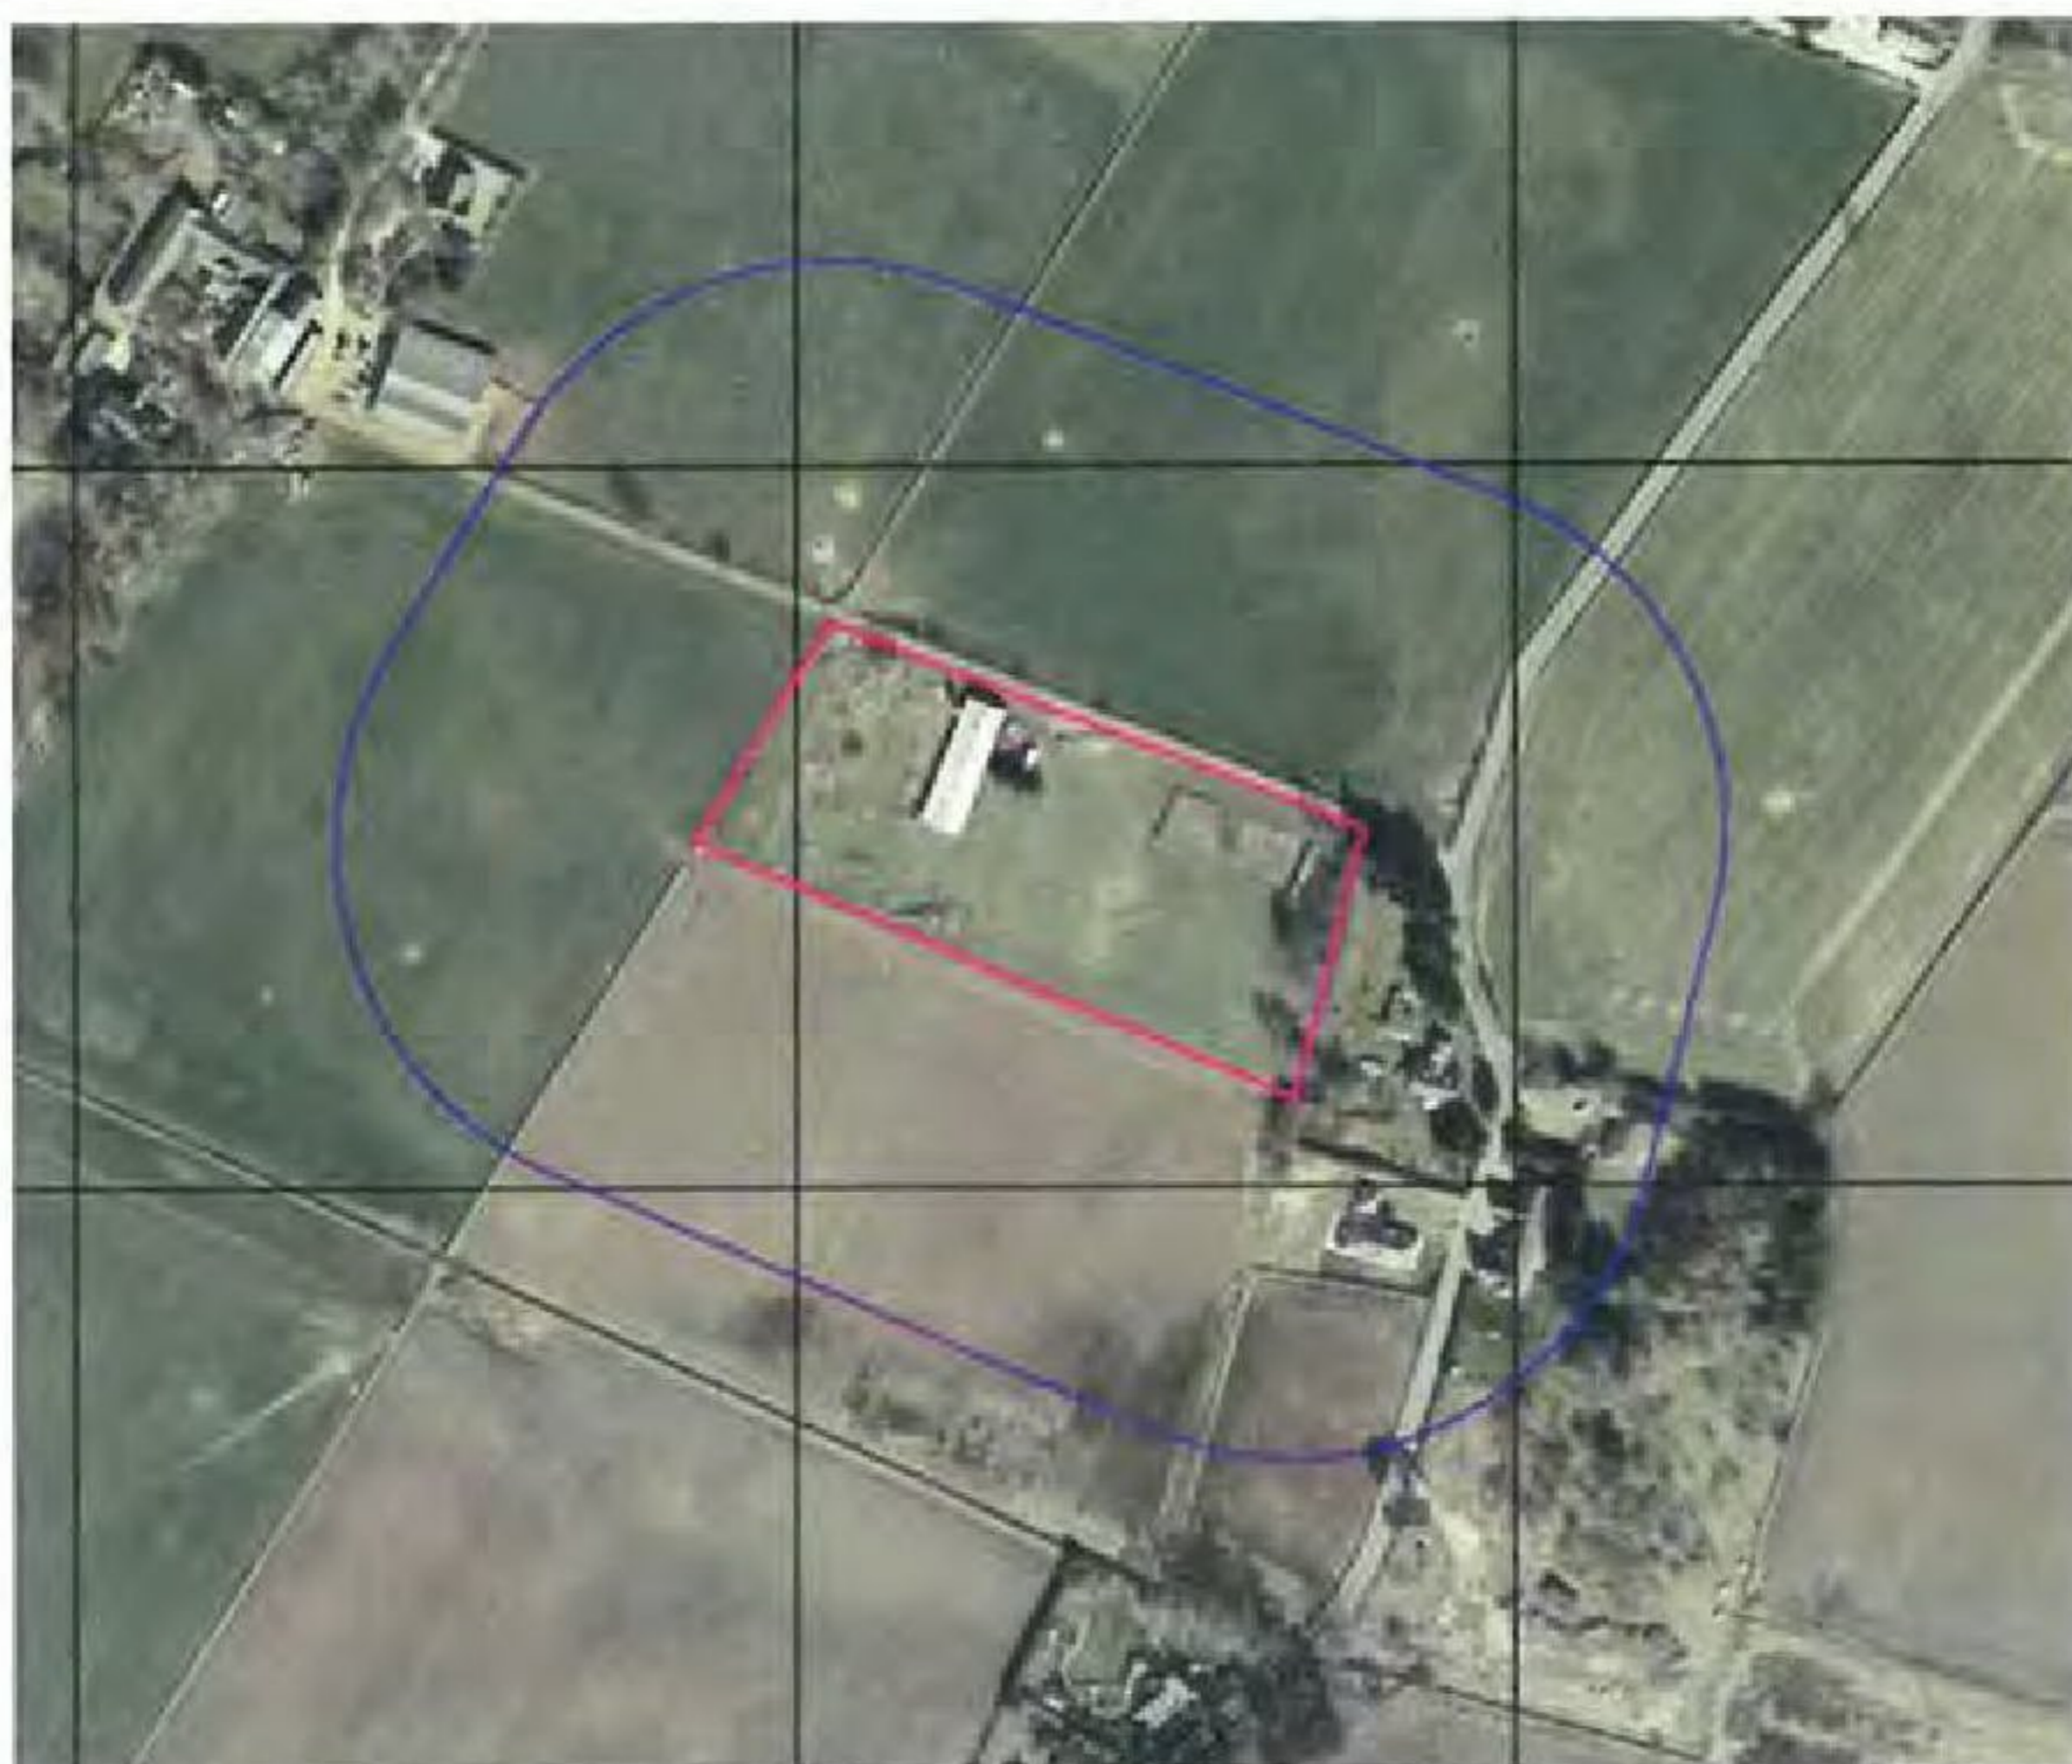
##### 3.1.2 The site comprises approximately 1.26 Hectares. A satellite image is shown in Figure 1 with site border detailed in pink.

Figure 1. Satellite image of site (in pink) and 50m perimeter (blue)

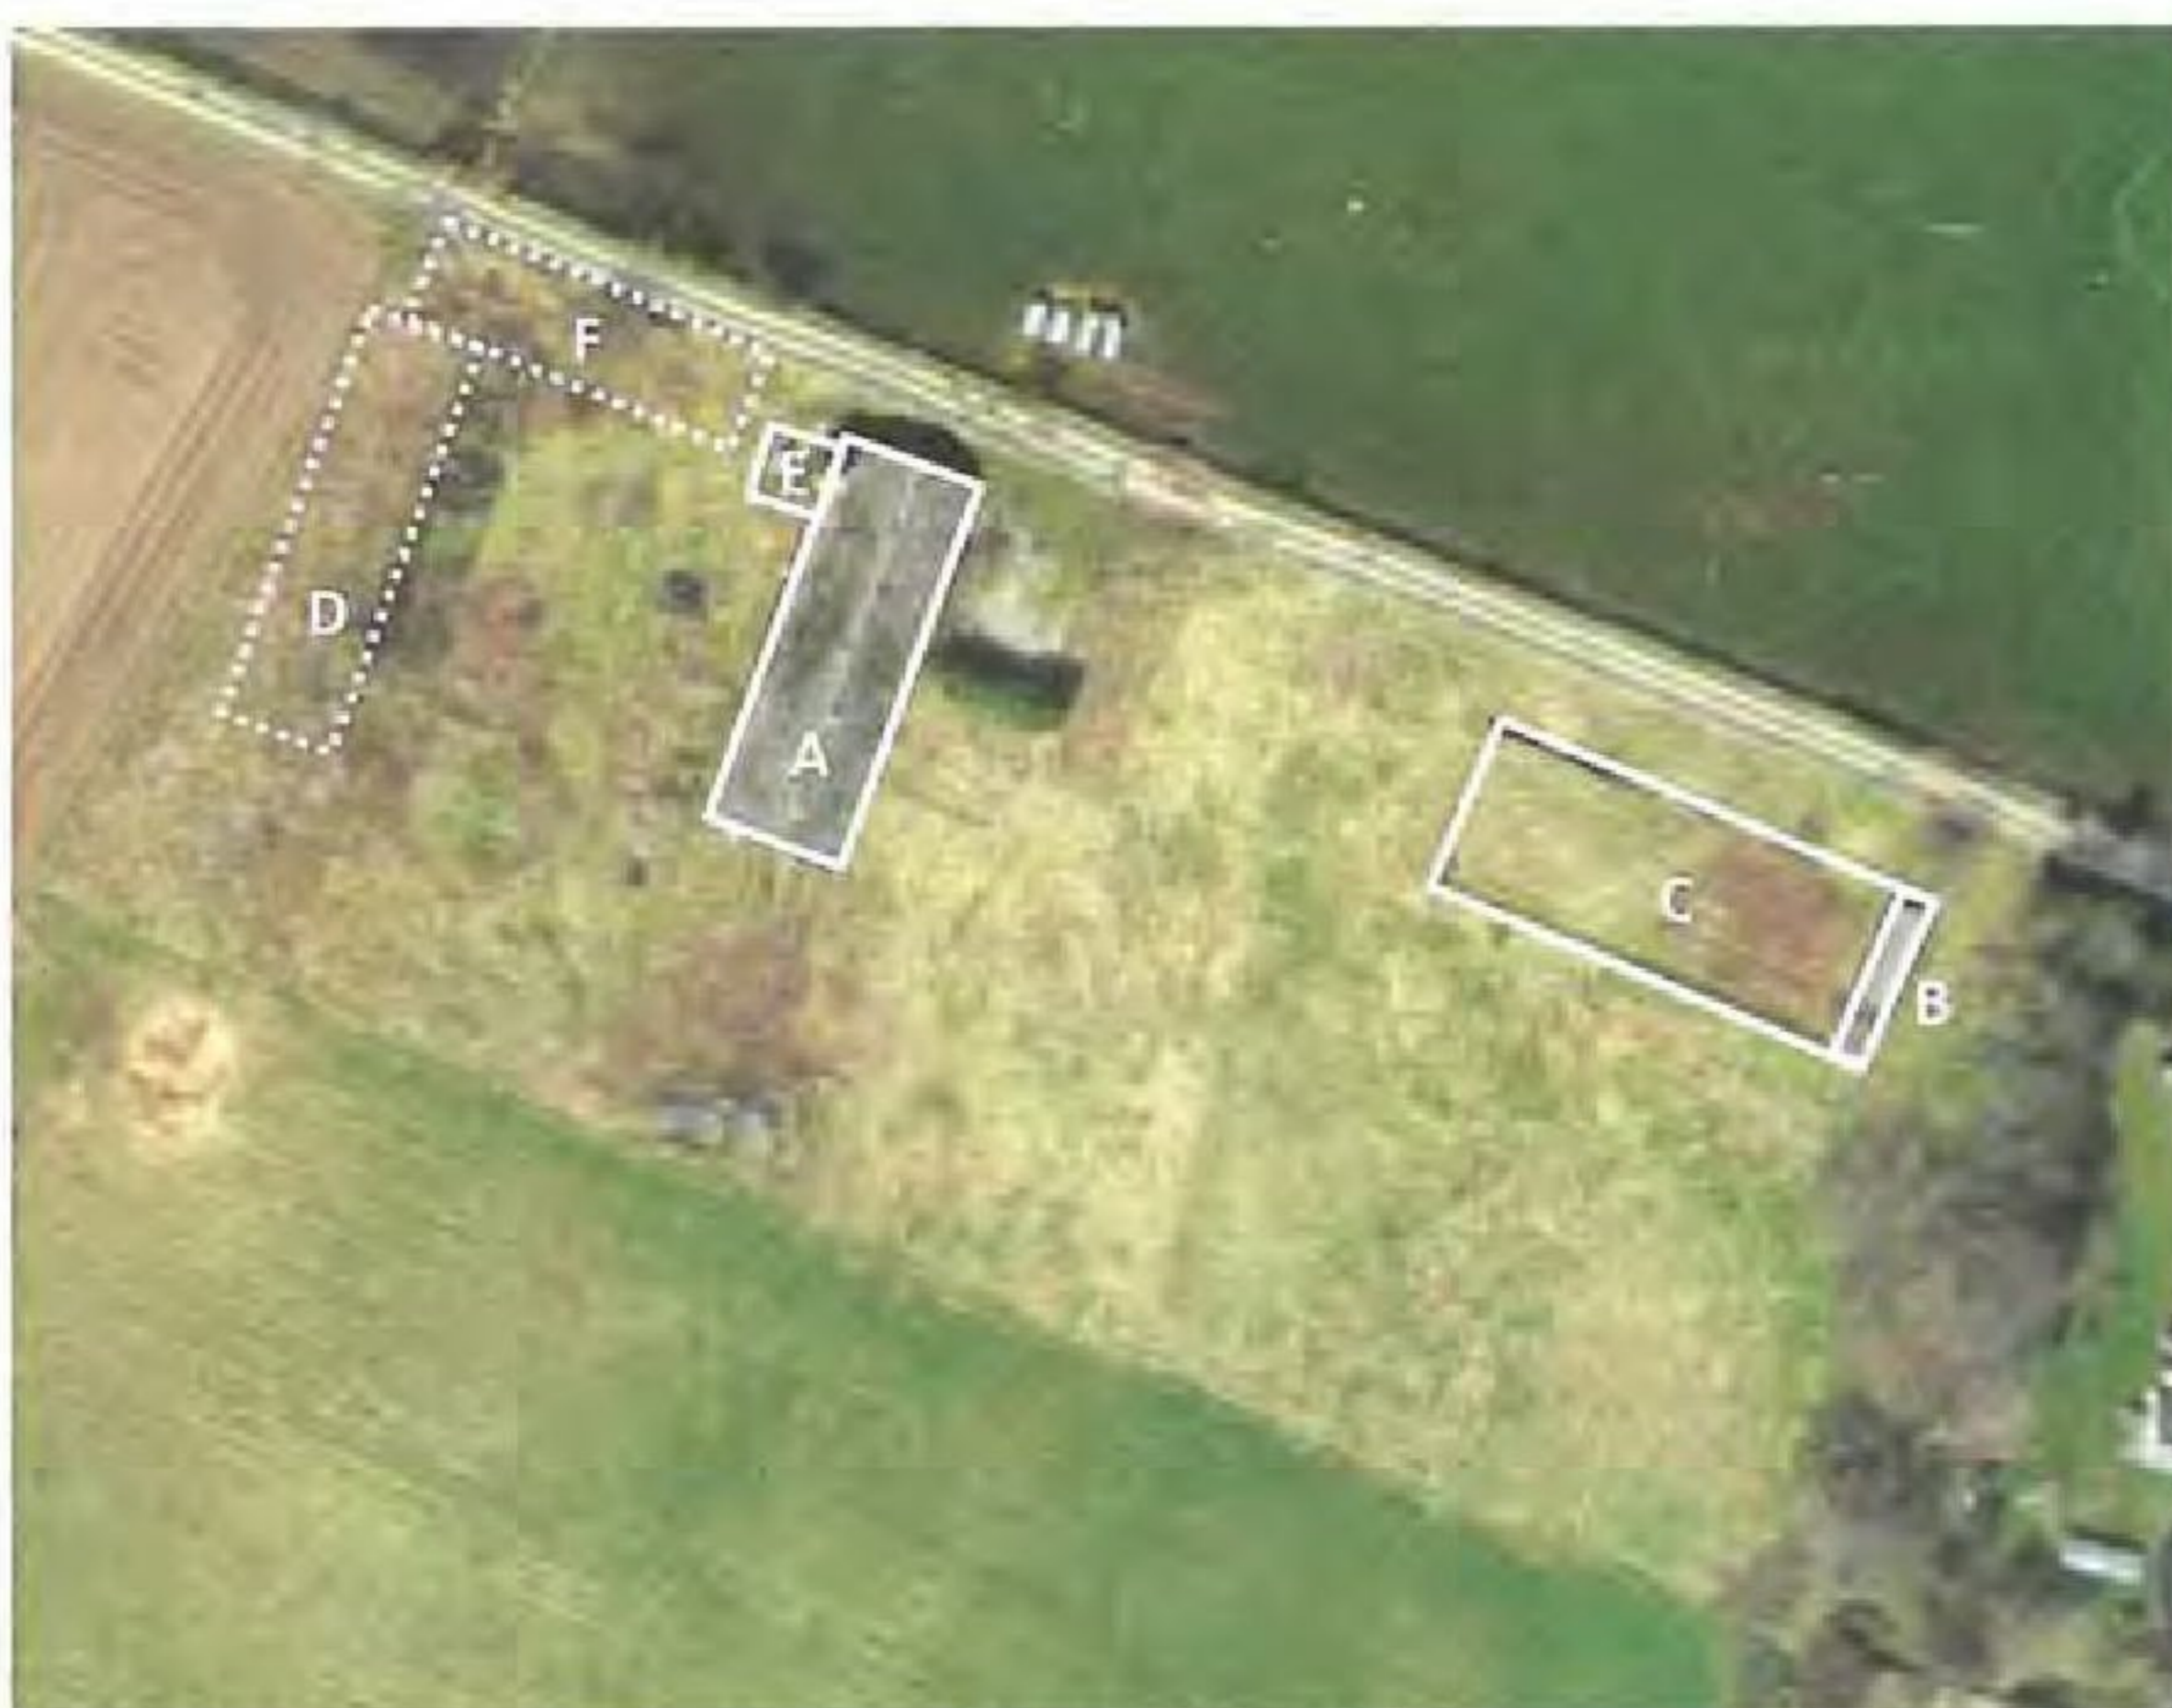
Figure 2. Satellite photograph showing site structures

3.1.3 The site comprises one functional agricultural shed (12 x 35m) currently used for miscellaneous storage and incorporating small office/ stores area. This is shown on Figure 2 as structure A. The site also has a derelict garden shed [B], the above-ground foundations of a large glasshouse structure [C], and the below-ground footings and demolition rubble assumed to be associated with the former poultry building at the westernmost location [D].

3.1.4 There is an agricultural feed hopper at location E. Area F shows a location with no known history of building but substantial asbestos contamination assumed to derive from the demolition of the former building D (see section 3.3)

4.2.1 In summary, asbestos cement totaling approximately 1000-1500 sq m is present in a relatively intact condition on structures at A and B as shown in Figure 2. Approximately 40% of the material is external to the structures and exposed to the elements.

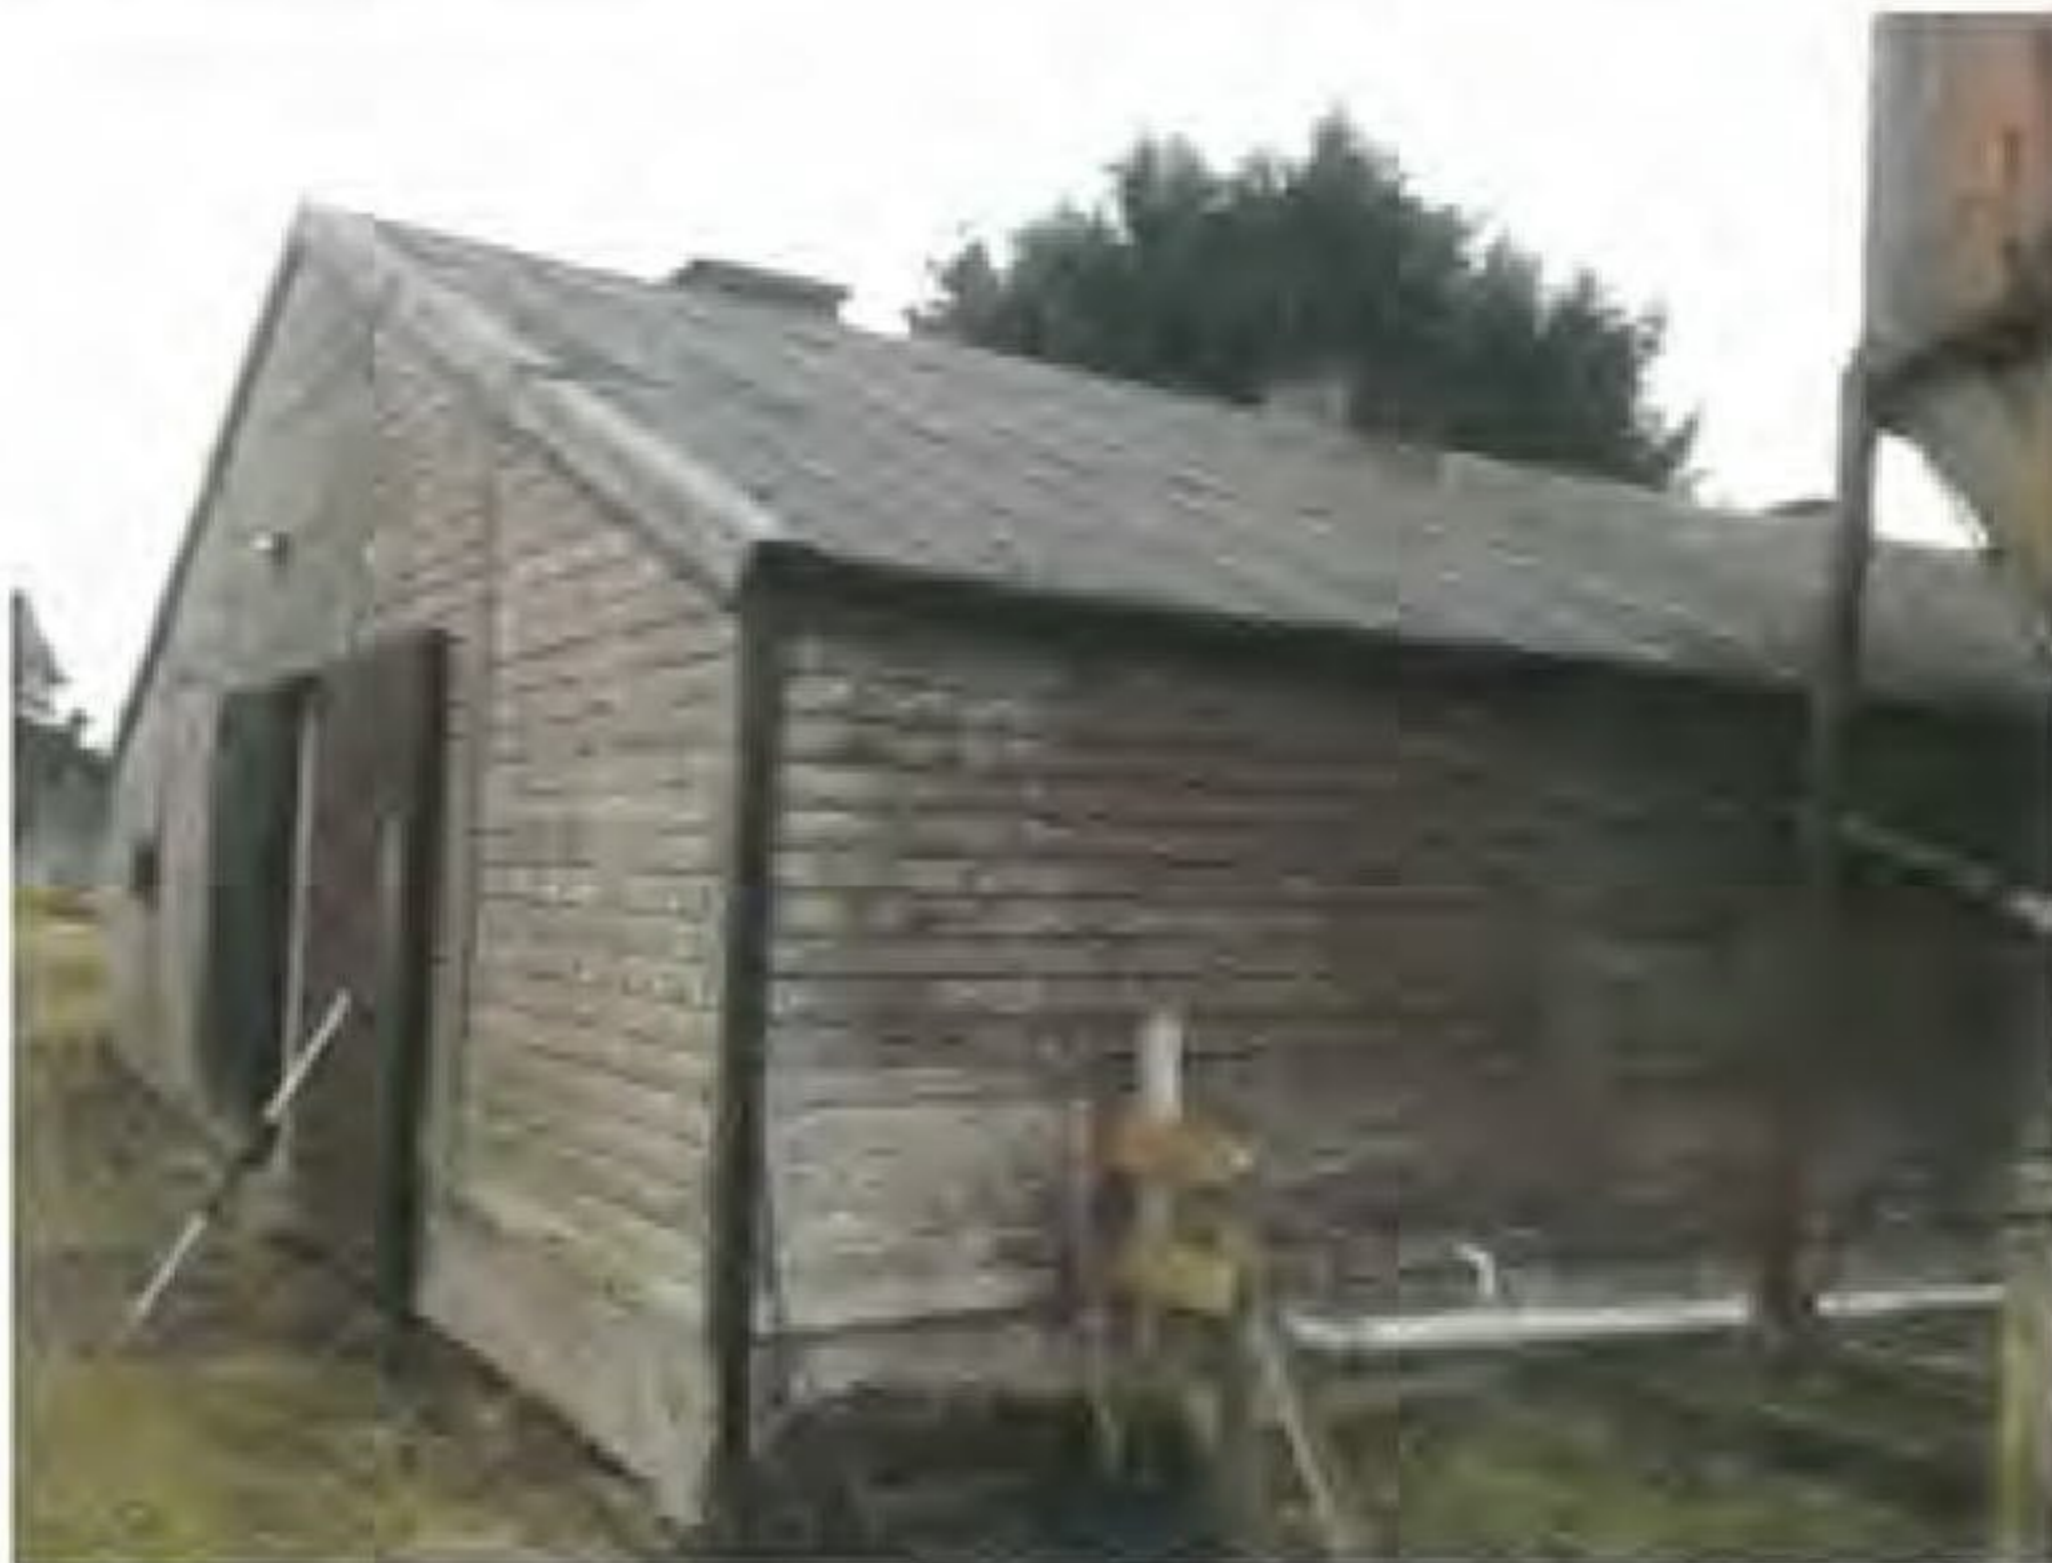
Figure 3. Photograph of front entrance of Poultry Unit shed (west elevation)

Some limited debris was noted on surface ground around the structure that appeared to be associated with the corrugated roof sheeting. This debris is discussed in more detail at section F below.

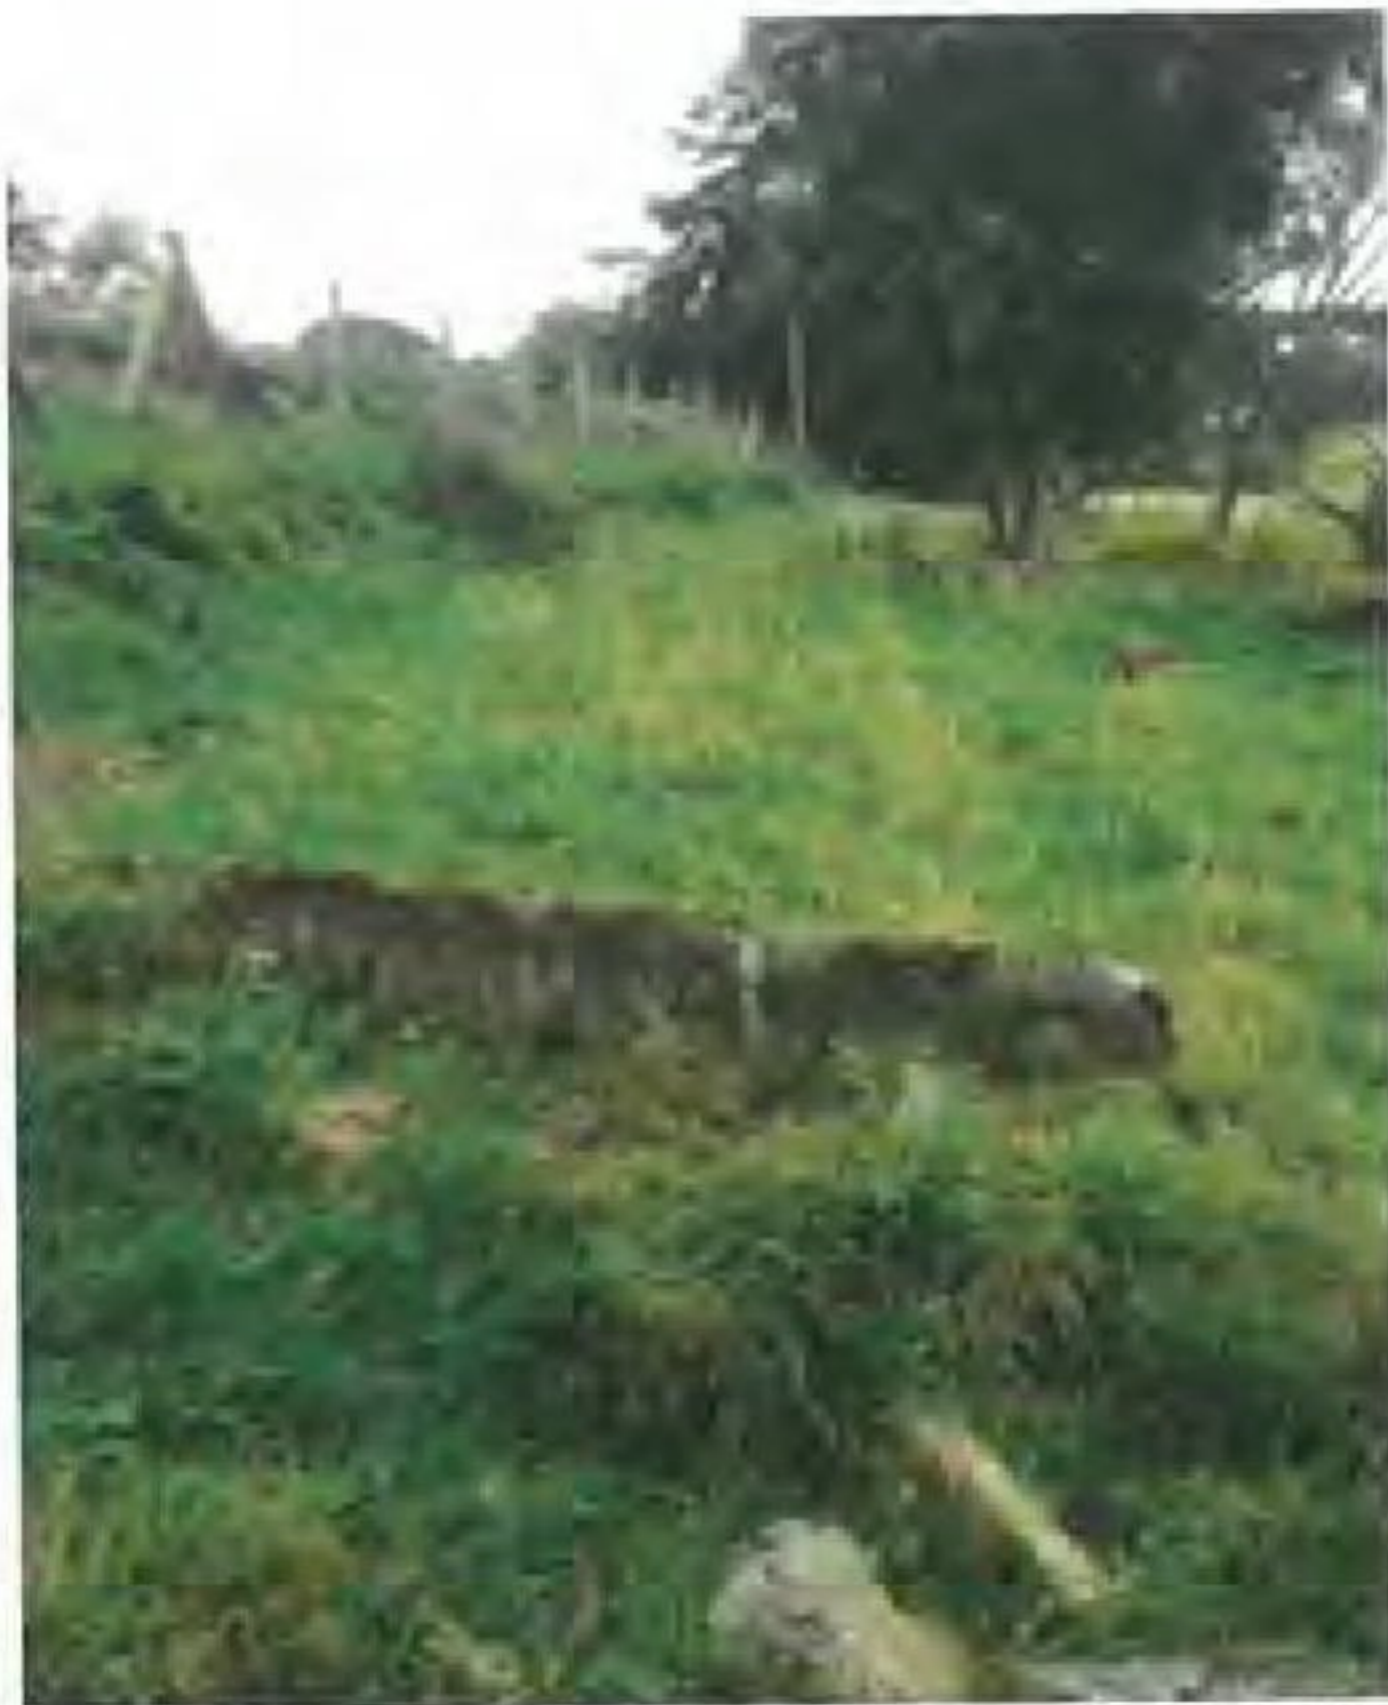
**Figure 7. Footing to unknown structure to east of B, with asbestos cement sheeting within wall.**

Figure 7 shows a small length of partially-buried footing to the east of the sheds, which has a section of asbestos cement forming part of the footing.

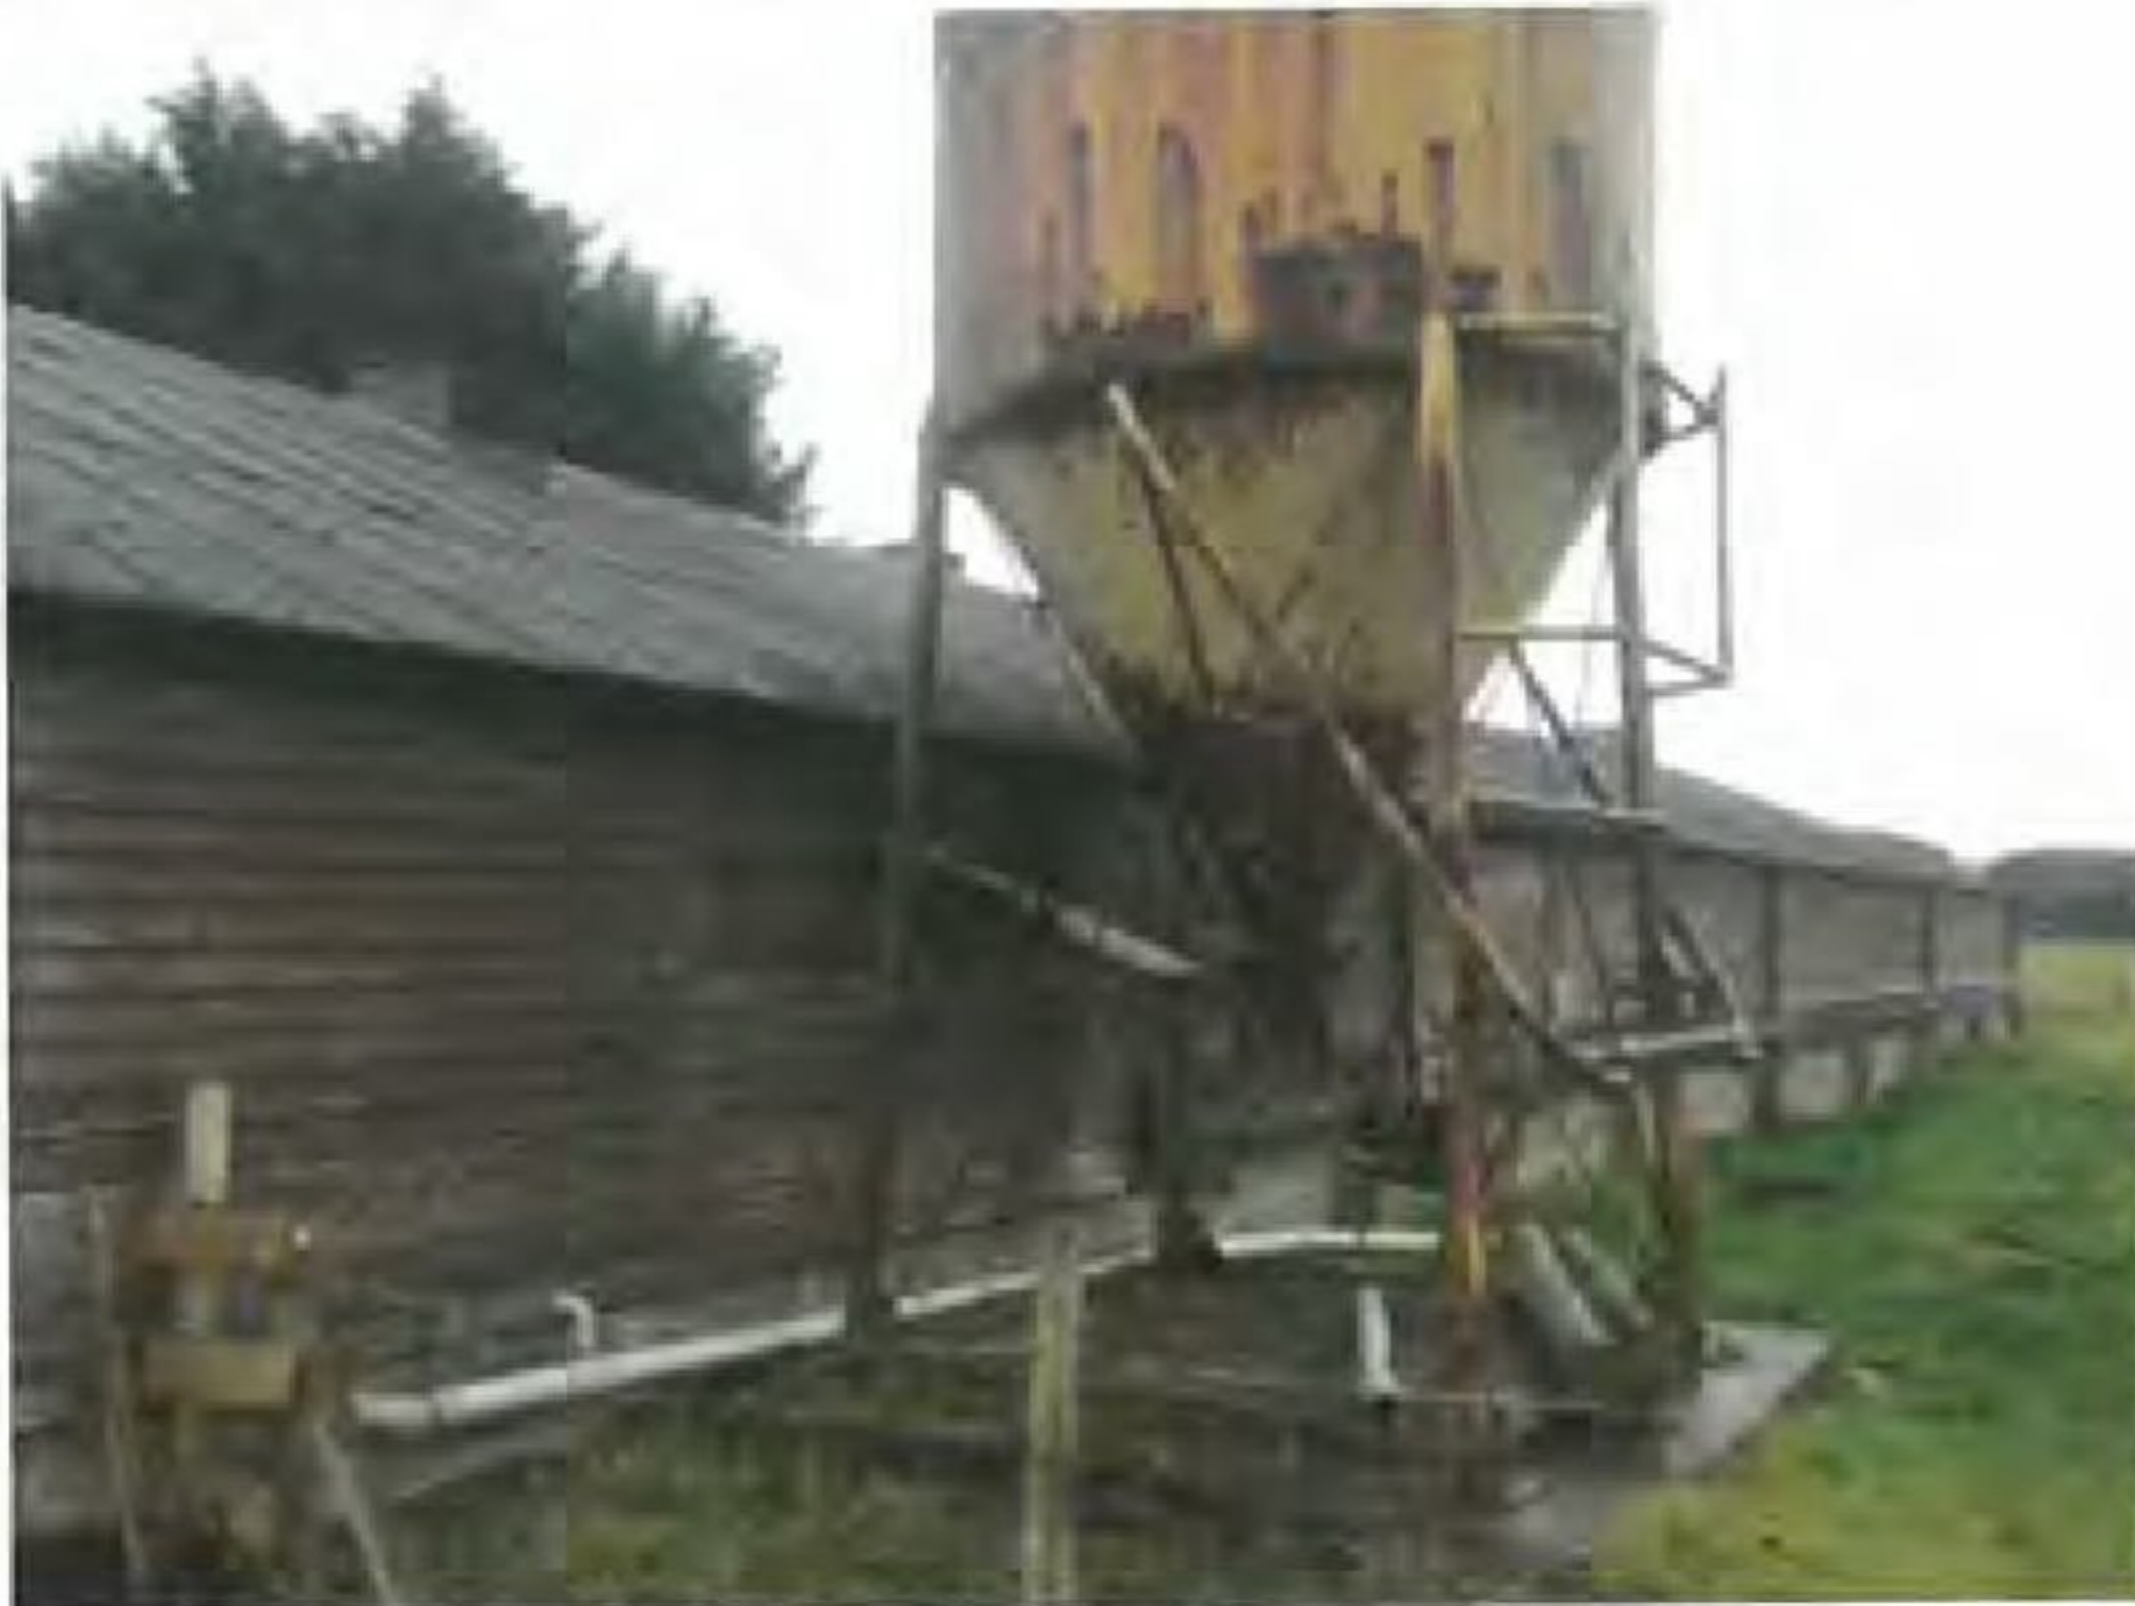
**Figure 8. Agricultural Feed Hopper, Location E**

- C. The former glasshouse to the immediate west of the sheds shown at B, has visible in-situ footings present above ground as well as some associated demolition waste (glazed timber frames).
- D. This is the area of a former agricultural shed demolished in the early 1990s. There is evidence of buried footings to the structure and extensive surface contamination with asbestos cement products as identified in-situ on the remaining shed [A] and discussed in more detail at section F.
- E. Figure 8 shows the agricultural feed hopper located to the immediate west of the main shed [A]. This comprises sheet metal only but should be assumed to contain some residual feed.
