**TECHNICAL REPORT P6799.02:  
STAGE 1 SITE INVESTIGATION**  
Burnside Poultry Unit, Little  
Clinterty, Kinellar,  
Aberdeenshire AB21 0TL

P6799.02		Page 1 of 28		Ethos Environmental Ltd	
Burnside Poultry Unit				Stage 1 Site Contamination Assessment	
Mr Graham Buchan				November 2016	
Form No	30-014	Date of Issue	27/04/2016	Issue no.	5.0

An assessment of site contamination has been carried out for the Burnside Poultry Unit site at Little Clinterty, Kinellar Aberdeenshire AB21 0TL. This involved review of historic maps, regulatory documentation etc plus site walkover. Due to the extensive presence of asbestos materials some sampling of asbestos debris was undertaken in tandem with an asbestos building survey undertaken at the same time on the main agricultural shed standing (reported at P6799.01).

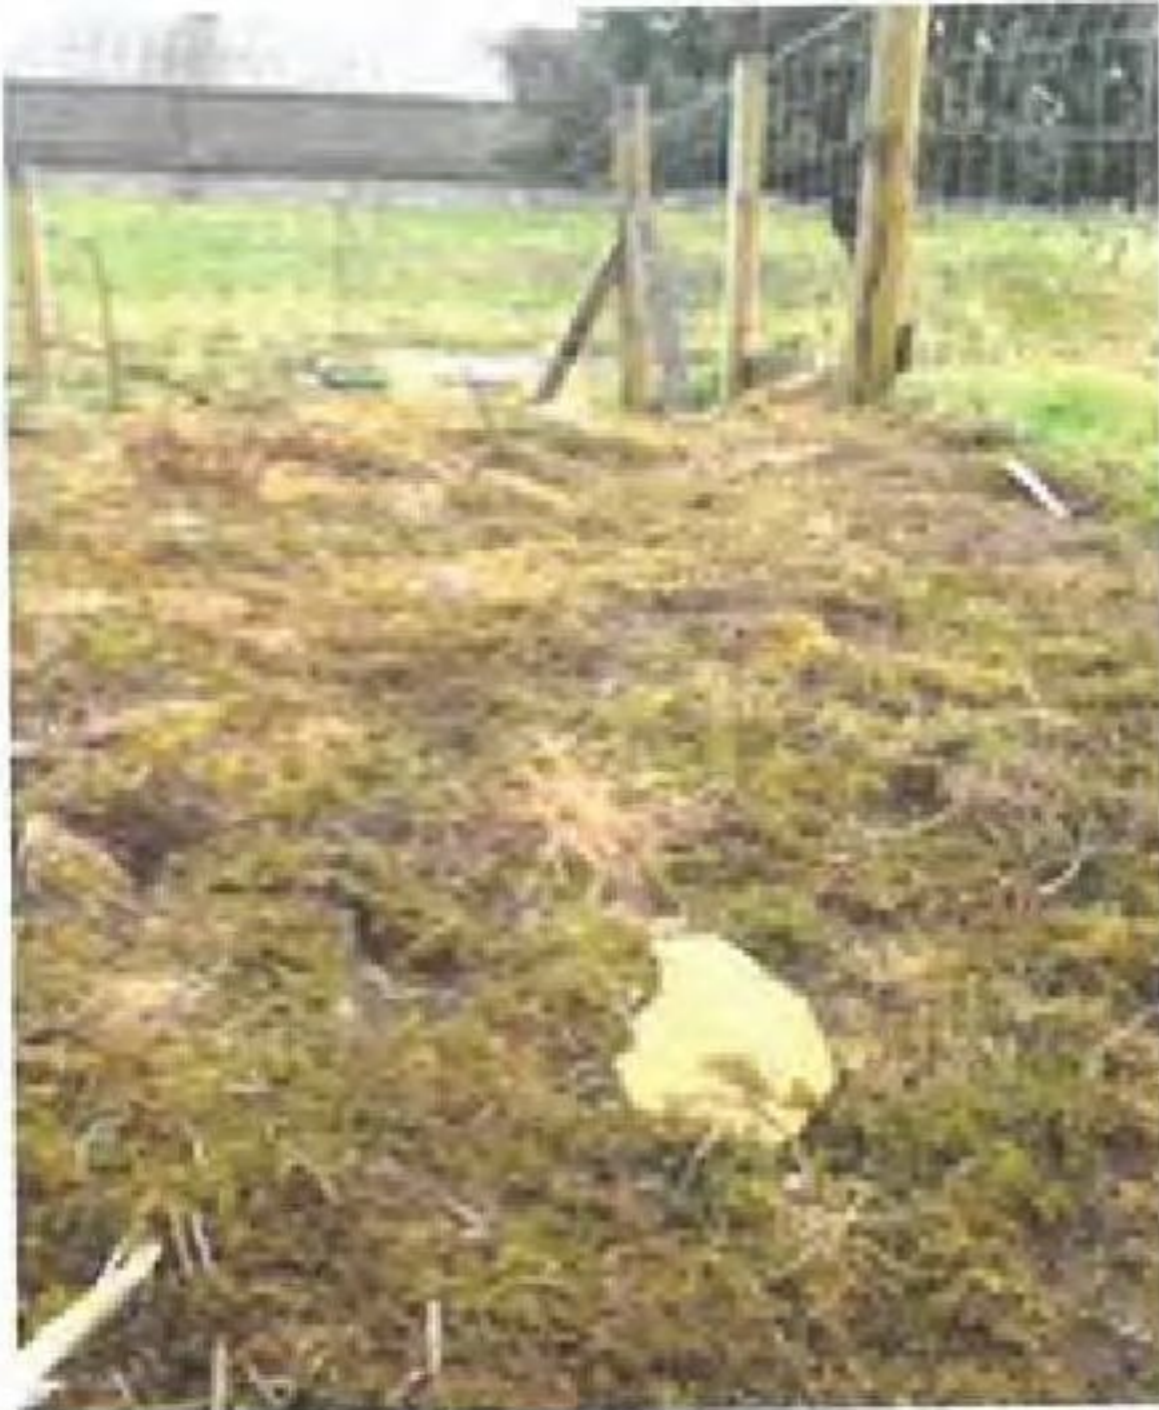
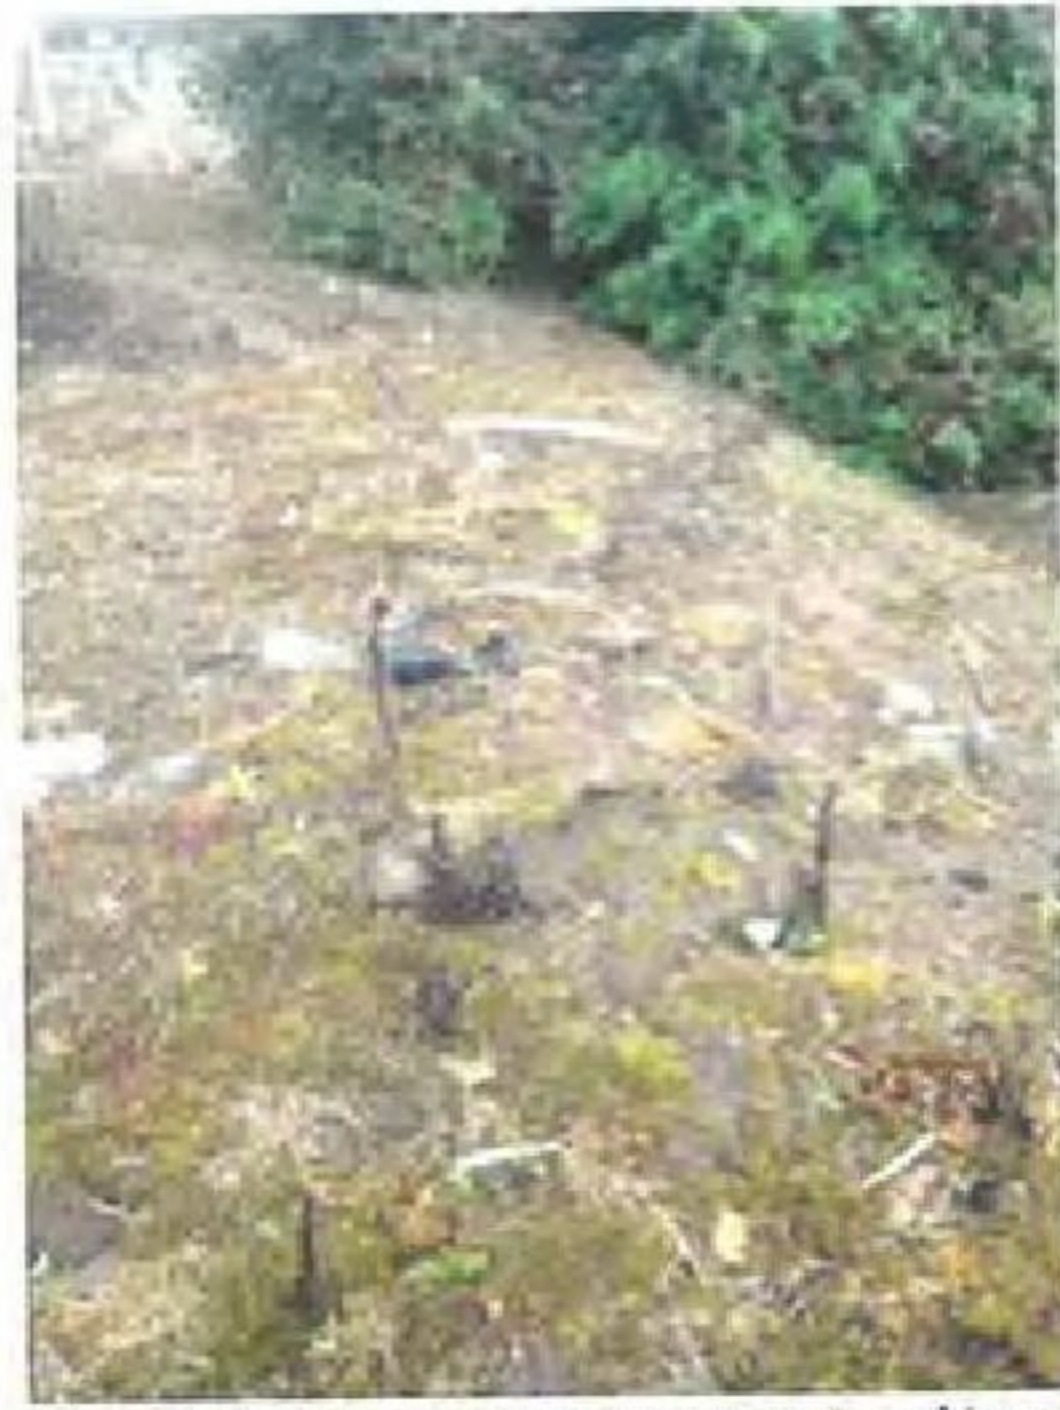
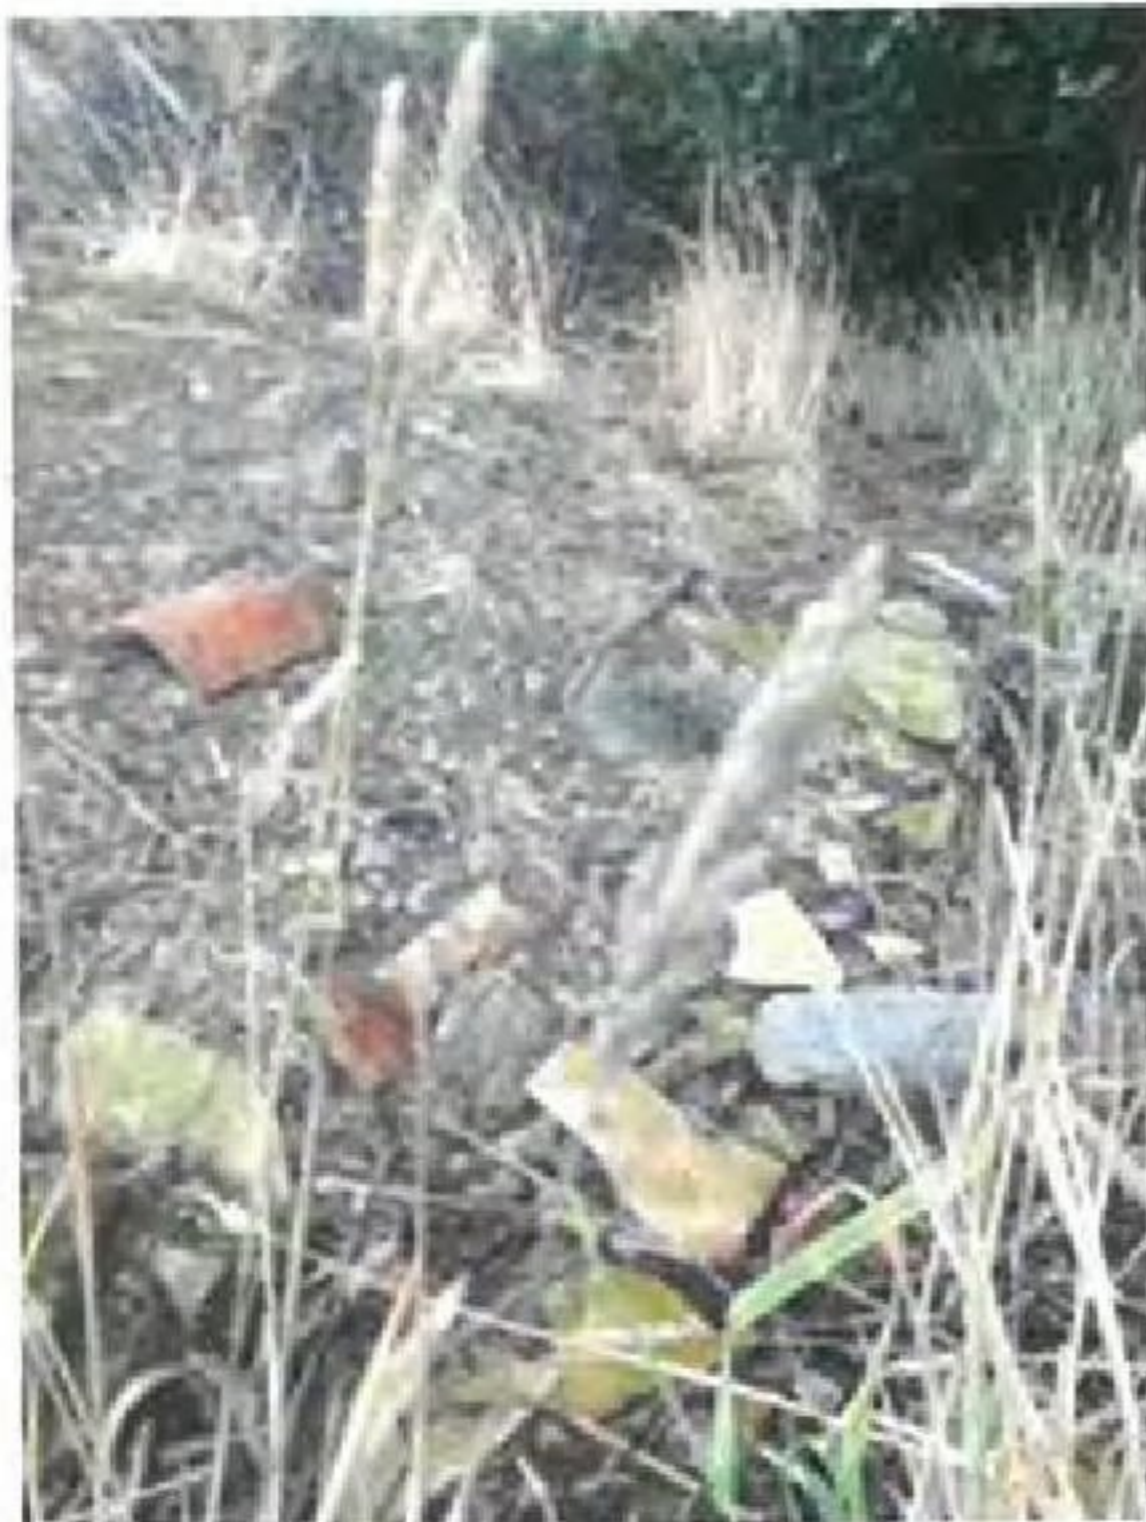
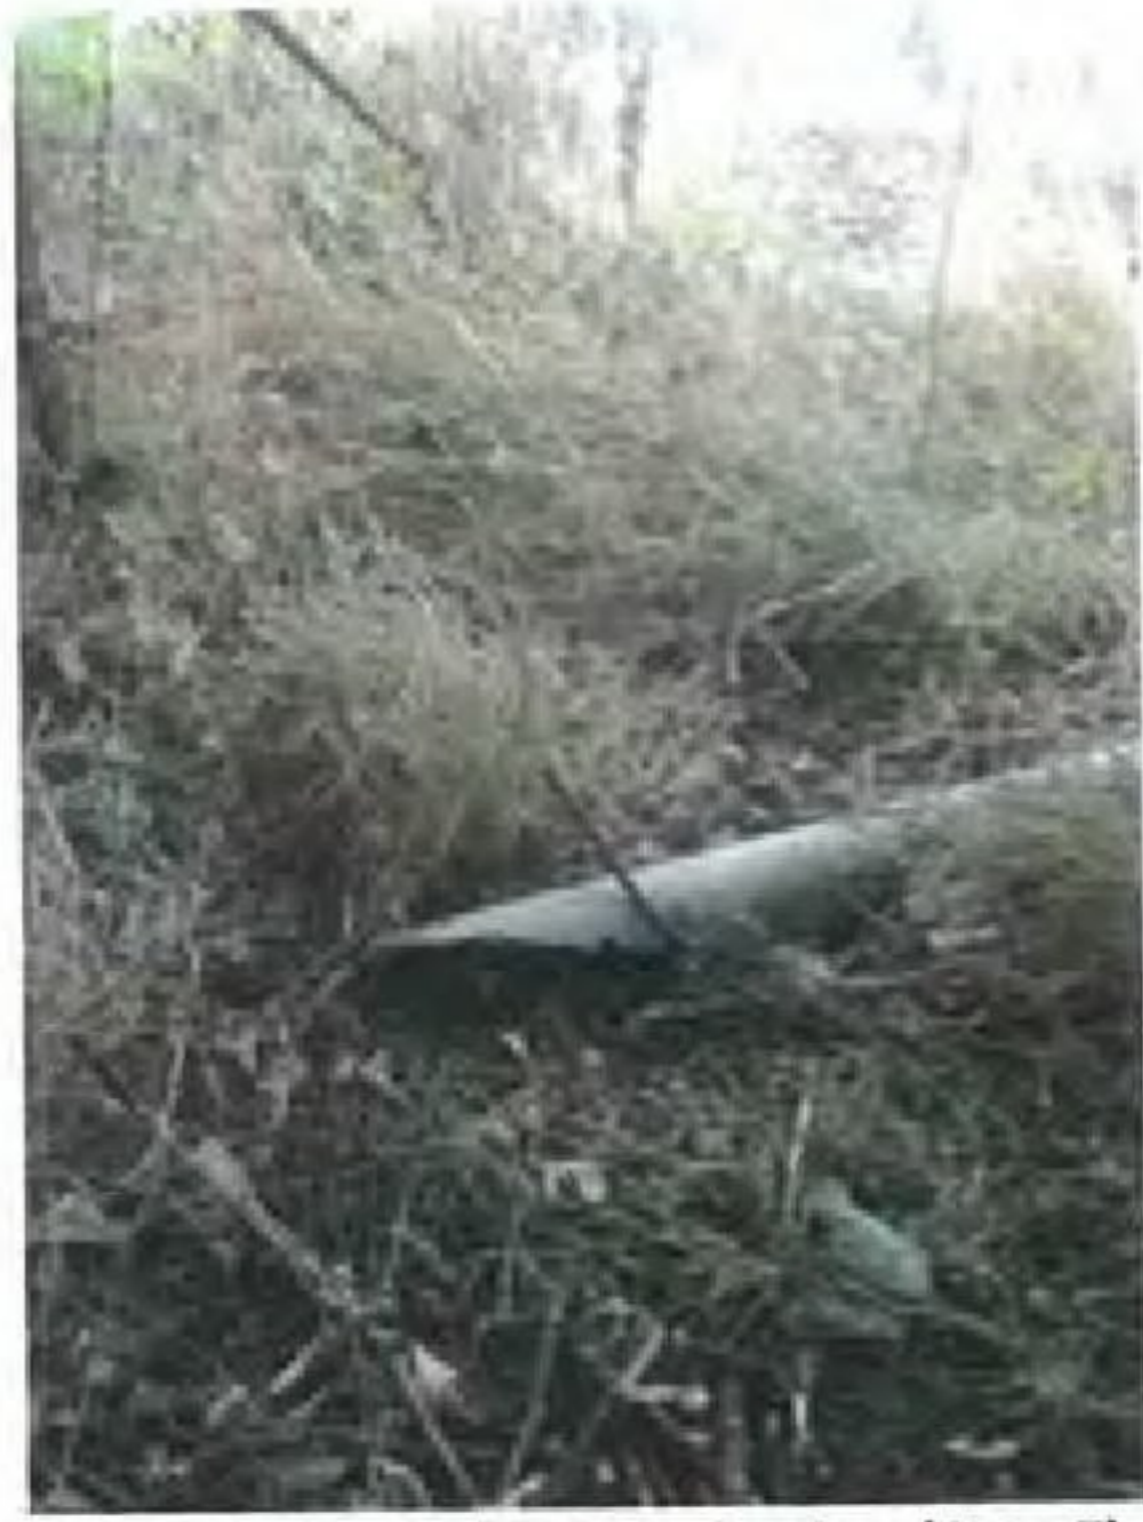
- F. Area F has no history of built structures above ground and no obvious evidence of below ground footings. This area has extensive contamination of the surface and immediate sub-surface with the two main asbestos products identified in-situ in the main shed [A], the internal flat, pale yellow asbestos cement sheeting located on the wall cladding and roof underside, and the external corrugated asbestos cement roof sheeting (see Figure 9a-c). There is additionally evidence of asbestos cement downpipes (see Figure 9d).

Figure 9a. Ground Contamination (Area F)

Figure 9b. Ground Contamination (Area F)

Figure 9c. Ground Contamination (Area F)

Figure 9d. Ground Contamination (Area F)

Asbestos cement debris was observed on ground surfaces at a number of locations elsewhere on the site. The debris was similar in colour, thickness and morphology to that observed in-situ in the Main Shed [A] forming either the corrugated external roof sheeting or the internal flat sheeting wall cladding and roof underside.

Analysis of these samples confirmed the presence of asbestos (chrysotile) in the material. Water sorption testing of the debris sampled from ground surfaces was also carried out. This indicated that in two out of the five samples tested, the contact with soil and moisture had degraded the cement matrix sufficiently to significantly reduce the cement composition such that water sorption capacity was >30% (Refer samples 67444, 67447, 67448, 67450 and 67451, Certificate No. A20653, Appendix 1). As such it is prudent to assume until otherwise indicated that any ground debris material assumed to be asbestos debris requires to be classed under the Regulations as "asbestos insulation board". This is a more friable and risky product category than the original un-degraded in-situ product retained in the Poultry Shed structure.

4.3.4 The material appears to have become sufficiently degraded to constitute “asbestos insulation board” in many instances, and this should be the default assumption until proved otherwise. As such it presents an elevated risk of fibre release compared to the un-degraded product still in-situ.

4.3.6 Given the condition of the asbestos contamination and the small fragments evident (suggesting extensive historical damage) it is likely that on-site decontamination and re-use of significant volumes of this soil material will not be cost-effective and it will require to be removed off-site and disposed of as special waste. For an area of approximately 100 sq m footprint and a soil volume with depth of 1.0m, the disposal costs for hazardous soils/demolition rubble containing asbestos would be likely to be in the region of £30-50,000 (100 cubic metres)
