# Appendix 1

Title UNION TERRACE GARDENS Balustrade Report As-Built			
Original Scale As Shown	Designed/Drawn Fraser Conway	Checked Fraser Conway	Authorised
Date 10/10/19	Date 10/10/19	Date 00/00/00	
Status W	Drawing Number UTG/FC002	Rev A

Project Title  
**Union Terrace Gardens**

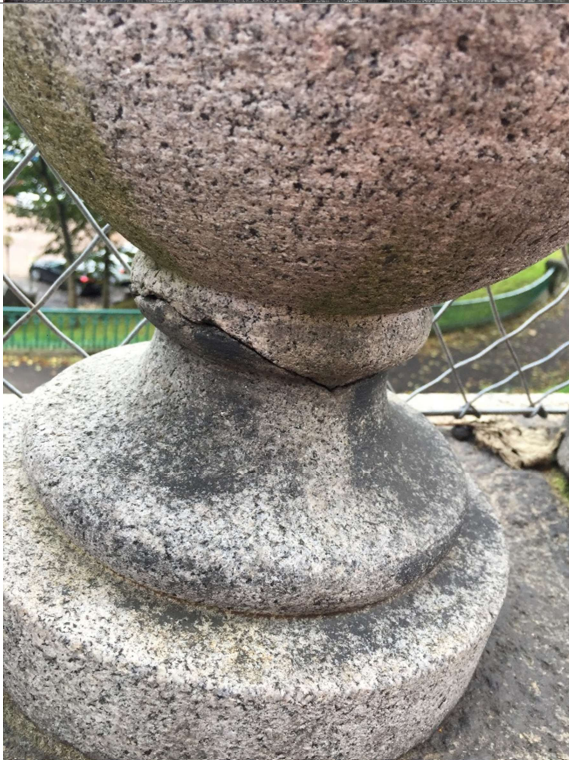
<p>5</p>	<p>Section 5 Balustrade 15</p>	<p>Paint on balustrade</p>	 
<p>6</p>	<p>Section 5 Balustrade 22</p>	<p>Crack through bottom neck</p>

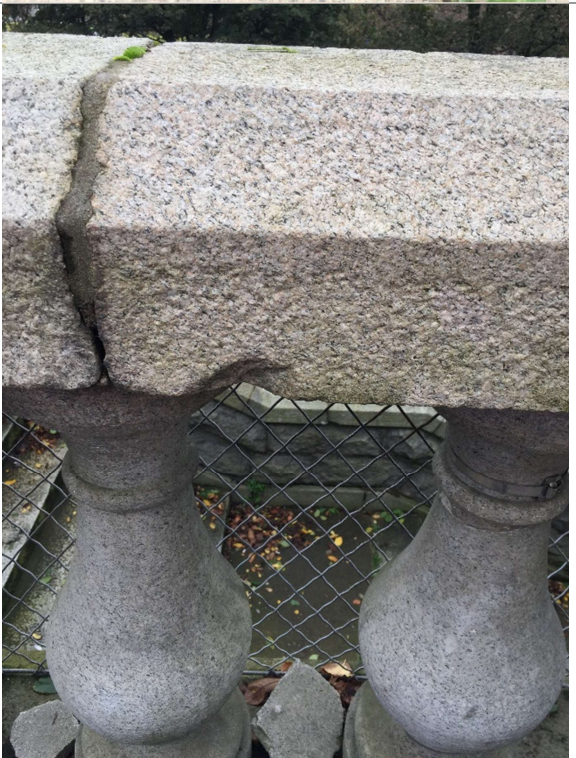
<p><b>19</b></p>	<p>Section 15 Balustrade 6</p>	<p>Crack through bottom neck</p>	 
<p><b>20</b></p>	<p>Section 16 Slab 5</p>	<p>Big chip on outer side</p>

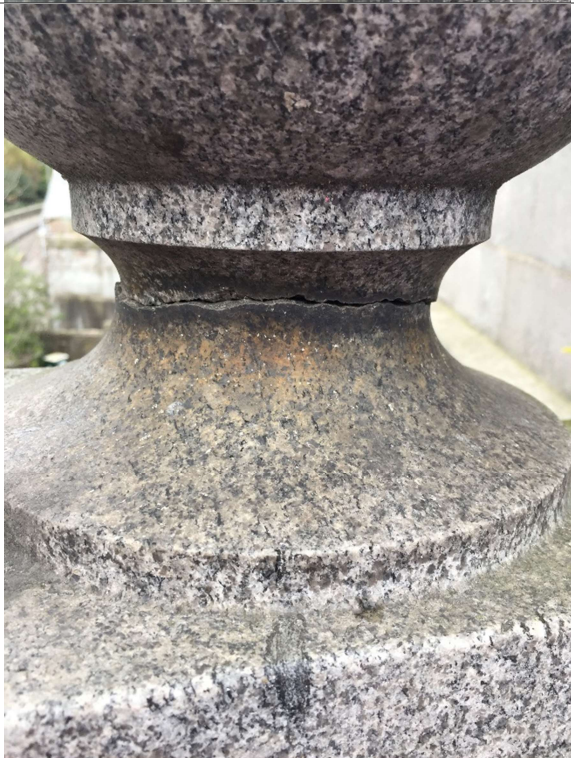
<p><b>39</b></p>	<p>East Union Street Section Balustrade 3</p>	<p>Crack through bottom neck</p>	 
<p><b>40</b></p>	<p>East Union Street Section Balustrade 4</p>	<p>Crack through bottom neck</p>
