7.3 THE BEACH BALLROOM

INTRODUCTION

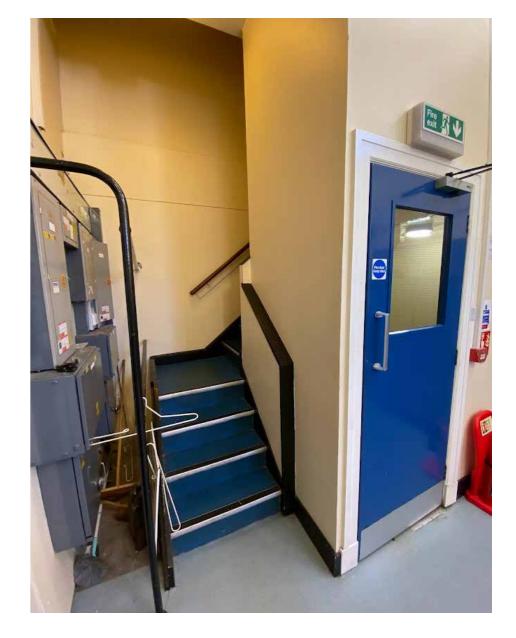
Unprotected escape staircase and exposed services

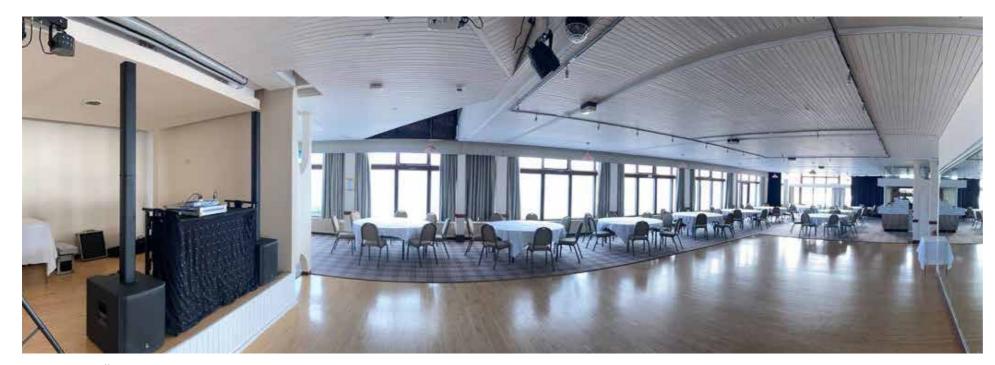
Existing Star Ballroom Interior

- O1 South end of Ballroom is cordened off with curtain screening which reduces usable space and does not maximise opportunities for views towards the beach

- Existing facade envelope is showing signs of corrosion due to the marine environment and general poor upkeep / maintenance. Weathering of materials likely to worsen over time. Single glazed curtain walling will continue to contribute to poor EPC rating (G-).

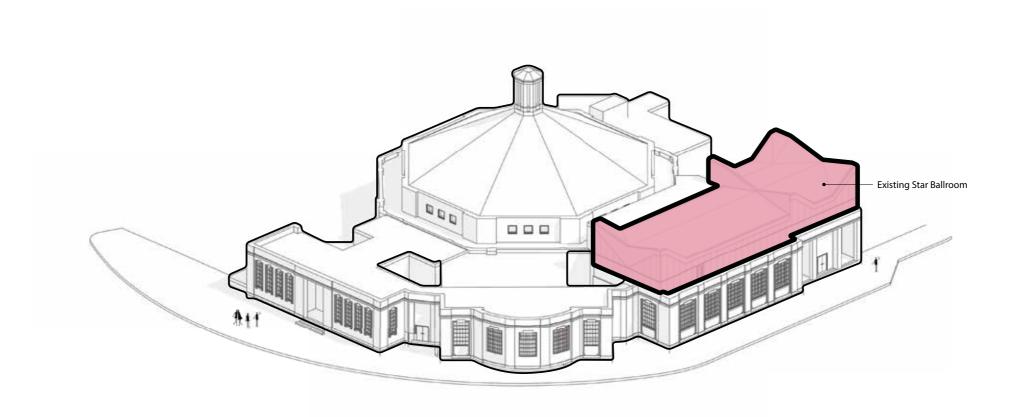
Existing Ballroom extension

The Star Ballroom extension is typical of 1970 design; the curtain walling and metal cladding has suffered from close proximity to the marine environment. Corrosion of the cladding portrays a distressed / weathered look to the building.

Replacement of the existing Star Ballroom would tackle a number of significant failings such as level access, energy performance, visual appearance, functionality and ongoing maintenance issues.

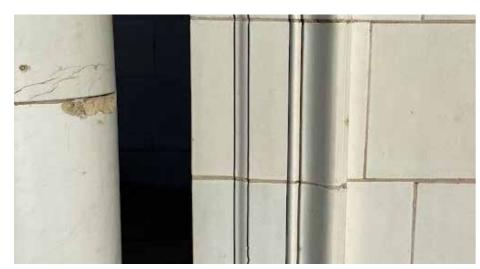
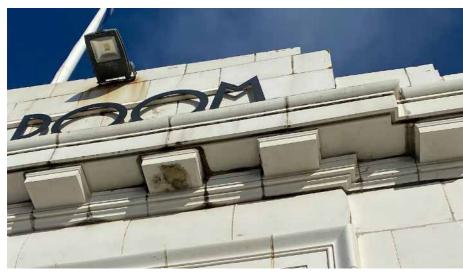
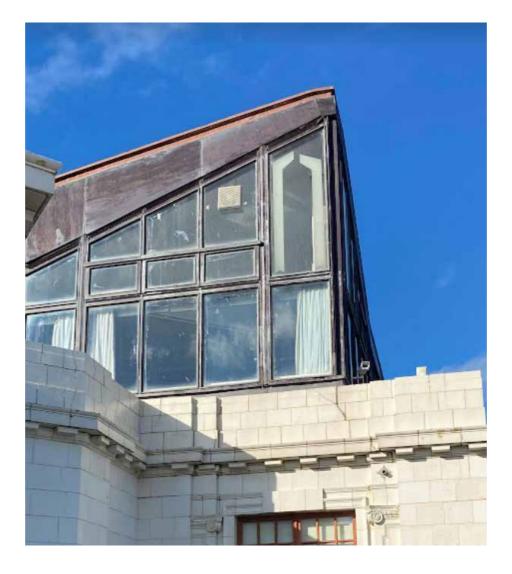
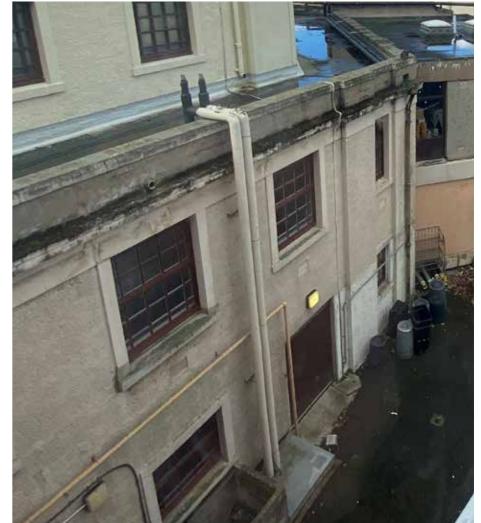
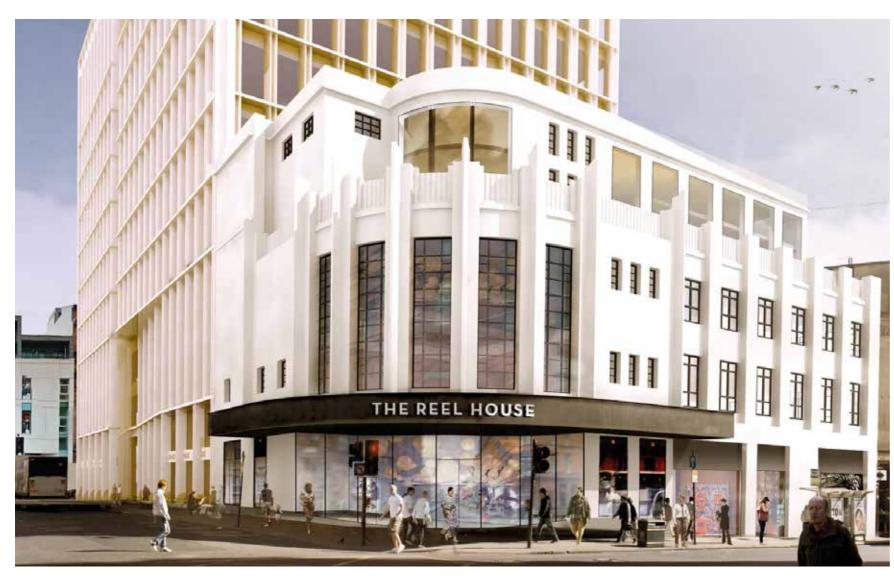
Although the west, south and east elevations of the original Ballroom building are in generally good condition, there are immediate and visible areas of deterioration in some areas most notably the Star Ballroom extension and the north elevation to the rear. The images below indicate some of these areas of concern.

In particular, the north elevation of the octagon is in poor condition, suffering from staining, damp and general poor upkeep. The tiled south facade would benefit from some intervention to repair broken ceramic tiling and remove staining.

Presently, the northern facade of the Ballroom is generally concealed from public view, however with the demolition of the Leisure Centre and implementation of the Masterplan, the Beach Ballroom will exist 'in the round' with no 'back elevation'. As such, it is recommended that the entire octagon envelope be restored to provide a continuous high standard of finish.

Consideration must be given to improving the roof drainage strategy so as to reduce the number of exposed rainwater downpipes around the building where possible.
