Balnagask
Outline RAAC Business
Case Review
July 2024
Issue 1

PROJECT TITLE:Balnagask RAAC Review

REPORT TITLE: Balnagask Outline RAAC Business Case Review

PROJECT REFERENCE: 160260

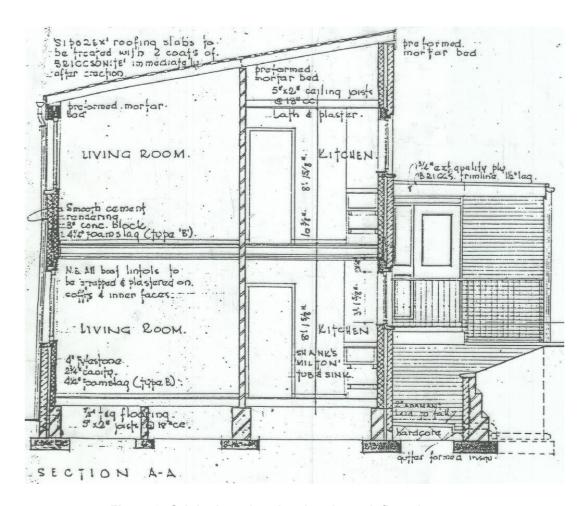
Figure 2: Original section drawing through flatted property

The properties at Balnagask are two-storey buildings with traditional cavity blockwork wall construction and mono-pitched 125mm (5") thick RAAC roof panels spanning front to back, bearing onto external walls and a 100mm thick central concrete brickwork partition. See Figures 2 - 5 showing typical existing building construction. Figure 6 shows the typical RAAC panels condition observed during structural surveys.

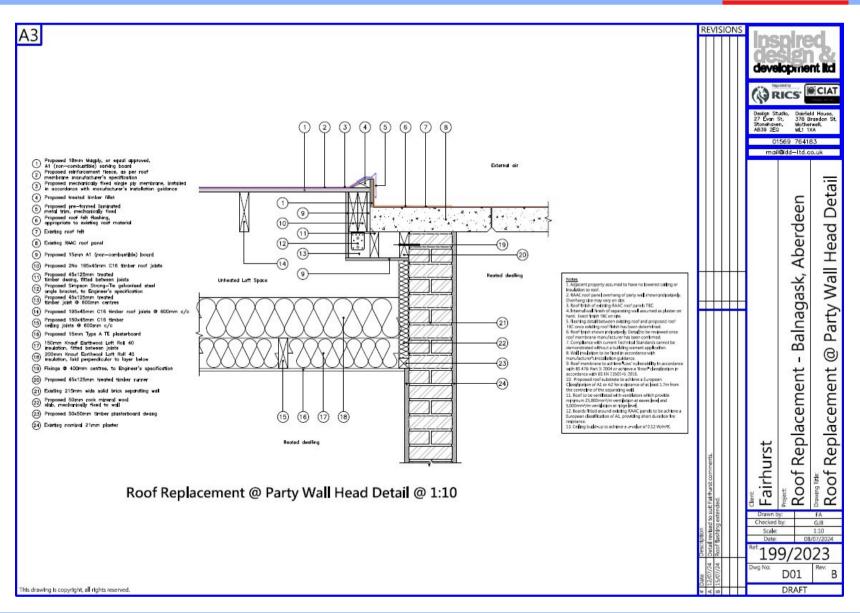
During our surveys existing RAAC panels were found to be bridging over party walls between properties. The 215mm party wall was also found to be built tight to underside of panels. Please see adjacent drawing showing the typical as built panel arrangement. To minimise disruption to adjacent properties during the removal of RAAC panels the following has been proposed:

New Roof Membrane Flashing: As part of the process, new roof membrane flashing will be installed up to the external face of the party wall. This ensures proper waterproofing and protects against any potential leaks.

For further detailed information, please refer to the proposed Architectural drawing D01.

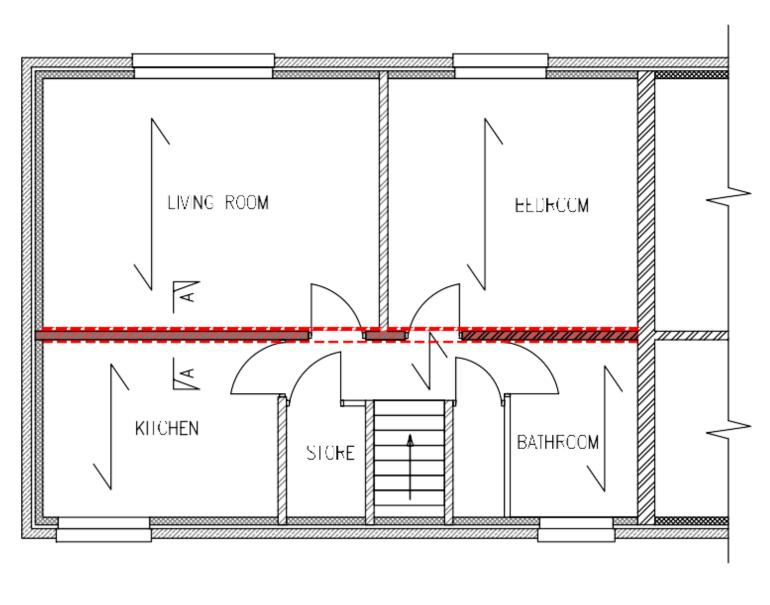
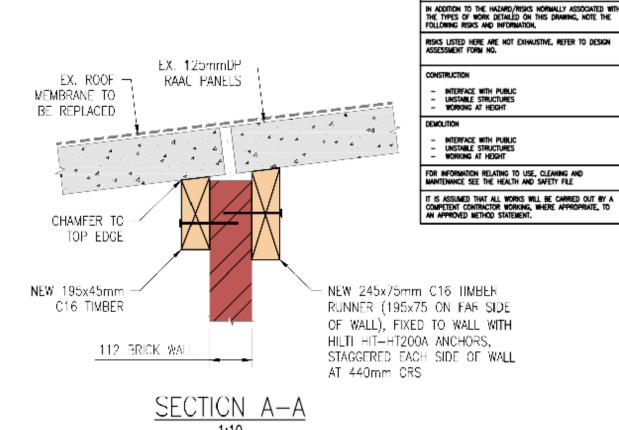
Option 1: Extending Bearing Supports

By virtue of the fact that the central support wall is only 100mm wide, none of the slabs supported on the central wall achieve the required 75mm minimum bearing, required by the IStructE guidance. Notwithstanding the fact that as part of the overall Risk Assessment we have undertaken and proven in all but one of our inspections that both longitudinal and transverse bars exist at the slab bearings along the central 100mm wide wall. Of all the slabs inspected to date, one slab within an unoccupied property was found to have a bearing of 10mm. This slab was considered **RED Critical**. Propping was put in place to temporarily address this defect.

NEW 195x75/245x75 C16 TIMBER RUNNER BOLTED TO WALL USING M10 HILTI HIT-HY200A ANCHORS AT 440mm c/c. MINIMUM EMBEDMENT 75mm
