FAIRHURST

Aberdeen City Council

Balnagask

Re-inspection Reports

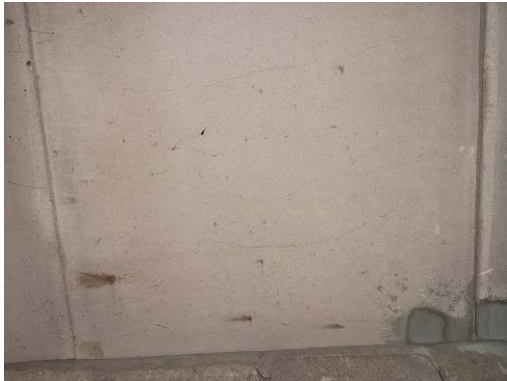
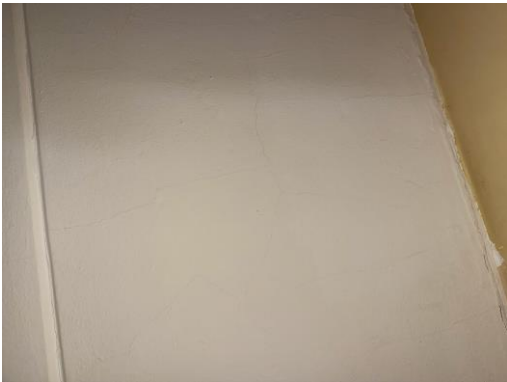
Risk Factors	Typical Survey Photographs
<p>Cut panels (Low Risk)</p> <ul style="list-style-type: none">– We did not identify any cut panels within the property via our hatch inspections.– No changes noted during inspection dated 27/01/2025.	
<p>Cracking (High Risk)</p> <ul style="list-style-type: none">– Transverse cracking found along full length of panels and within 500mm of the support.– No changes noted during inspection dated 27/01/2025.

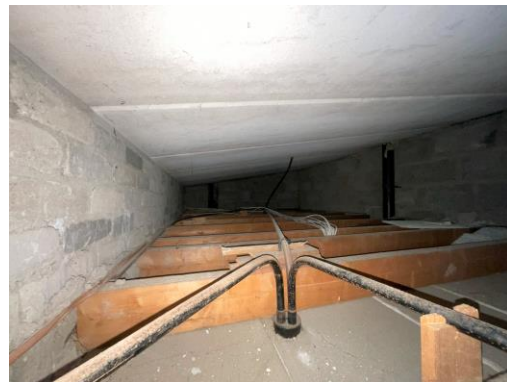
- No deflection measurements taken through the hatches, however, no excessive deflections noted from visual inspection.
- No changes noted during inspection dated 27/01/2025.

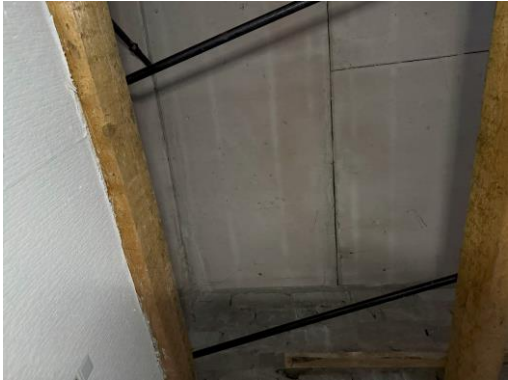
Risk Factors	Typical Survey Photographs
<p>Cut panels (High Risk)</p> <ul style="list-style-type: none">– Cut panel noted within the bathroom in the property.

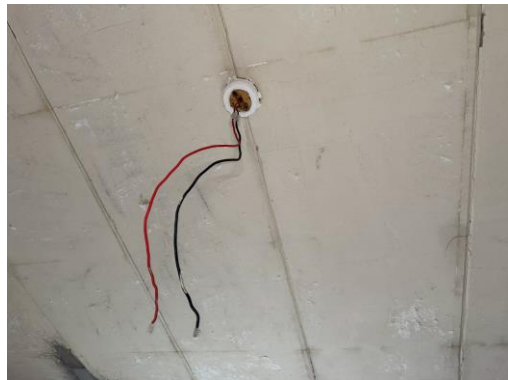
**Builder's works / building modifications
(High Risk)**

- Typically cored on site during construction for penetration of conduits and SVP with damage to units.

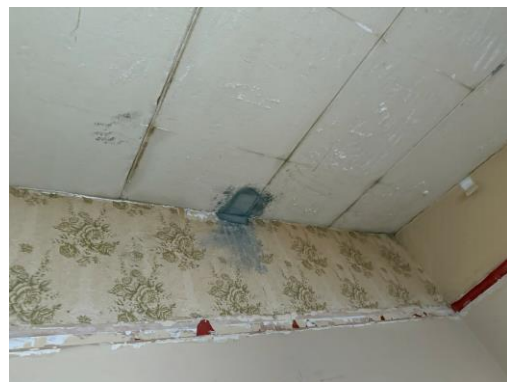
- Deflection measurements were taken during the initial inspections, with no issues present.
- Areas were visually inspected during this follow up inspections, with no issues noted.

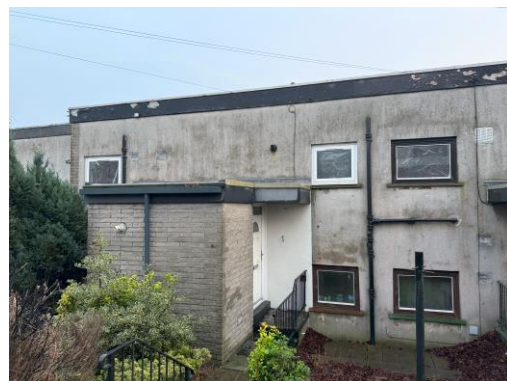
- Replacement roofing system with additional insulation noted.

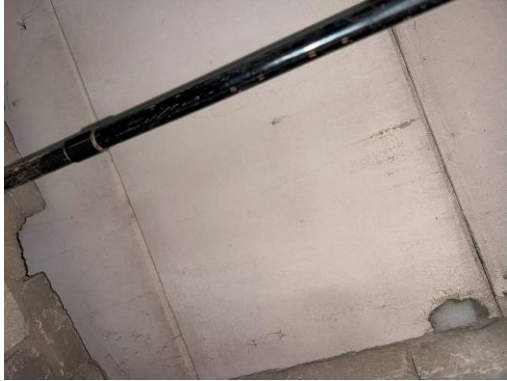
Risk Factors	Typical Survey Photographs
Cut panels (Low Risk) <ul style="list-style-type: none">– We did not identify any cut panels within the property via our hatch inspections.– No changes noted during inspection dated 23/01/2025.	
Cracking (High Risk) <ul style="list-style-type: none">– Transverse cracking found along full length of panels and within 500mm of the support.– No changes noted during inspection dated 23/01/2025.

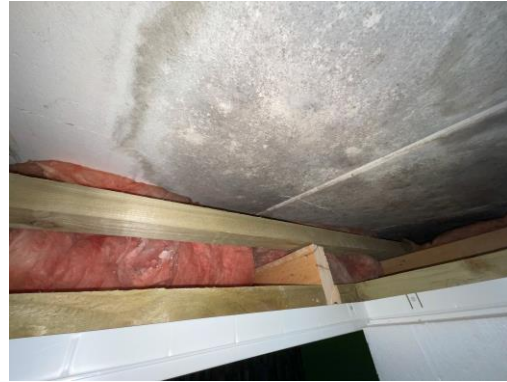
Water ingress (Medium Risk)

- Damp / mould noted to underside of panels within pend only, however, no visible signs of water penetration.
- No changes noted during inspection dated 23/01/2025.

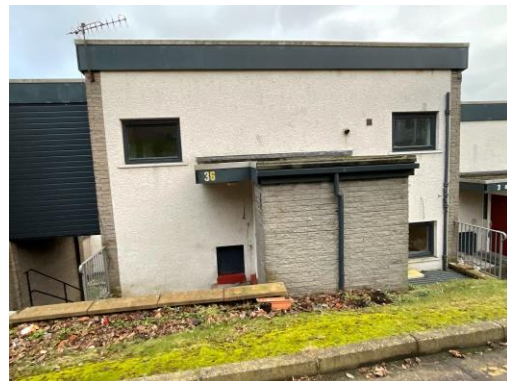
- Replacement roofing system with additional insulation noted.
- No changes noted during inspection dated 23/01/2025.

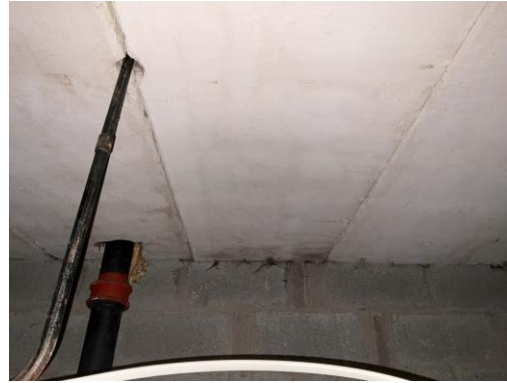
**Builder's works / building modifications
(High Risk)**

- Typically cored on site during construction for penetration of conduits and SVP with damage to units

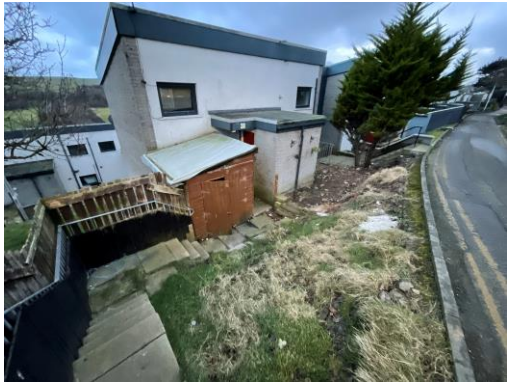
<p>Adverse or changes in loading (Medium Risk)</p> <ul style="list-style-type: none"> – Replacement roofing system with additional insulation noted

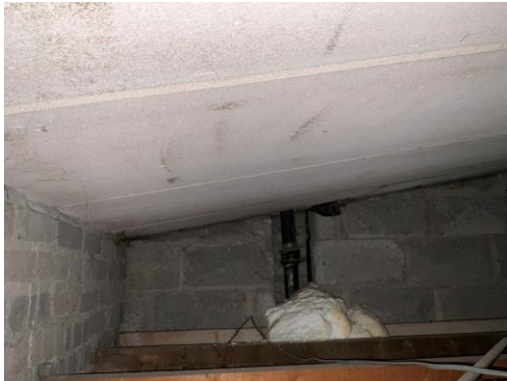
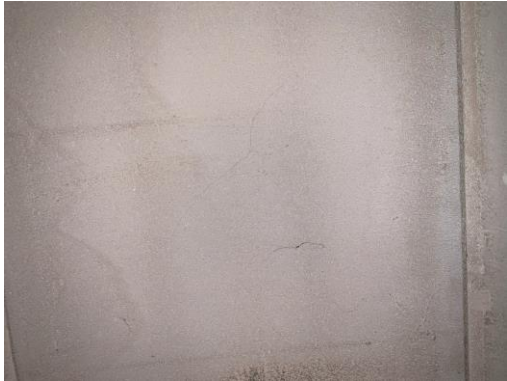
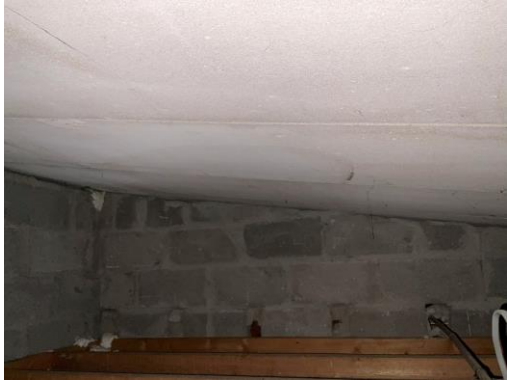
Risk Factors	Typical Survey Photographs
Cut panels (Low Risk) <ul style="list-style-type: none">– We did not identify any cut panels within the property via our hatch inspections.– No changes noted during inspection dated 23/01/2025.	
Cracking (High Risk) <ul style="list-style-type: none">– Transverse cracking found along full length of panels and within 500mm of the support.– Minor concrete spalling to edge of 1no. panel– No changes noted during inspection dated 23/01/2025.

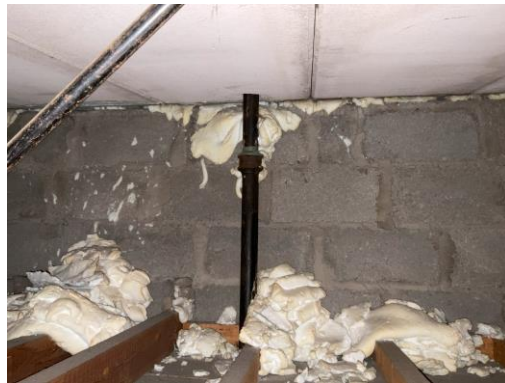
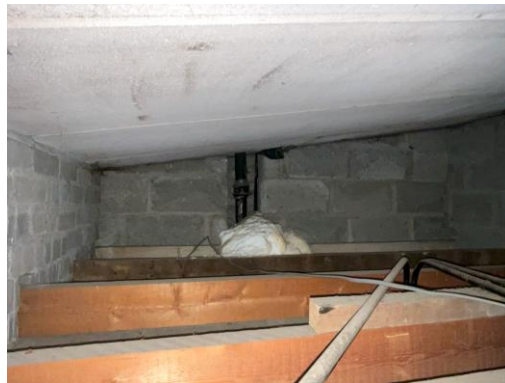
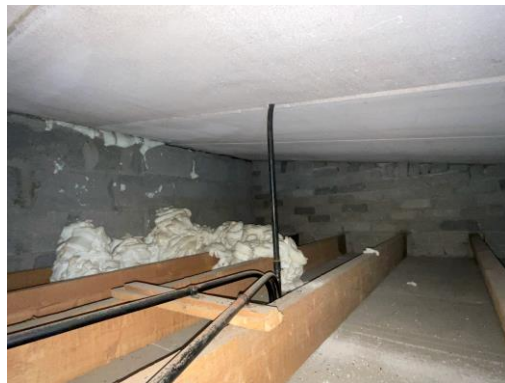
**Builder's works / building modifications
(High Risk)**

- Typically cored on site during construction for penetration of conduits and SVP with damage to units
- Expanding foam material noted in roof space
- No changes noted during inspection dated 23/01/2025.

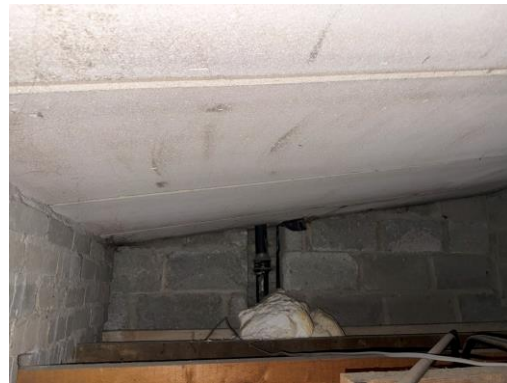
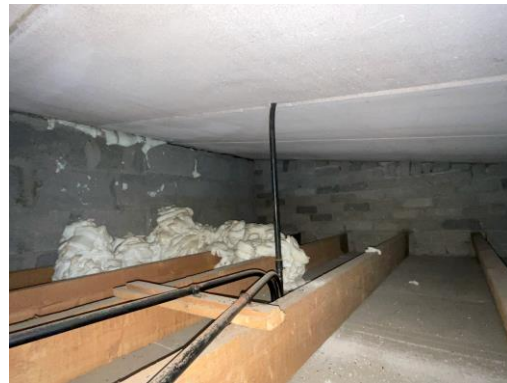
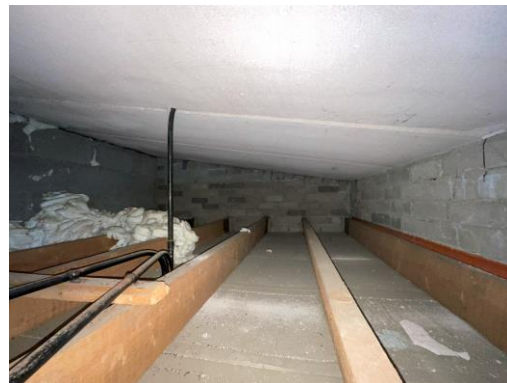
Deflection measurements (Medium Risk)

- No deflection measurements taken through the hatches, however, no excessive deflections noted from visual inspection.
- No changes noted during inspection dated 23/01/2025.

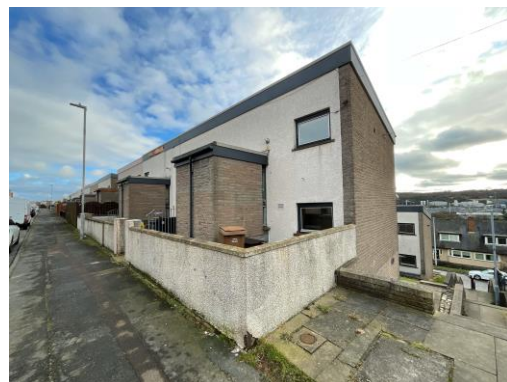
Adverse or changes in loading (Medium Risk)

- Replacement roofing system with additional insulation noted
- No changes noted during inspection dated 23/01/2025.

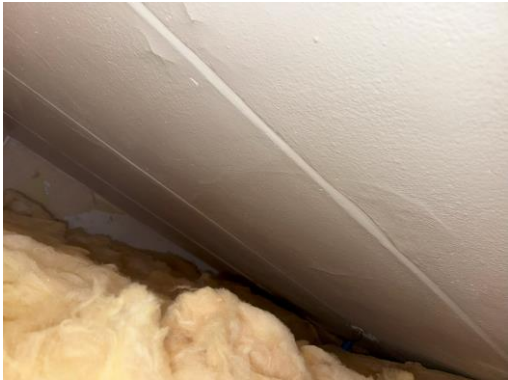
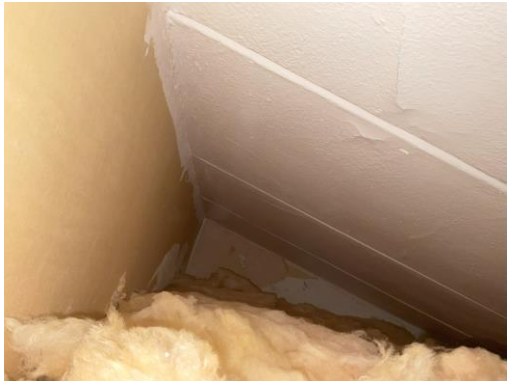
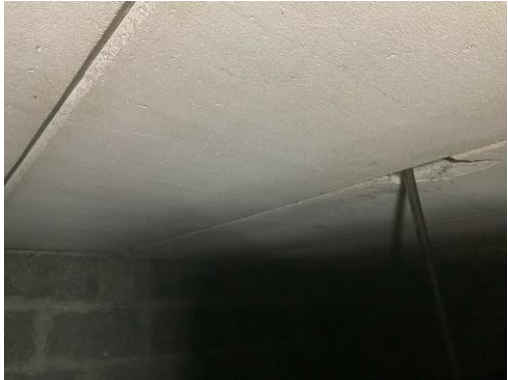
Risk Factors	Typical Survey Photographs
Cut panels (Low Risk) <ul style="list-style-type: none">– We did not identify any cut panels within the property via our hatch inspections.– No changes noted during inspection dated 27/01/2025.	
Cracking (High Risk) <ul style="list-style-type: none">– Transverse cracking found along full length of panels and within 500mm of the support.– No changes noted during inspection dated 27/01/2025.

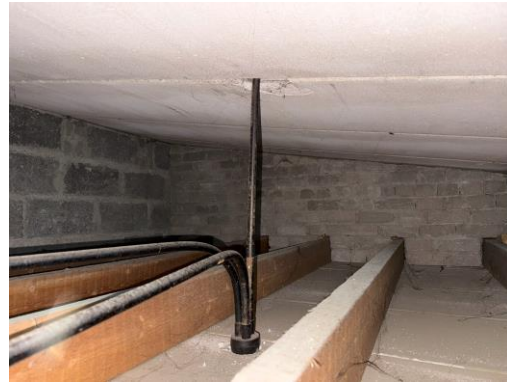
**Builder's works / building modifications
(High Risk)**

- Typically cored on site during construction for penetration of conduits and SVP with damage to units
- No changes noted during inspection dated 27/01/2025.

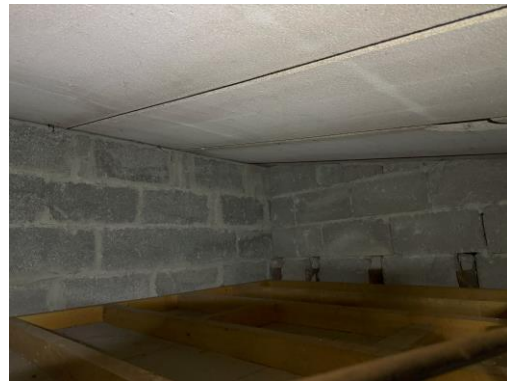
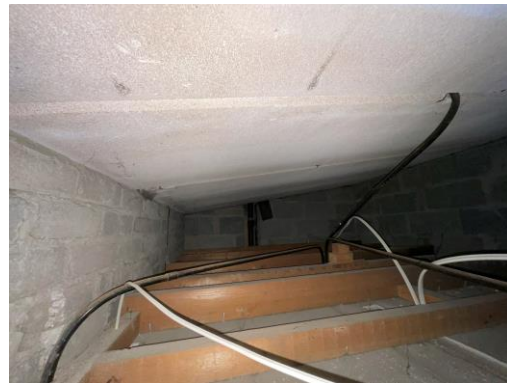
Deflection measurements (Medium Risk)

- No deflection measurements taken through the hatches, however, no excessive deflections noted from visual inspection.
- No changes noted during inspection dated 27/01/2025.

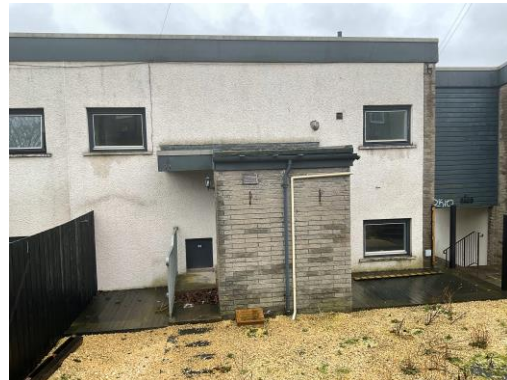
Adverse or changes in loading (Medium Risk)

- Replacement roofing system with additional insulation noted
- No changes noted during inspection dated 27/01/2025.

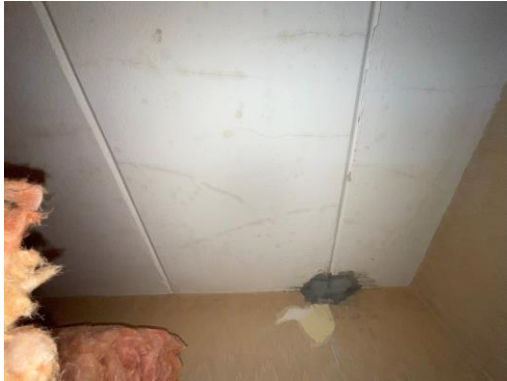
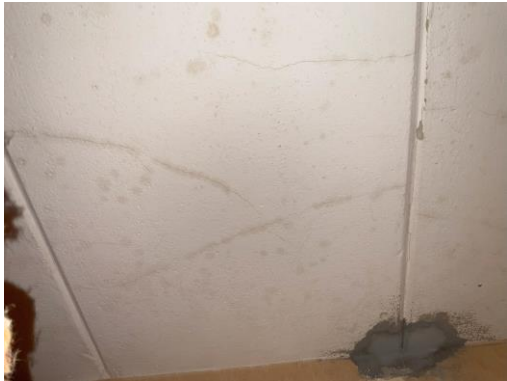
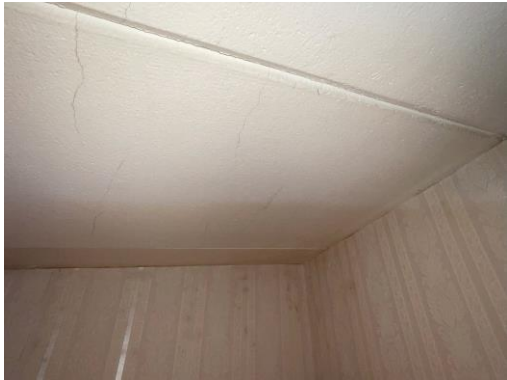
Risk Factors	Typical Survey Photographs
Cut panels (Low Risk) <ul style="list-style-type: none">– We did not identify any cut panels within the property via our hatch inspections.– No changes noted during inspection dated 23/01/2025.	
Cracking (High Risk) <ul style="list-style-type: none">– Transverse cracking found along full length of panels and within 500mm of the support.– No changes noted during inspection dated 23/01/2025.

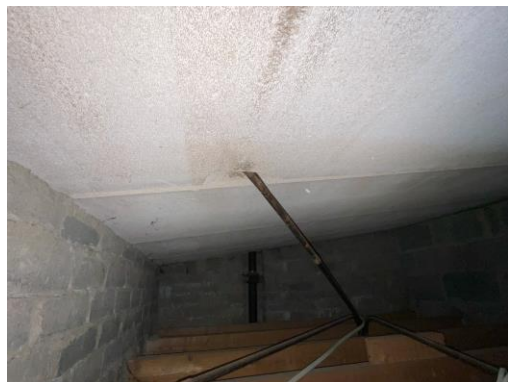
**Builder's works / building modifications
(High Risk)**

- Typically cored on site during construction for penetration of conduits and SVP with damage to units
- No changes noted during inspection dated 23/01/2025.

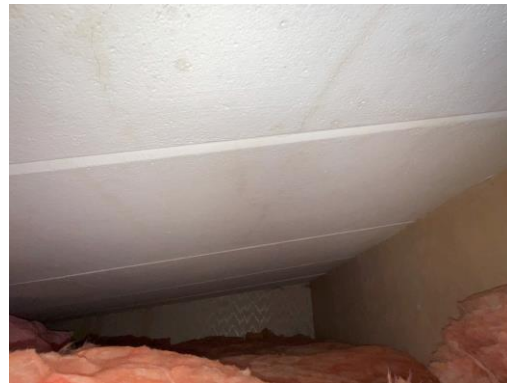
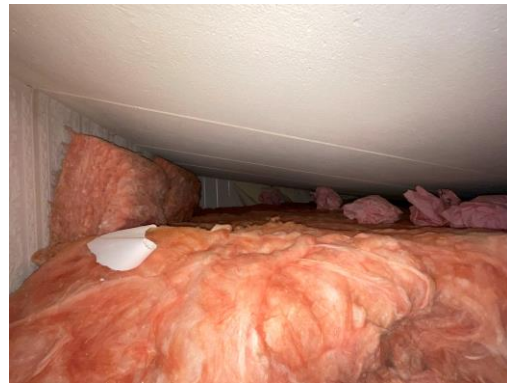
Deflection measurements (Medium Risk)

- No deflection measurements taken through the hatches, however, no excessive deflections noted from visual inspection.
- No changes noted during inspection dated 23/01/2025.

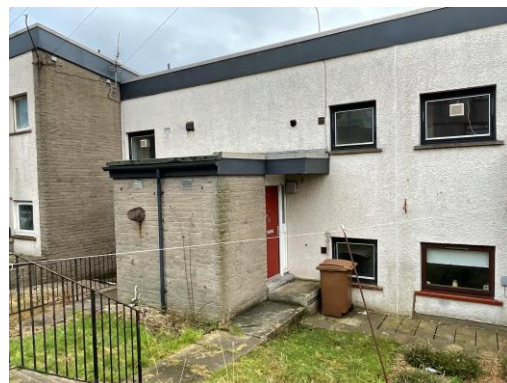
**Adverse or changes in loading (Medium Risk)**

- Replacement roofing system with additional insulation noted
- No changes noted during inspection dated 23/01/2025.

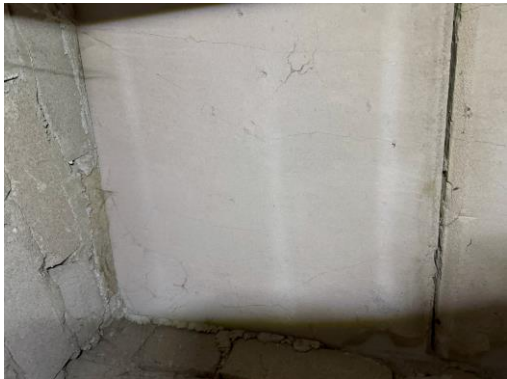
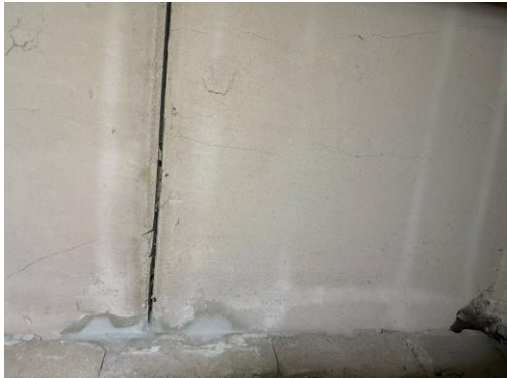
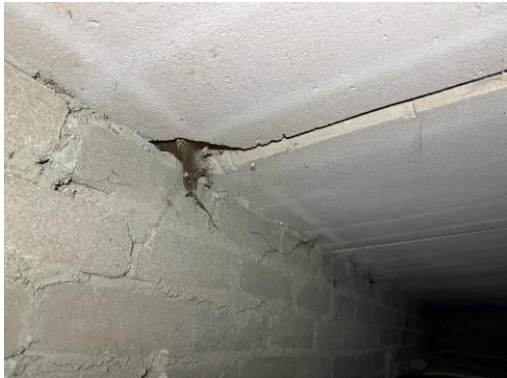
Risk Factors	Typical Survey Photographs
Cut panels (Low Risk) <ul style="list-style-type: none">– We did not identify any cut panels within the property via our hatch inspections.– No changes noted during inspection dated 27/01/2025.	
Cracking (High Risk) <ul style="list-style-type: none">– Transverse cracking found along full length of panels and within 500mm of the support.– Longitudinal cracking noted along 1no. panel.– Minor spalling noted with reinforcement noted in 1no. location.– No changes noted during inspection dated 27/01/2025.

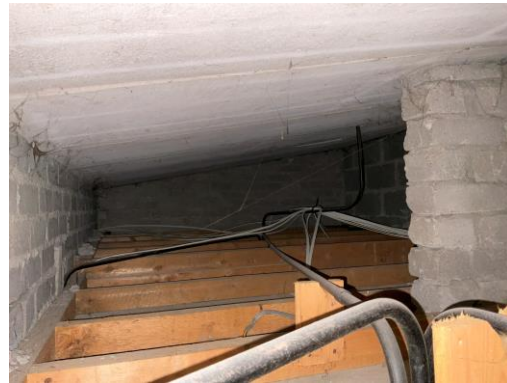
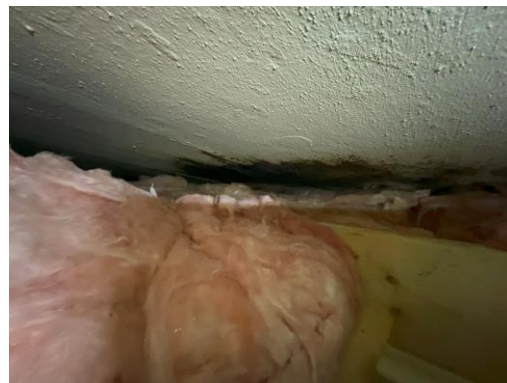
**Builder's works / building modifications
(High Risk)**

- Typically cored on site during construction for penetration of conduits and SVP with damage to units
- Previous repair noted to panel
- No changes noted during inspection dated 27/01/2025.

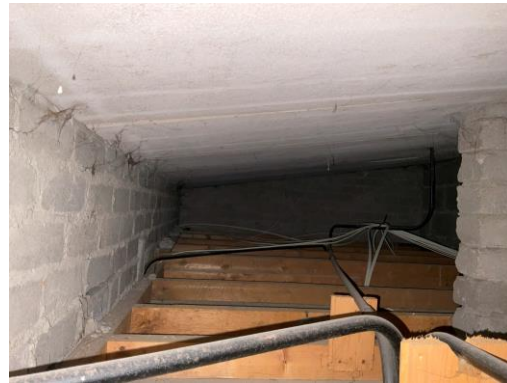
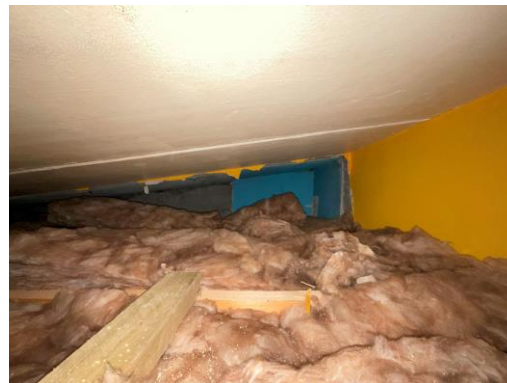
Deflection measurements (Medium Risk)

- No deflection measurements taken through the hatches, however, no excessive deflections noted from visual inspection.
- No changes noted during inspection dated 27/01/2025.

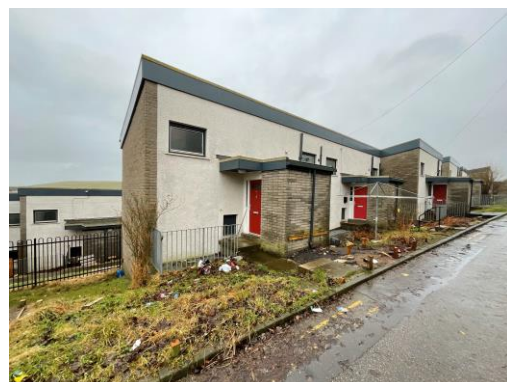
Adverse or changes in loading (Medium Risk)

- Replacement roofing system with additional insulation noted.
- No changes noted during inspection dated 27/01/2025.

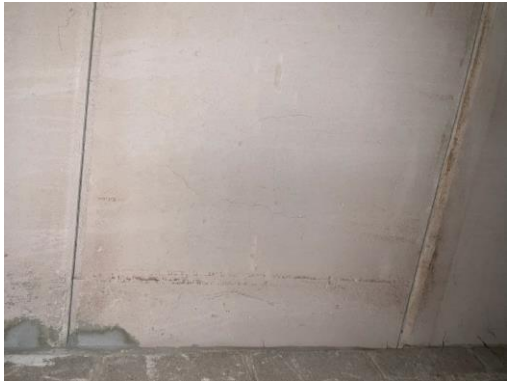
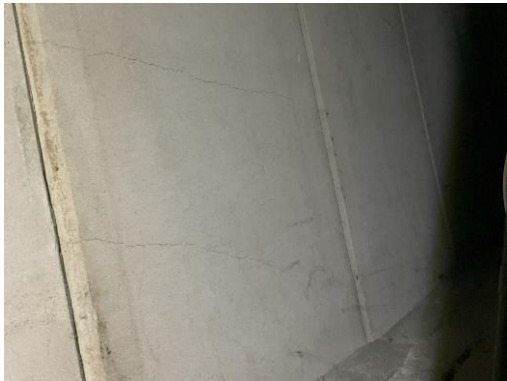
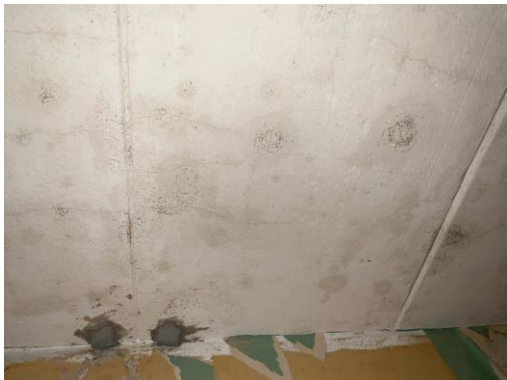
Risk Factors	Typical Survey Photographs
<p>Cut panels (Low Risk)</p> <ul style="list-style-type: none">– We did not identify any cut panels within the property via our hatch inspections.– No changes noted during inspection dated 27/01/2025.	
<p>Cracking (High Risk)</p> <ul style="list-style-type: none">– Transverse cracking found along full length of panels and within 500mm of the support.– No changes noted during inspection dated 27/01/2025.

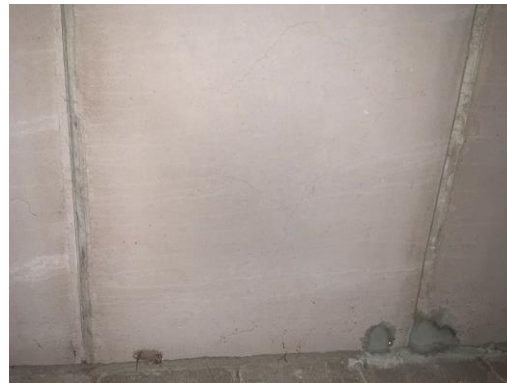
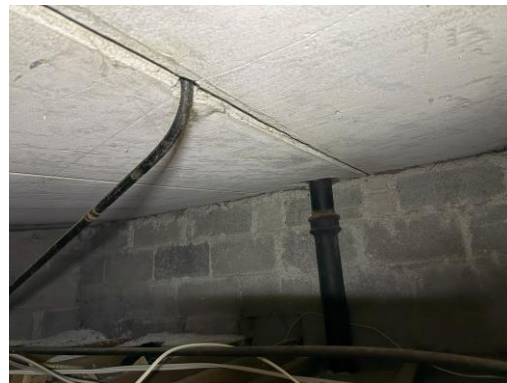
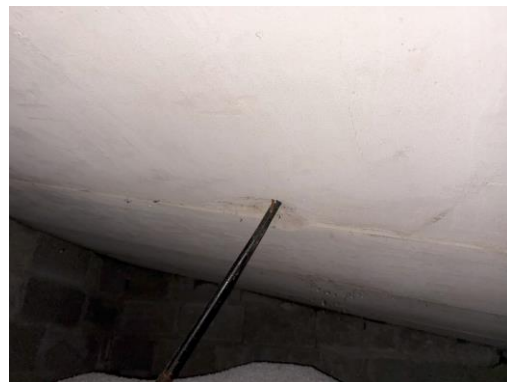
**Builder's works / building modifications
(High Risk)**

- Typically cored on site during construction for penetration of conduits and SVP with damage to units
- No changes noted during inspection dated 27/01/2025.

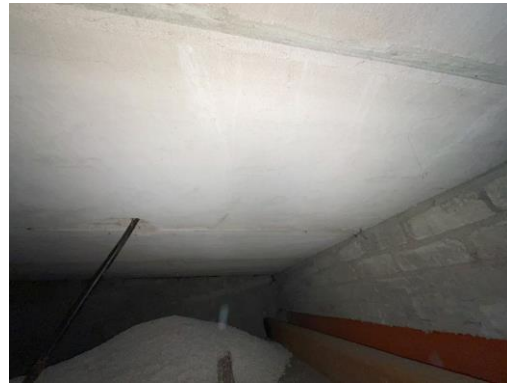
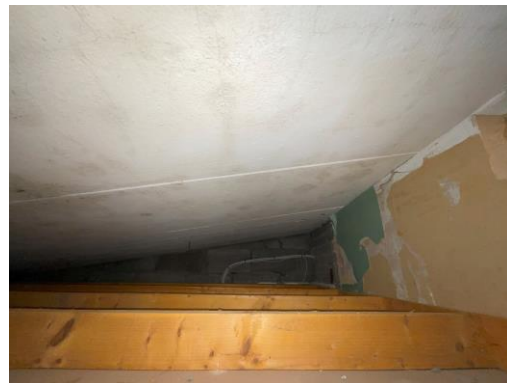
Deflection measurements (Medium Risk)

- No deflection measurements taken through the hatches, however, no excessive deflections noted from visual inspection.
- No changes noted during inspection dated 27/01/2025.

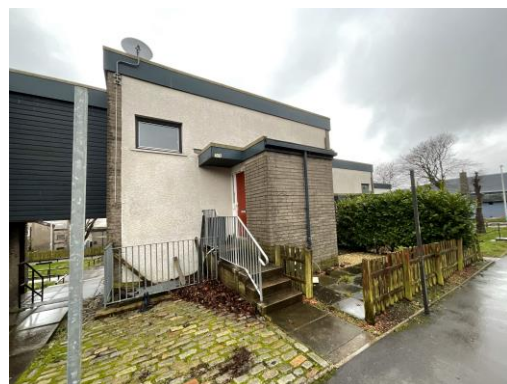
Adverse or changes in loading (Medium Risk)

- Replacement roofing system with additional insulation noted
- No changes noted during inspection dated 27/01/2025.

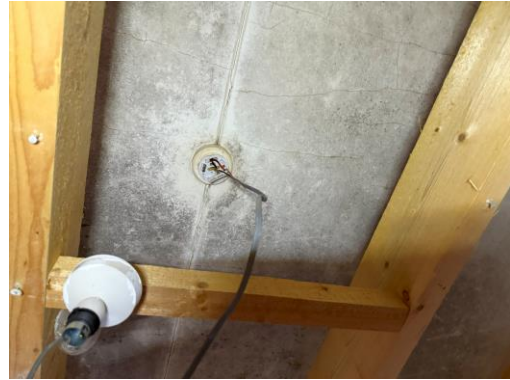
Builder's works / building modifications
(High Risk)

- Typically cored on site during construction for penetration of conduits and SVP with damage to units.

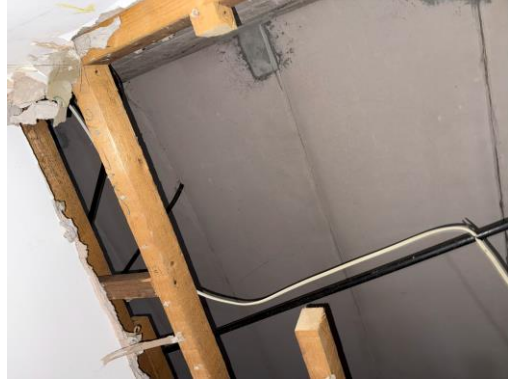
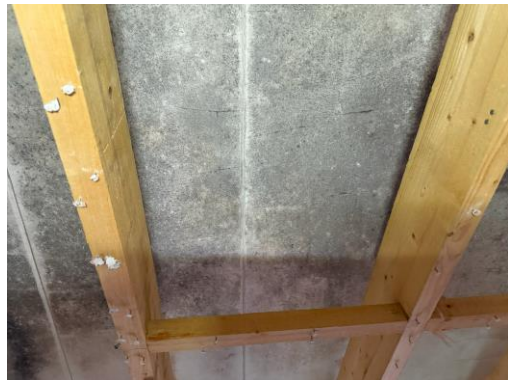
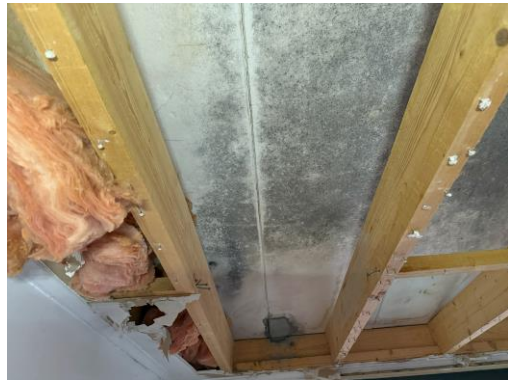
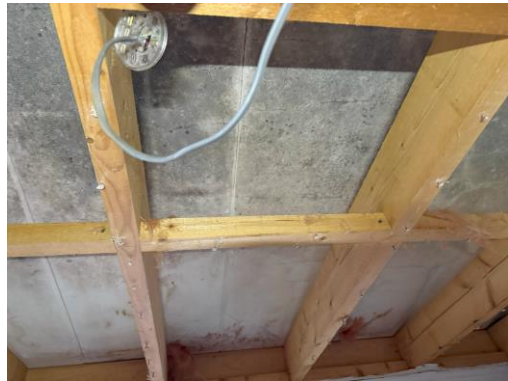
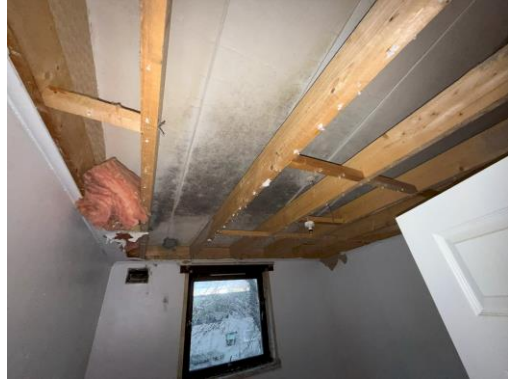
Water ingress (Low Risk)

- We did not identify any water ingress within the property, however we did note the presence of black mould present to the panels within the bedroom

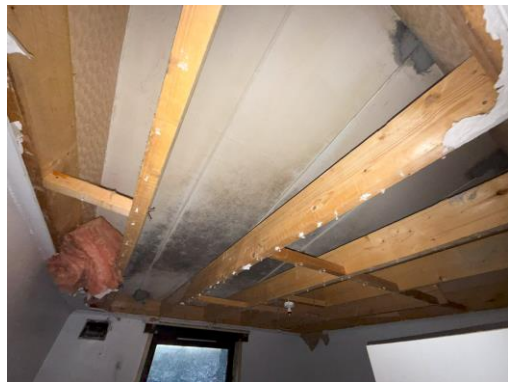
**Adverse or changes in loading
(Medium Risk)**

- Replacement roofing system with additional insulation noted.
