Aberdeen North Beach Coastal Defence

Feasibility Report

31 March 2017

Document reference: 378926 | 005 | B

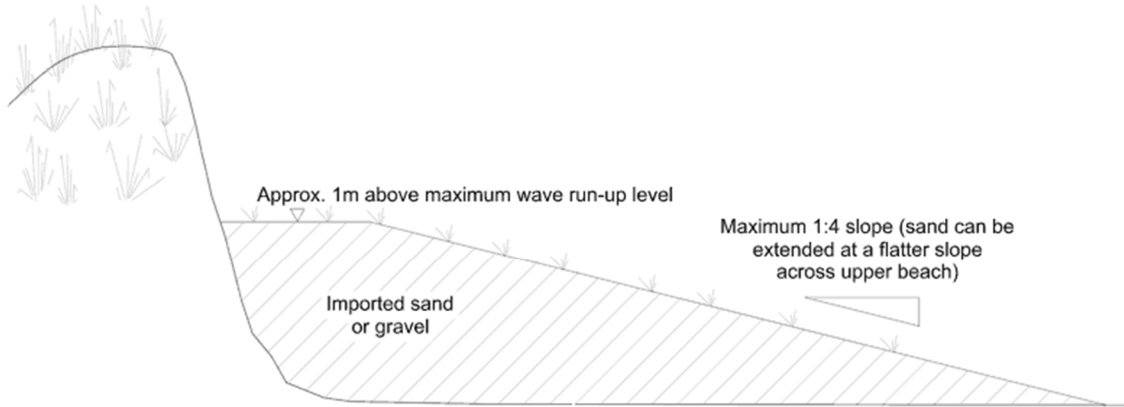
Figure 2: Beach Recharge

Imported sand should be stabilised by transplanting, fencing and/or thatching
