Donmouth Road Coastal Embankment

Phase 1 Desk Study

16 March 2017

Aberdeen City Council
Marischal College
Broad Street
Aberdeen
AB10 1AB

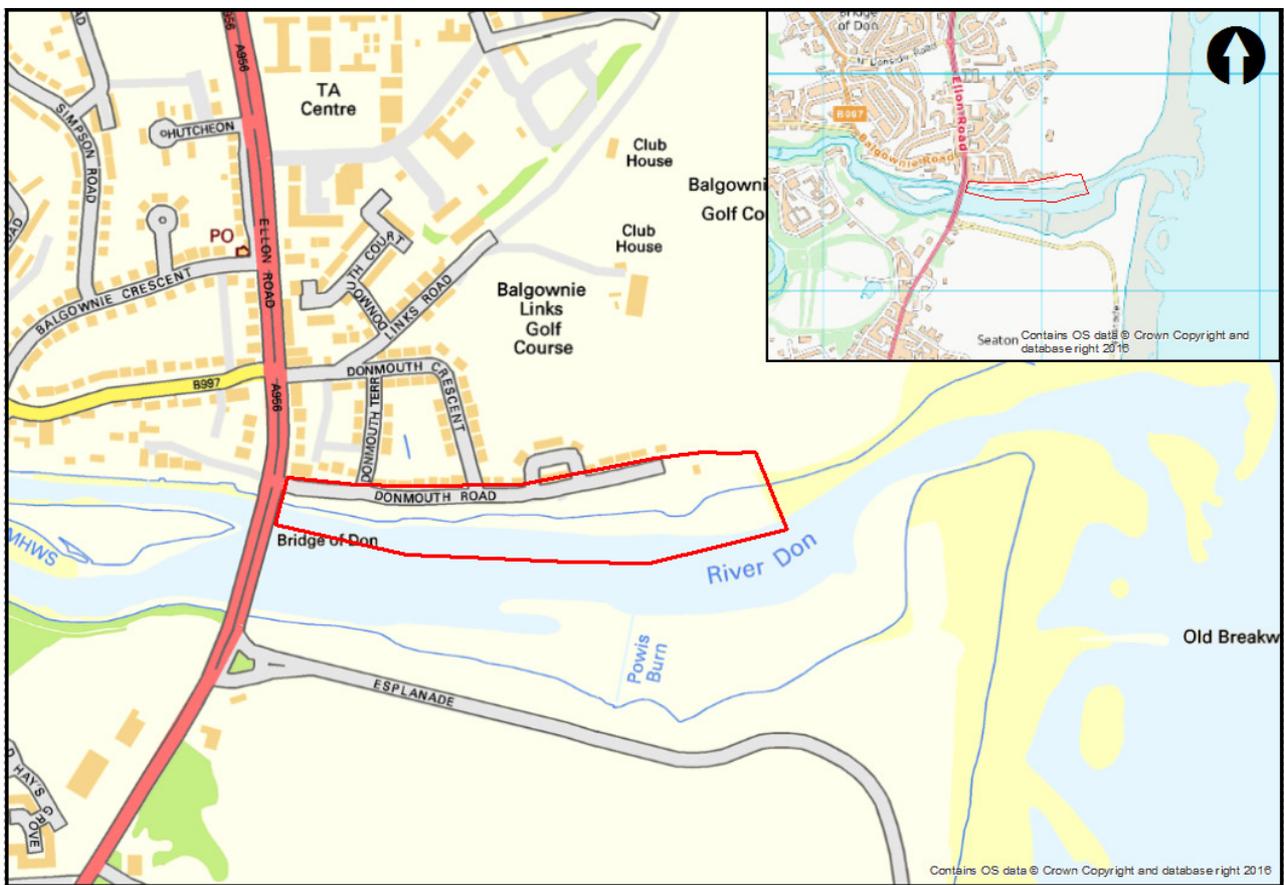
Figure 1.1: Indicative Site Boundary

Aberdeen City Council (ACC) have commissioned Mott MacDonald Ltd (MML) to undertake an initial assessment of the condition of a section of coastal embankment at the mouth of the River Don, Aberdeen and produce a Stage 1 Desk Study as part of an assessment of the site. This site is known as Donmouth Road Coastal Embankment. A site plan is included as Figure 1.1.

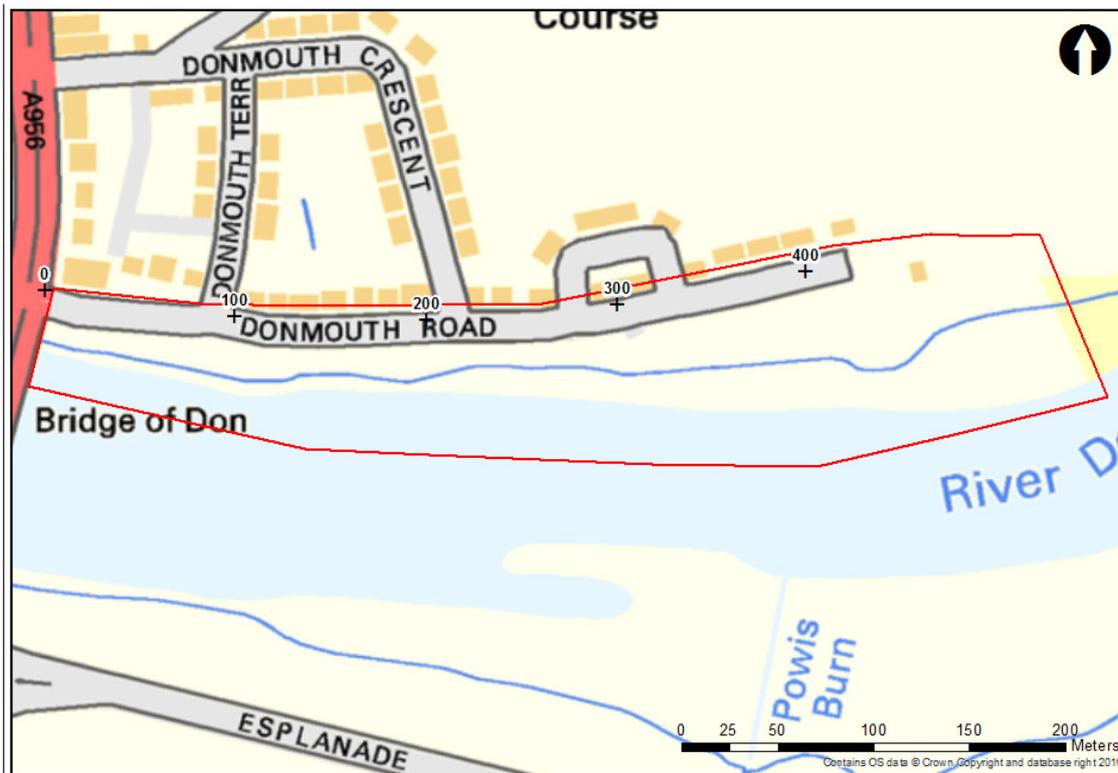
Figure 2.1: Site Plan Showing Chainages

A desk-based assessment of the site and ground conditions has been undertaken using information from readily available sources outlined in Section 1.2. To aid with description of the site, chainages have been assigned to Donmouth Road, as shown in Figure 2.1.

Note: Chainages in 100m intervals and noted as 'Ch100' in report text

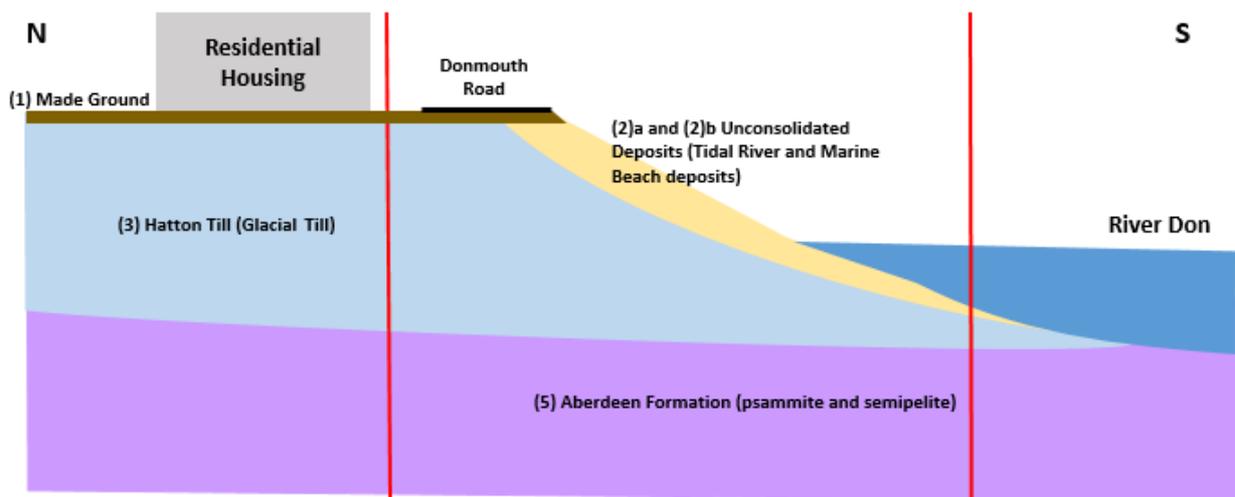
Figure 2.3: Illustrative Preliminary Ground Model

The preliminary ground model for the site has been compiled using available published information, and is shown in Table 2.2 and Figure 2.3.

(4) Brig o' Balgownie – Conglomerate and Sandstone is not shown, however expected to be encountered beneath superficial deposits in the east of the site.

Strata ID	Thickness (m)	Description	Comment
(1) Made Ground	Unknown	Unknown	Associated with historical development of the site and Donmouth Road.
(2) Unconsolidated deposits	(2)a Tidal River Deposits	Clay, silt and sand with localised peat and gravel	Present across the majority of the site.

(5) Aberdeen Formation	Unknown	Interlayered psammite and semipelite	Present in the west of the site.
